**STRUCTURAL ASSESSMENT AND REPORTING**

**THE LEAKING ROOF STRUCTURE  
TO THE DWELLING**

**ERF 4045, LEHAE EXT 1,  
19 BEAVER STREET**

**Reference: 51580-01**

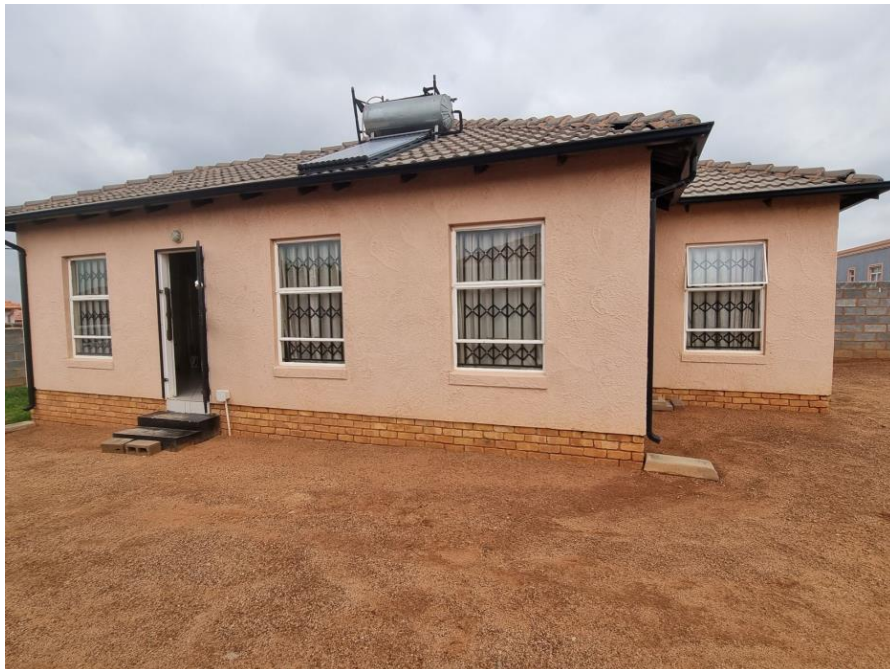
*Figure 1: Front/side elevation of the house*

ERF 4045 is located in Lehae Ext 1, Johannesburg. Lehae being one of Gauteng's newest suburbs is approximately twenty minutes by road from Johannesburg and situated next to Lenasia. The single storey dwelling comprises of a kitchen, living area, bathroom and 3 bedrooms. It is constructed out of masonry brickwork and the internal walls are plastered smooth and painted. The external walls are plastered and painted with a rough textured finish. The ceiling consists of gypsum board with gypsum cornices. The hip roof structure comprises of double roman concrete roof tiles on engineered timber trusses.

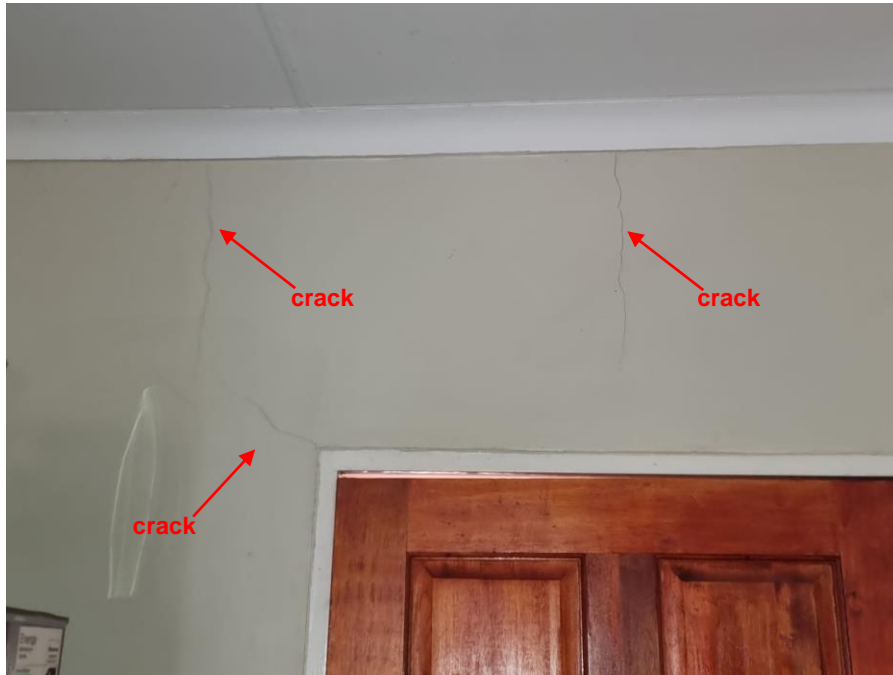
*Figure 2: Ceiling cornice and door frame*

Observed minor to moderate vertical and diagonal cracks extending from the ceiling cornice and door frame, (figure 2).

- We can confirm that the vertical and diagonal cracking to the internal wall in the kitchen, vertical cracking to the internal wall in bedroom 2 and diagonal cracking to the internal wall outside bedroom 2 and 3 is foundation related.

- Any damages shall be repaired.
- The cracks to all walls shall be repaired with a highly flexible sealant.
- The walls shall be re-painted.
- The Contractor shall take all necessary precautions to avoid damage to other areas of the building. The building must be returned to the owner in an acceptable, approved manner.

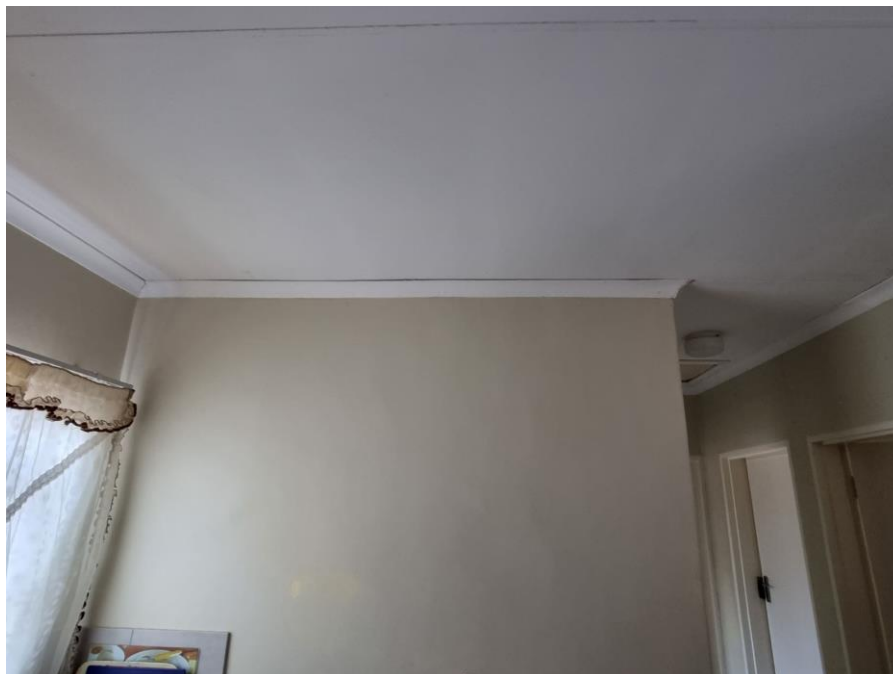
*Figure 3: Cornice and ceiling*

There is a noticeable gap between the cornice and ceiling, (figure 3).

- The gaps between the ceiling and cornice in the kitchen and bedroom 3 is minor as it is due to a loss of adhesion between the cornices and walls.

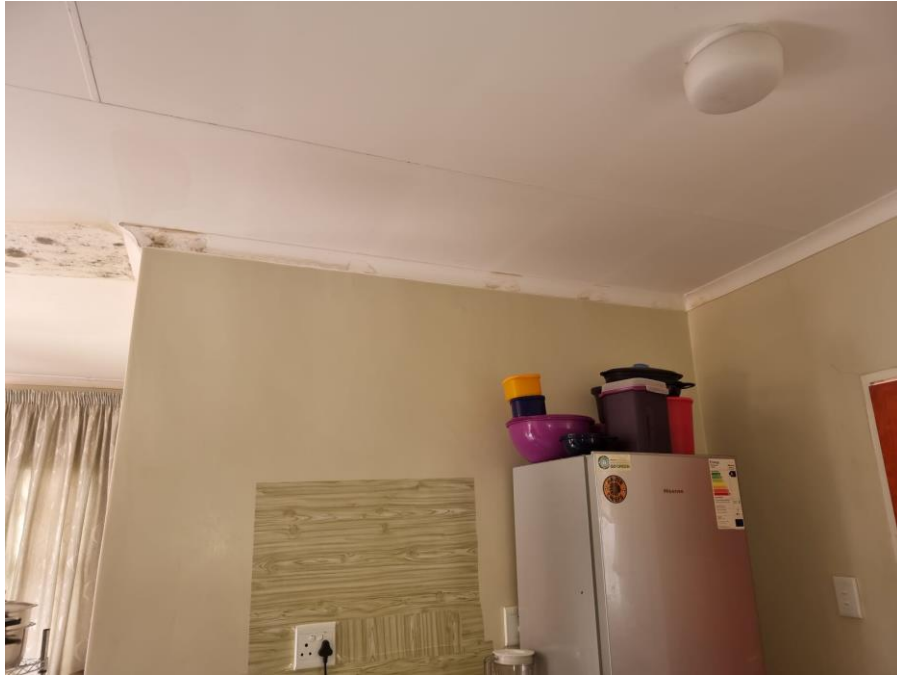
*Figure 4: Ceiling and cornices*

Water damage to the ceiling and cornices was observed, (figure 4).

- It would appear that the cause of water damage to the ceiling and cornices in the kitchen and living room, the cornices in the passageway and ceiling and cornices in bedroom 2 is due to water seepage through the gaps in the double roman concrete tiles as well as the ridge capping. The valley on the outside of the living room could also contribute to the water damage and flaking paint to the ceiling and cornices in the living room as it appears to be leaking.

- The solar geyser must be reinstalled on the rooftop and the plumbing shall be reconnected.
- The damaged ceiling boards and cornices in the kitchen, living room, passageway and bedroom 2 shall be replaced where necessary, cleaned, prepared and repainted to match the existing.

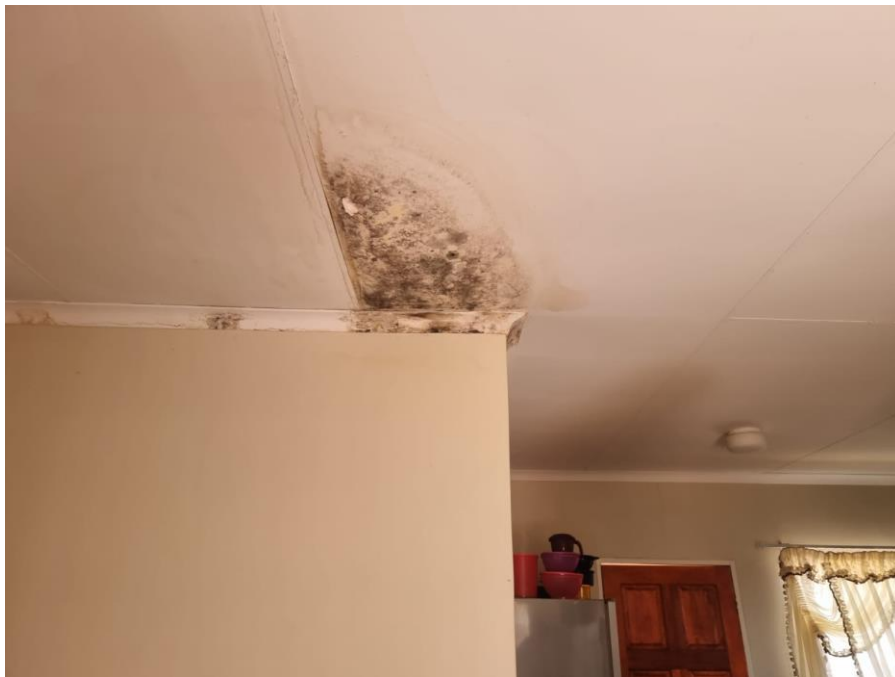
*Figure 5: Ceiling and cornice*

Observed water damage and flaking paint to the ceiling and cornice, (figure 5).

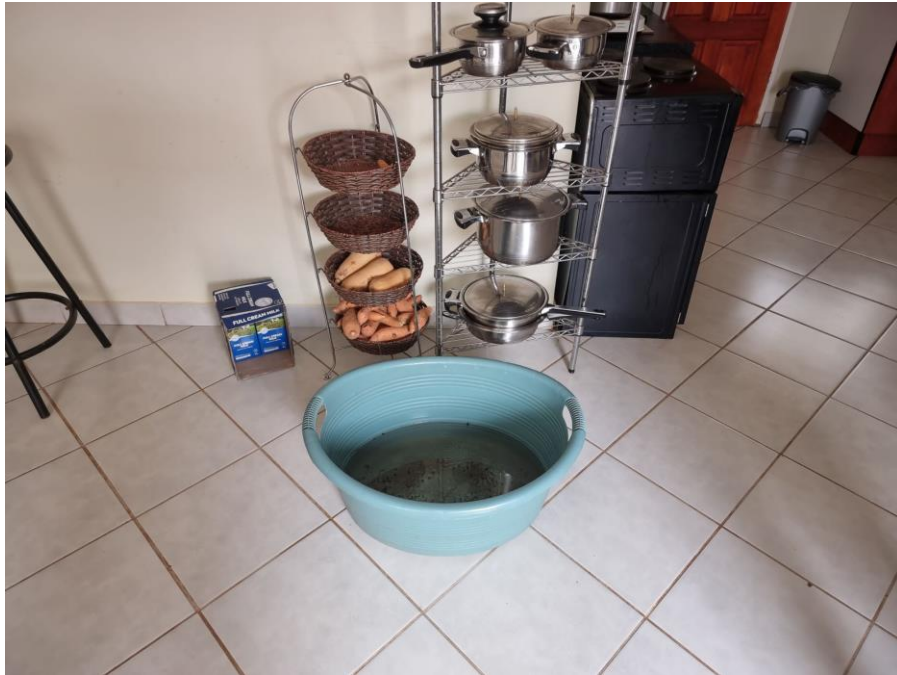
*Figure 6: Floor*

Observed a dish on the living room floor to collect water from the roof leak, (figure 6).

- The roof does not benefit from an underlay as a secondary water barrier therefore water leaks directly onto the ceiling thus damaging it. The water that collects on the ceiling boards also drips down onto the floor which is evident in the living room.

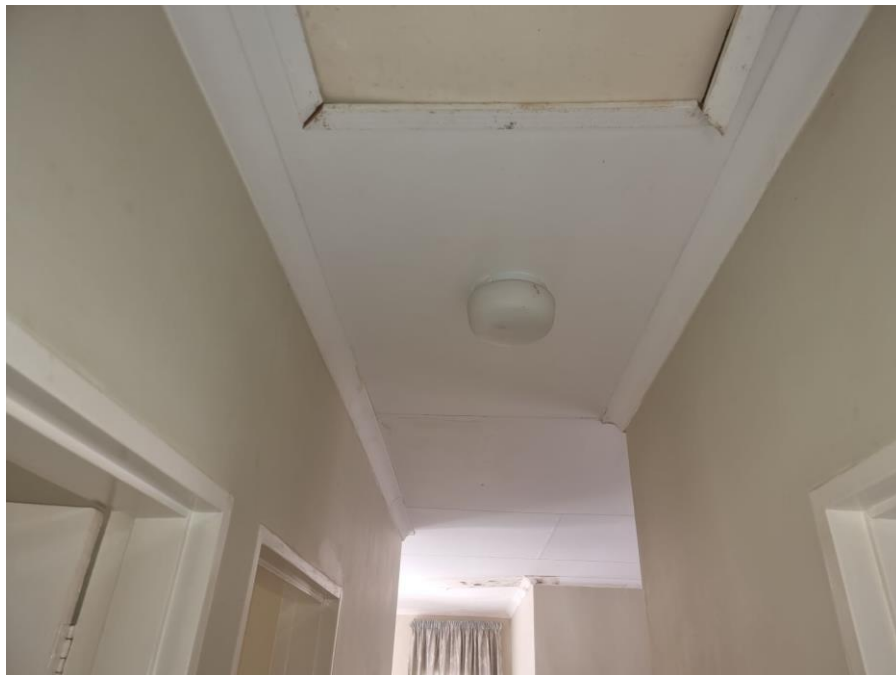
*Figure 7: Cornice*

Observed water damage to the cornice, (figure 7).

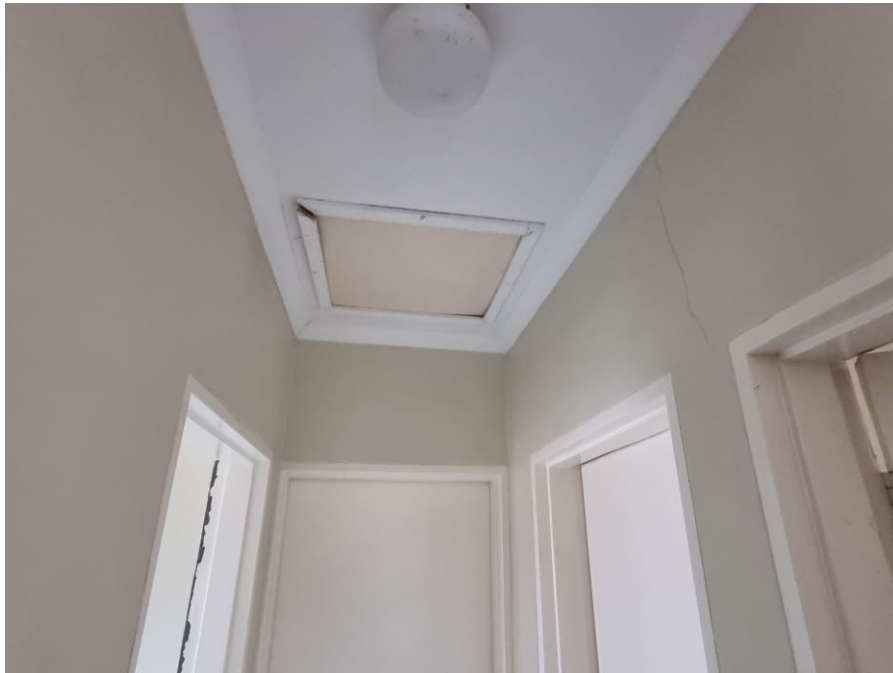
*Figure 8: Trap door*

The trap door frame appears to be loose around the corners, (figure 8).

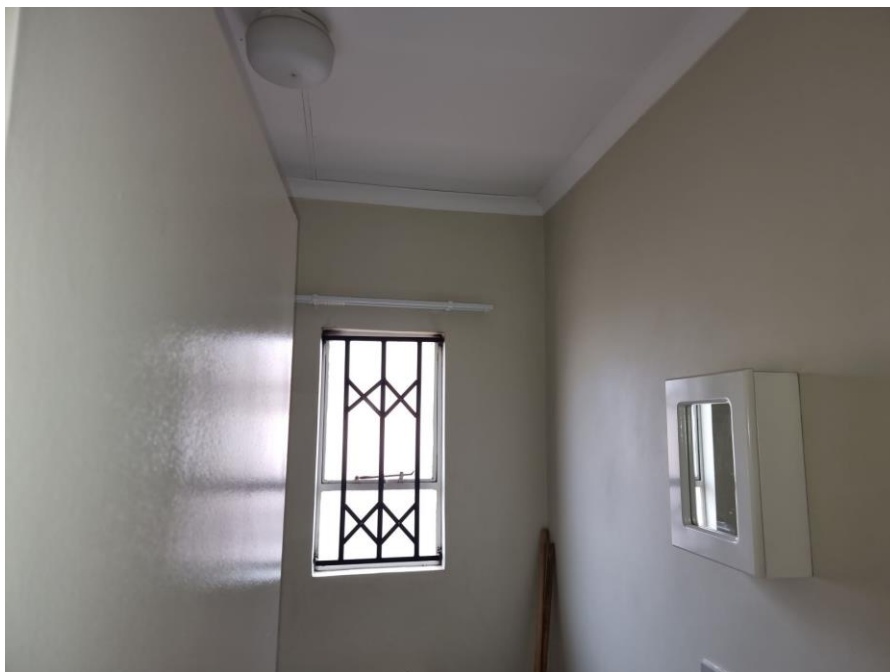
*Figure 9: Ceiling*

The ceiling appears to be in a satisfactory condition as no water seepage was visible, (figure 9).

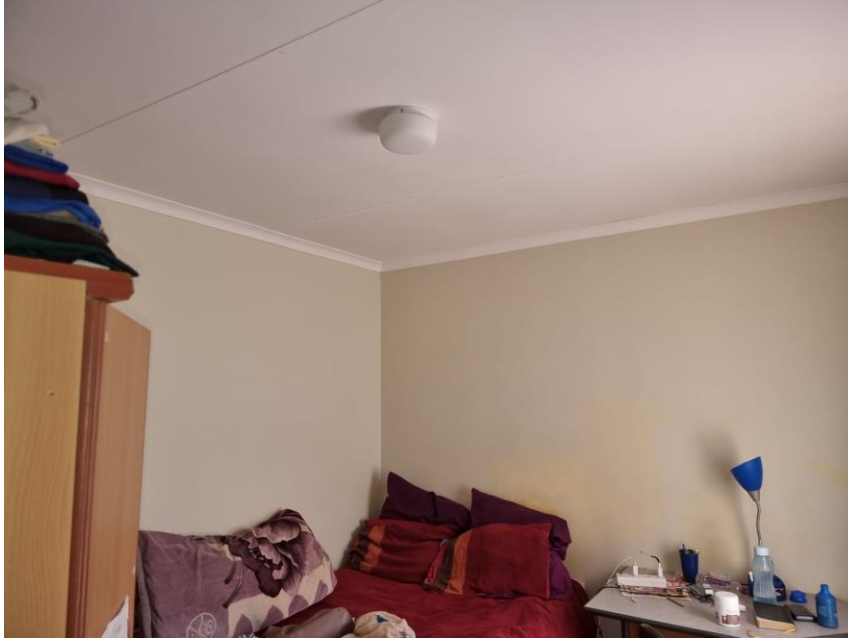
*Figure 10: Ceiling*

The ceiling appears to be in a satisfactory condition as no water seepage was visible, (figure 10).

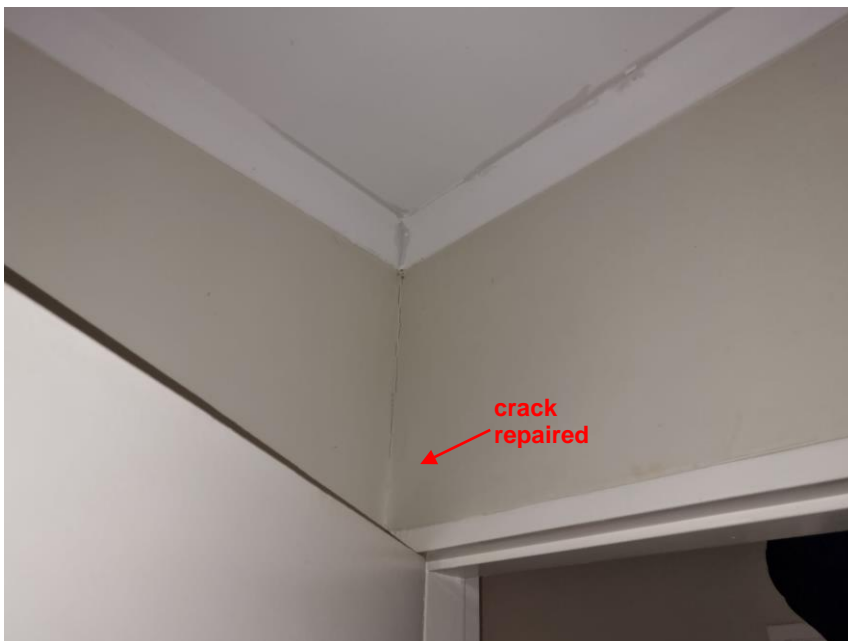
*Figure 11: Ceiling and cornice*

Observed a minor to moderate vertical crack extending from the cornice to the door frame. Attempts appear to have been made to repair the gap between the ceiling and cornice and the vertical crack on the cornice, (figure 11).

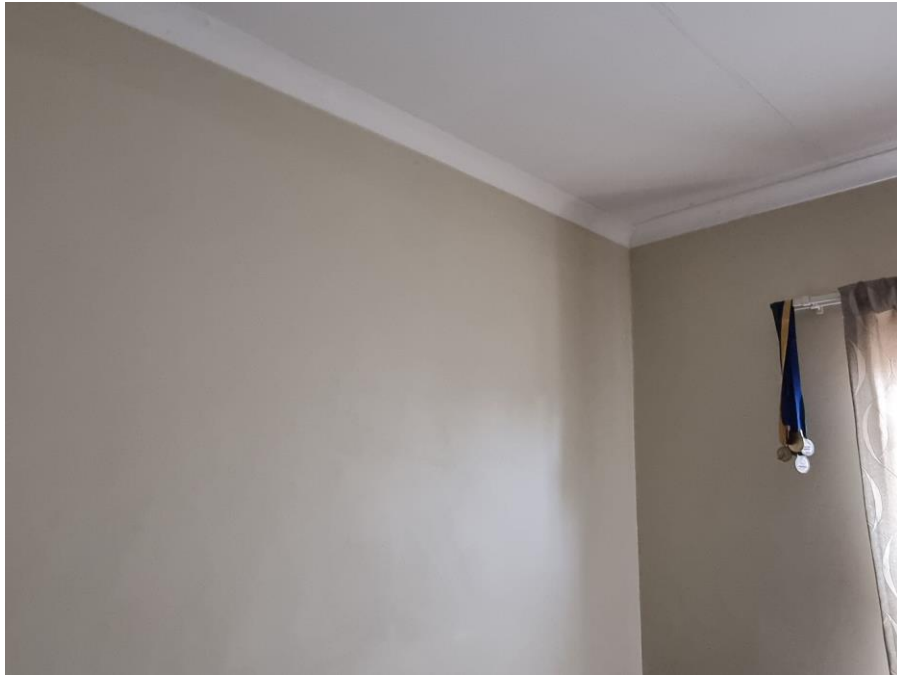
*Figure 12: Ceiling*

Observed water damage to the ceiling, (figure 12).

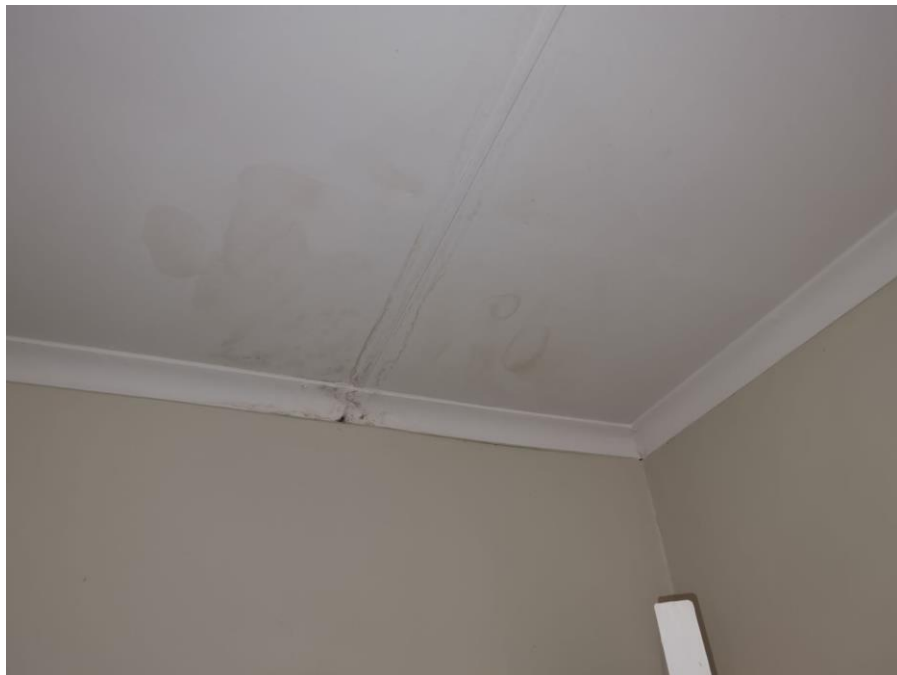
*Figure 13: Ceiling and cornice*

Observed water damage to the ceiling and cornice. There is also evidence of fungi growth from the cornice, (figure 13).

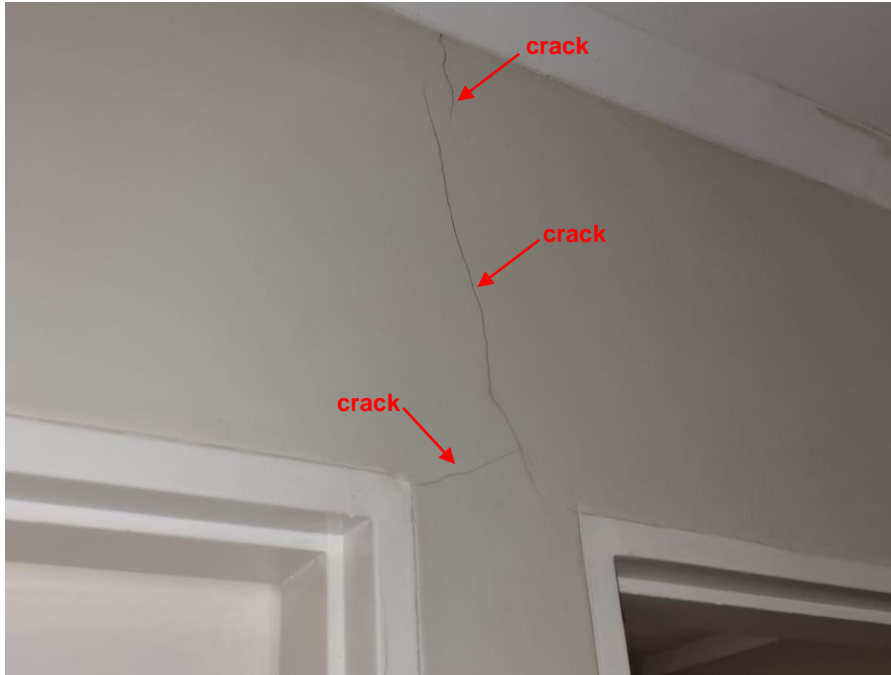
*Figure 14: Ceiling cornice and door frame*

Observed minor to moderate diagonal cracks extending from the ceiling cornice and door frame, (figure 14).

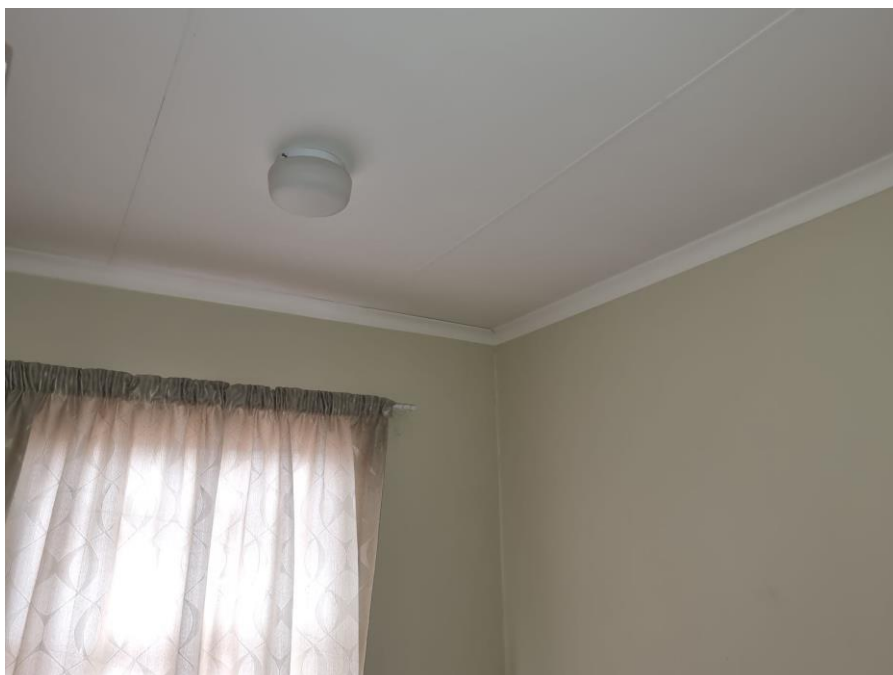
*Figure 15: Ceiling and cornice*

There is a noticeable gap between the ceiling and cornice, (figure 15).

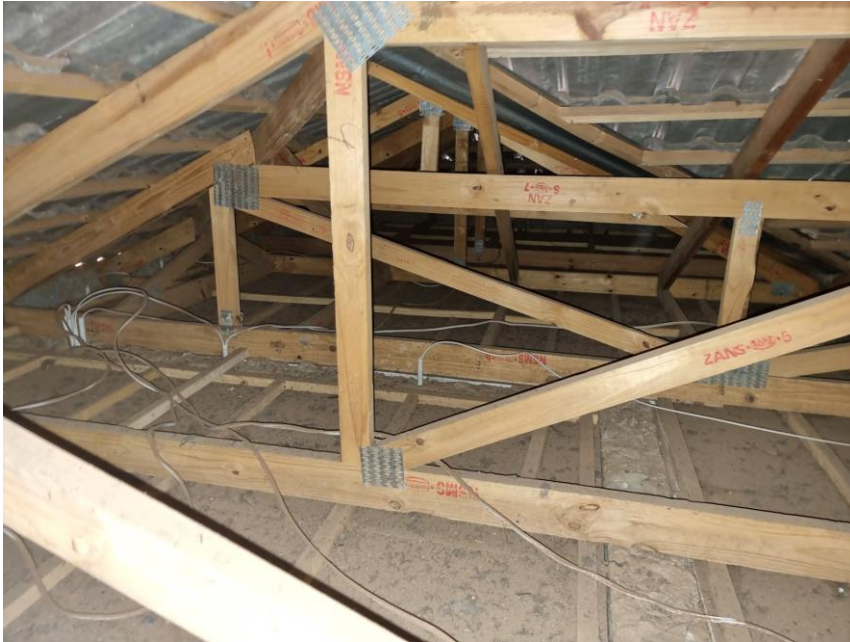
The roof structure comprises of engineered prefabricated “Cross hipped” timber trusses at approximately 760mm centres. The cross-sectional dimension of the top chord and bottom chord truss members measures 38mm x 114mm and the webs are 38mm x 76mm. The connection of the members comprises of metal gangnailed connector plates.

*Figure 16: Engineered timber roof trusses with concrete tile covering*

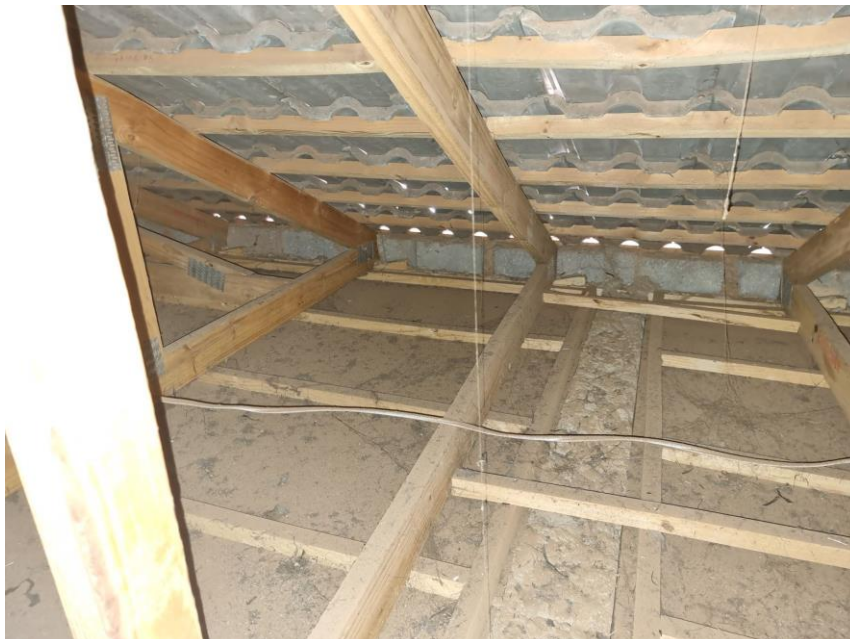
*Figure 17: Engineered timber roof trusses and galvanised truss anchors*

The trusses do not appear to be erected straight and vertically plumb as there are no nailed wedges on either side of the trusses. Some of the galvanised truss anchors are omitted and not securely fixed, (figure 17).

- Based on our observations of the structural elements of the roof erection, the roof structure appears to be unstable for the following reasons:
  - There is a lack of galvanised truss anchors in certain areas and some are not securely fixed.

- The valley outside the living room shall be checked for possible leaks and replaced with a deeper profile section if necessary.
- The missing nailed wedges shall be added on either side of the trusses to ensure the truss members are erected straight and vertically plumb.

- The existing roof anchors shall be fastened.
- The hip trusses and fly trusses must be connected to the girder with galvanised truss hangers and other missing truss hangers shall also be installed.

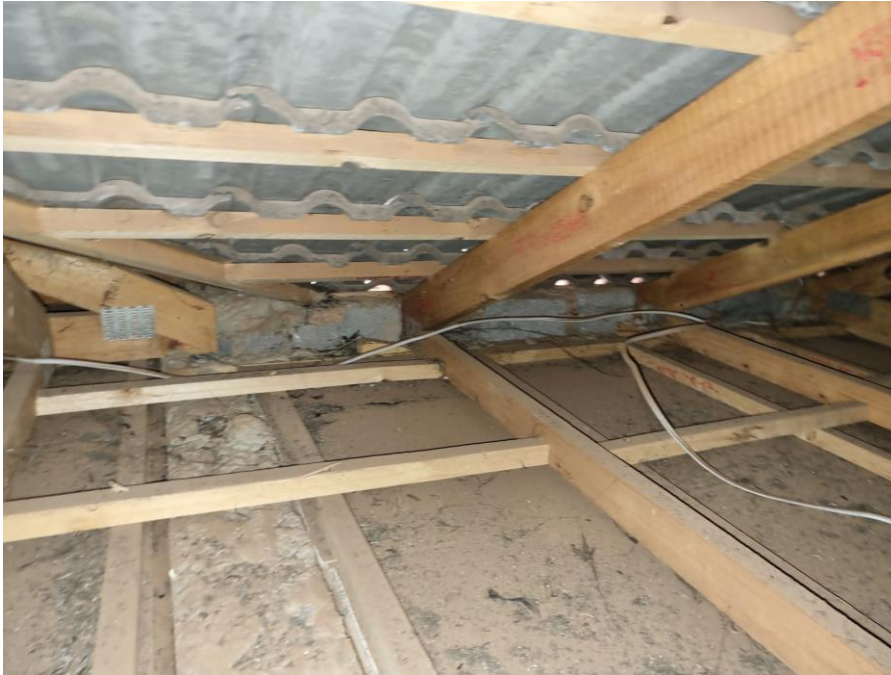
*Figure 18: Galvanised truss anchors*

Some of the galvanised truss anchors are omitted and others are not securely fixed, (figure 18).

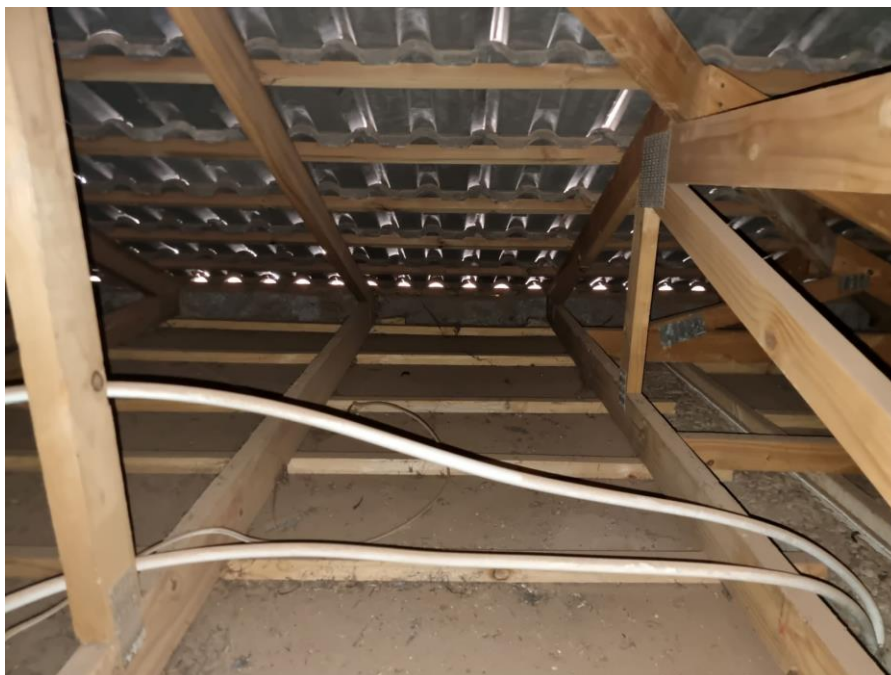
*Figure 19: Double roman concrete roof tiles*

The double roman concrete roof tiles appear to be loose as there are noticeable gaps allowing sunlight to enter through, (figure 19).

- It is possible that water seepage through the ceilings and roof structure is as a result of the inadequate spacing of the battens where they are too far apart from each other or the double roman concrete roof tiles are not set properly. The double roman concrete roof tiles could also be distorted or dislodged.

- An underlay waterproofing membrane shall be provided. The existing 38mm x 38mm battens must be fixed to the rafters at 345mm centres or to the technical specification of the tiles to ensure the minimum overlap.

- The existing double roman concrete roof tiles shall be carefully cleaned and re-laid over the underlay membrane.
- The ridge capping shall be cleaned and refixed with a suitable mortar.

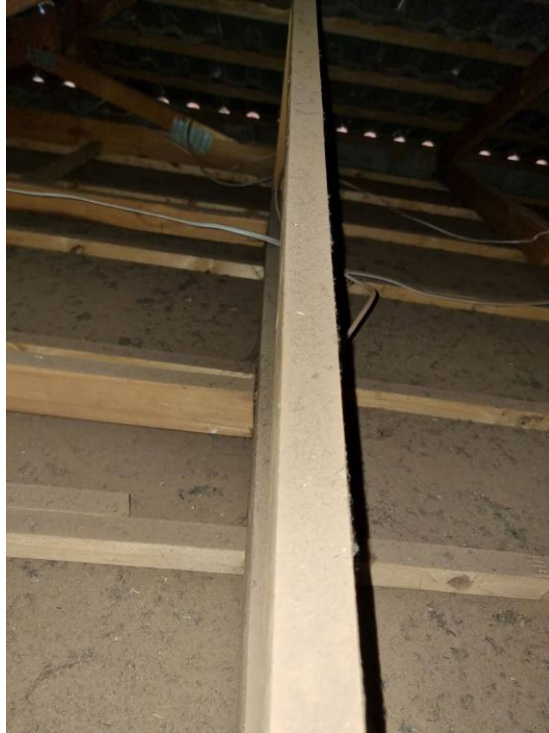
*Figure 20: Hip trusses and fly trusses connected to girder*

The hip trusses and fly trusses are connected to the girder with nails and the truss hangers are missing, (figure 20).

- There is a lack of galvanised truss hangers as the hip trusses and fly trusses are nailed to the girder.
  - There are missing fly rafters in the corners of the living room and bedroom 1.

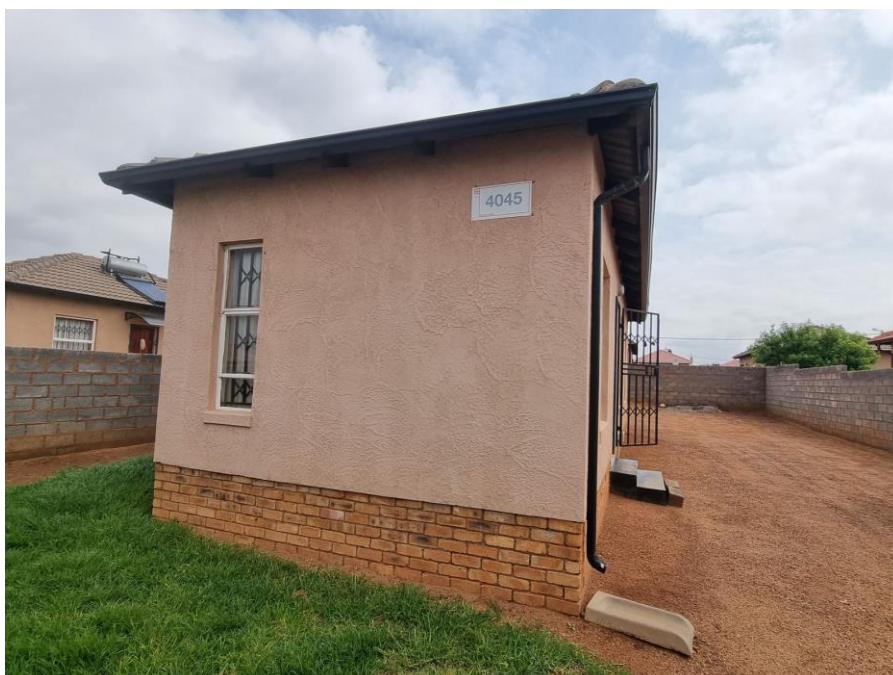
*Figure 21: Front elevation of the house*

Observed several stormwater concrete channels, (figure 21).

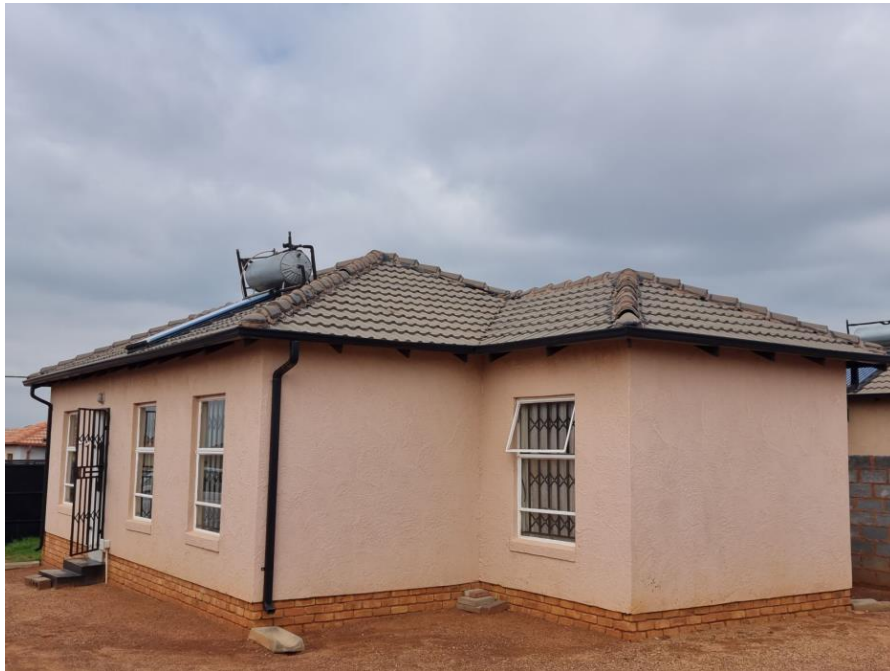
*Figure 22: Rear/side elevation of the house*

The aluminum gutters are fixed to the ends of the rafters, (figure 22).

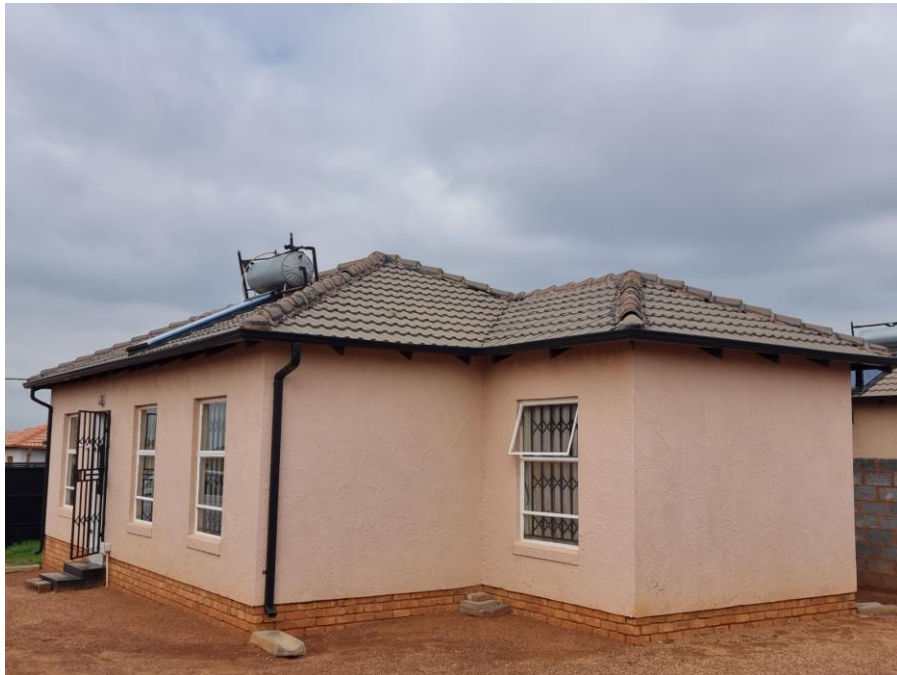
*Figure 24: Rear/side elevation of the house*

Observed broken mortar joints and loose ridges, (figure 24).

- There is no underlay waterproofing membrane present.
  - The ridge caps appear inadequate as the mortar used to bed the ridges is eroding.
  - The valleys appear inadequate.

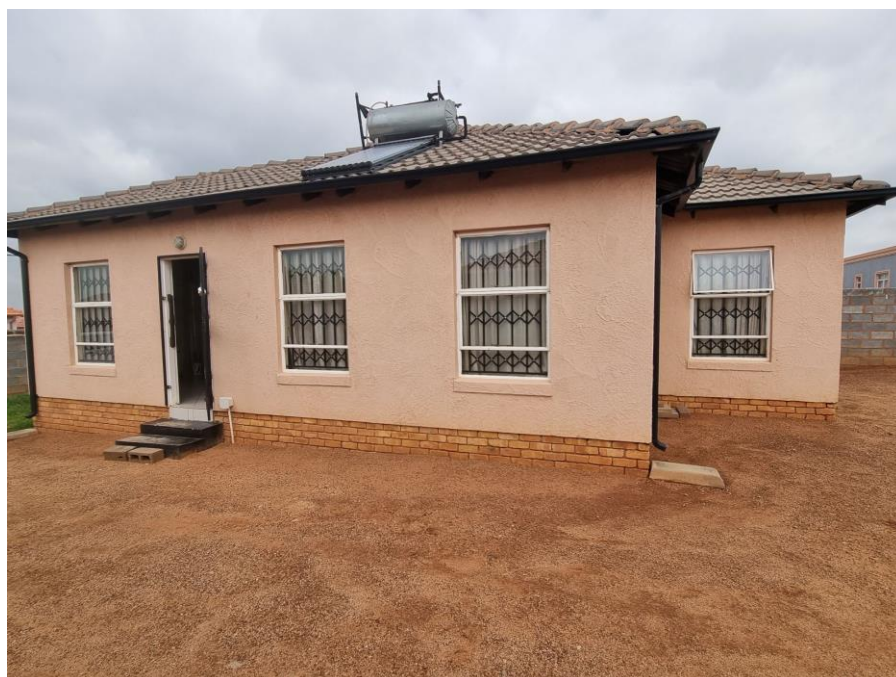
*Figure 25: Side elevation of the house*

Observed broken mortar joints and loose ridges, (figure 25).

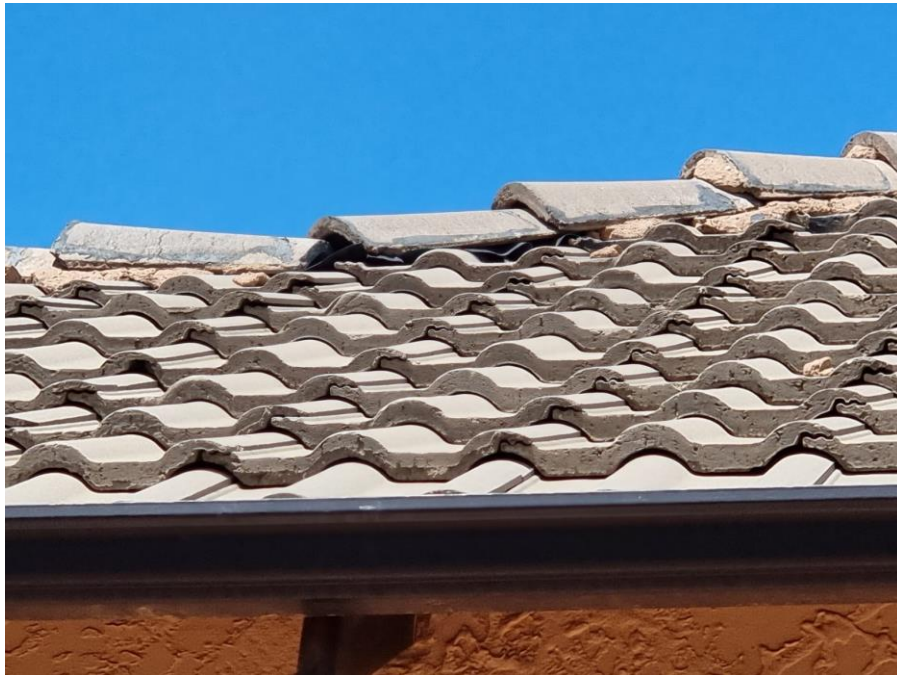
*Figure 26: Side view of ridges*

Observed broken mortar joints and loose ridges, (figure 26).

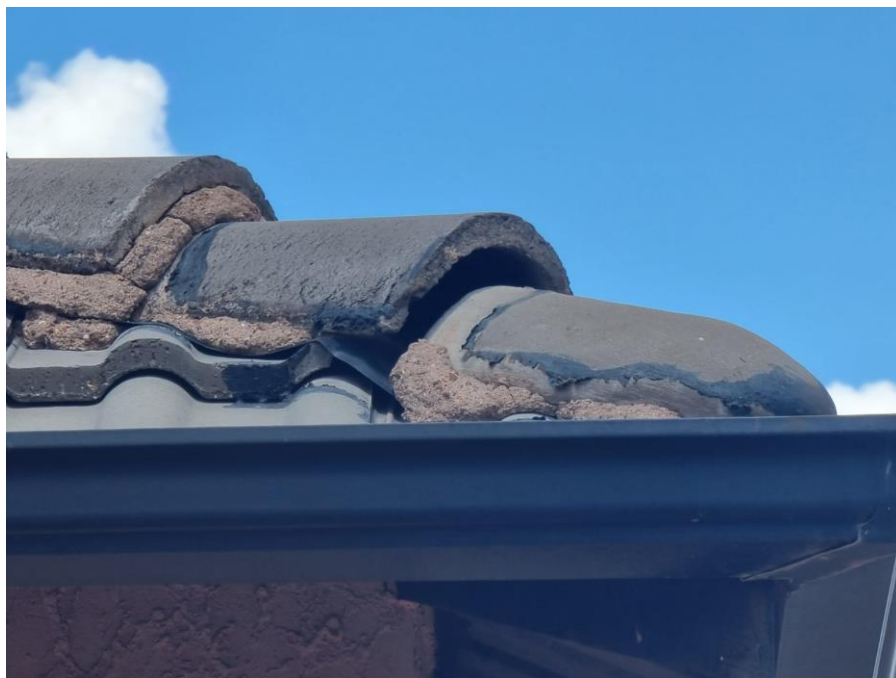
*Figure 27: Side view of ridges*

Observed a lack of mortar in the joints, (figure 27).

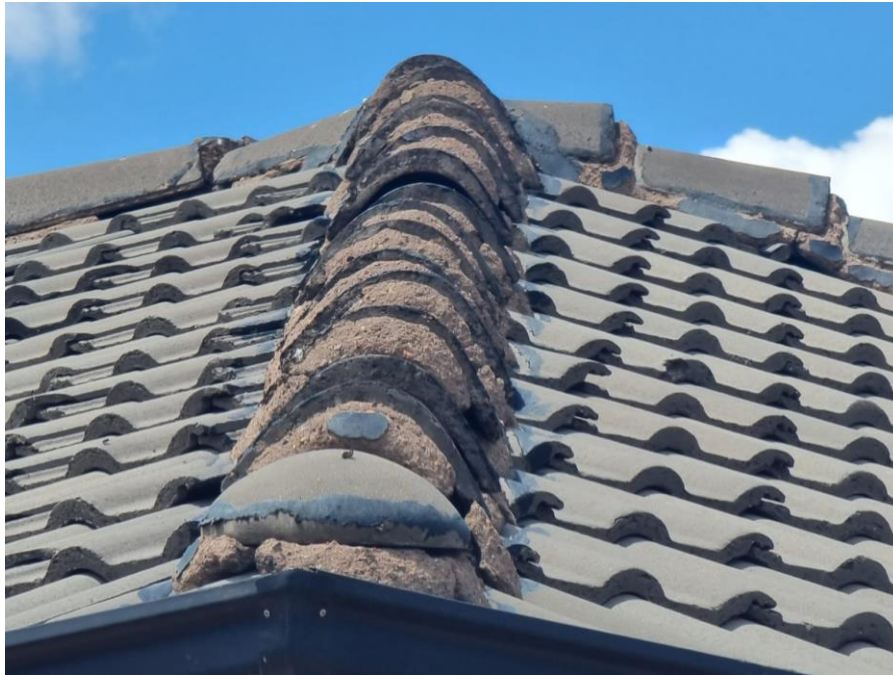
*Figure 28: End view of ridges*

Observed broken mortar joints and loose ridges, (figure 28).

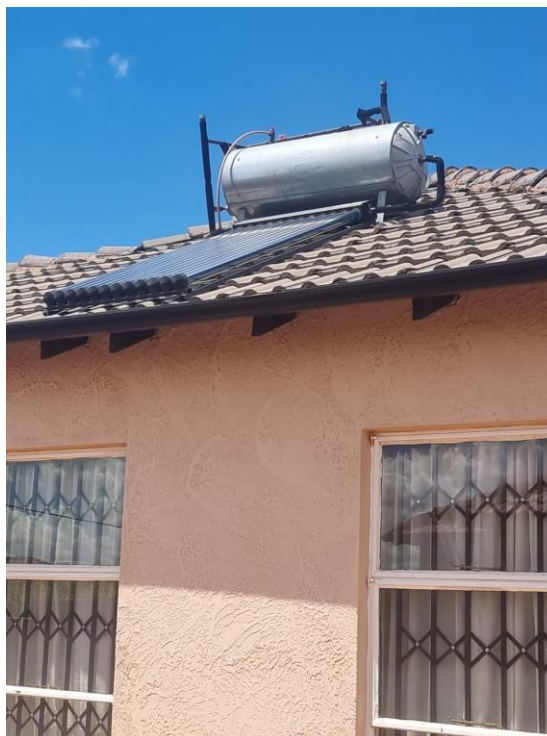
*Figure 29: Front view of solar geyser*

Observed a solar geyser on the rooftop, (figure 29).

- The owner/occupants shall move out of the dwelling and to temporarily accommodate prior to any work being carried out.
- The solar geyser located on the rooftop shall be removed during the reconstruction of the roof structure and stored for reuse.
- The double roman concrete roof tiles and ridge caps shall be carefully removed and stored for reuse.
- The existing 38mm x 38mm battens shall be removed and stored for reuse.

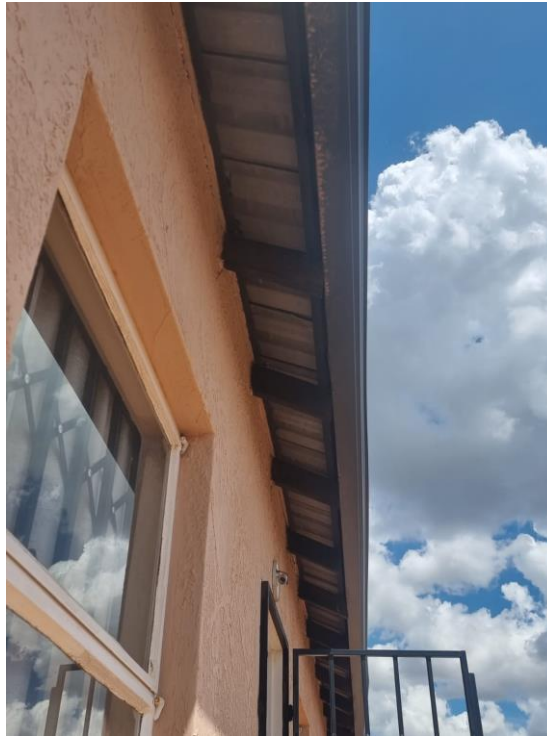
*Figure 30: Roof overhang*

Observed a one tile roof overhang, (figure 30).

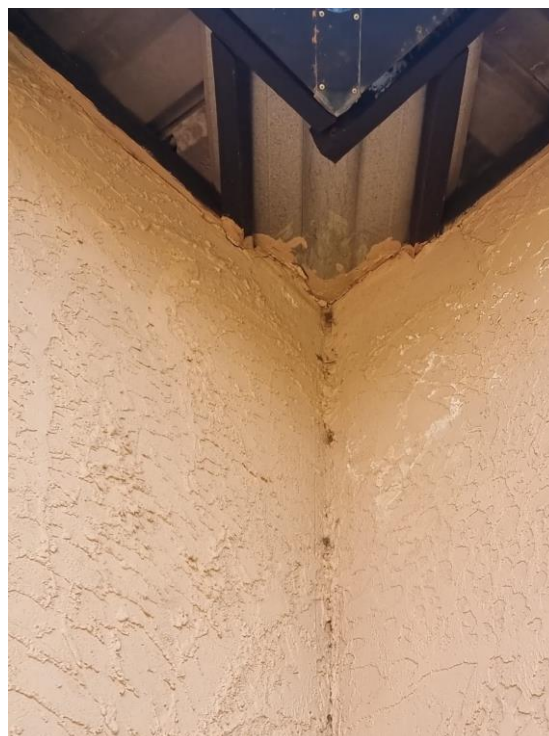
*Figure 31: Valley end, viewed from outside*

Galvanised sheet metal valley gutter was observed, (figure 31).
