HOUSE MNGADI

ERF 5259 BLUE VALLEY GOLF AND COUNTRY ESTATE

STRUCTURAL ASSESSMENT

ASSESSMENT REPORT

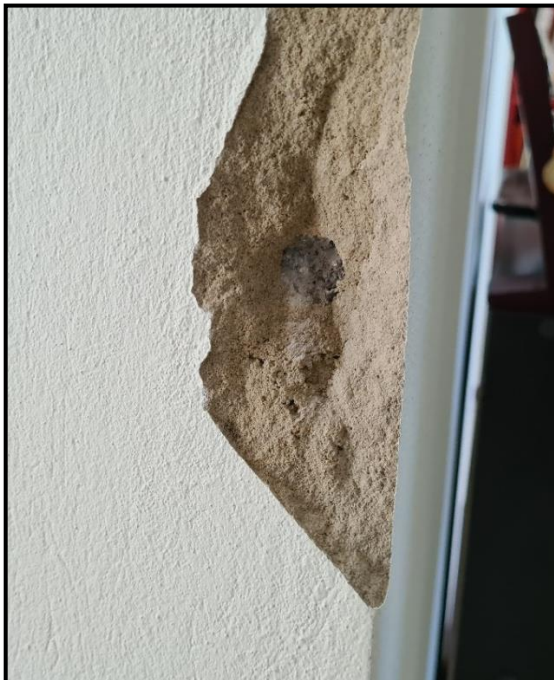
Figure 5-1 Brick pops – Pyjama Lounge – Image 01

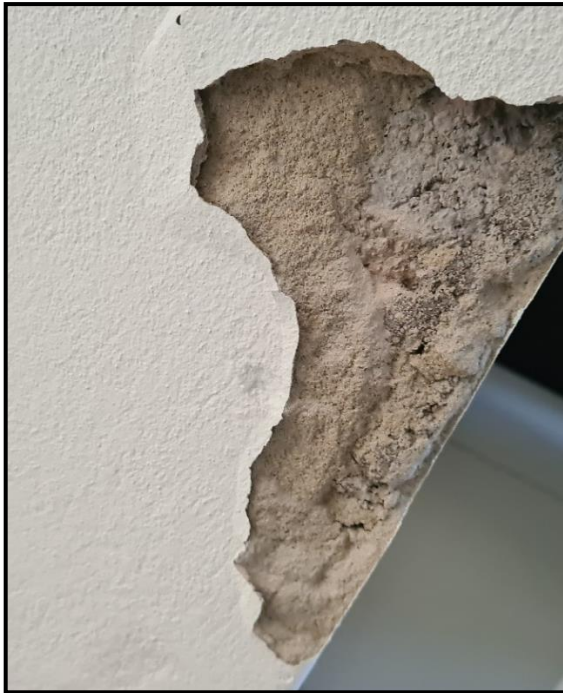
Figure 5-2 Brick pops - Pyjama Lounge - Image 02

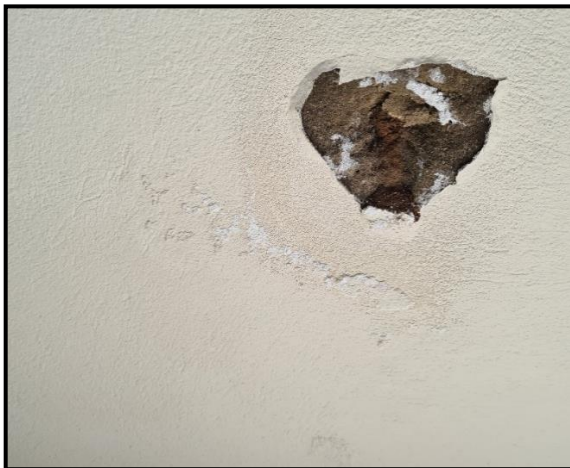
Figure 5-3 Brick pops - Image 03

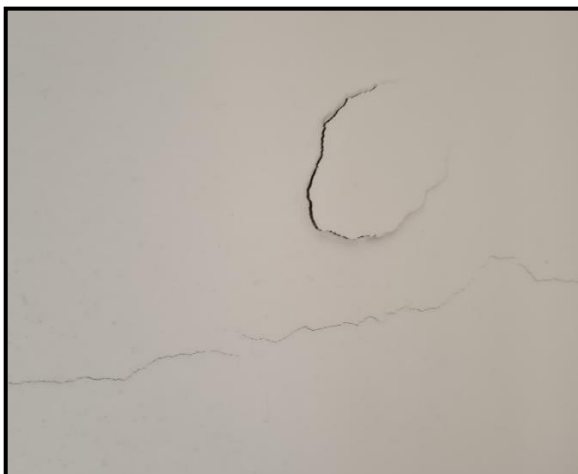
Figure 5-4 Brick pops - Image 04

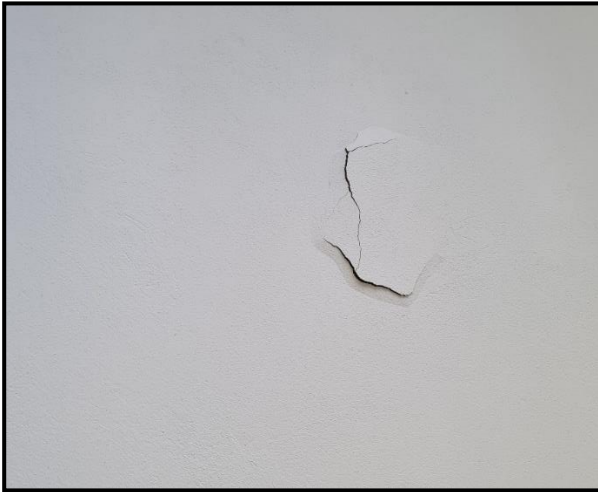
Figure 5-5 Brick pops - Image 05

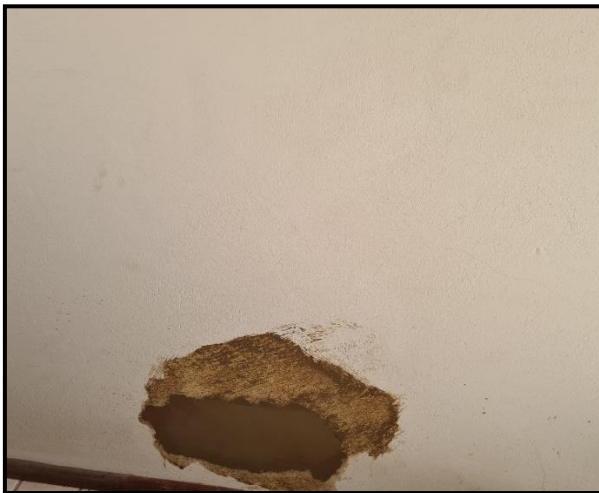
Figure 5-6 Sampling Popped Bricks - Image 01

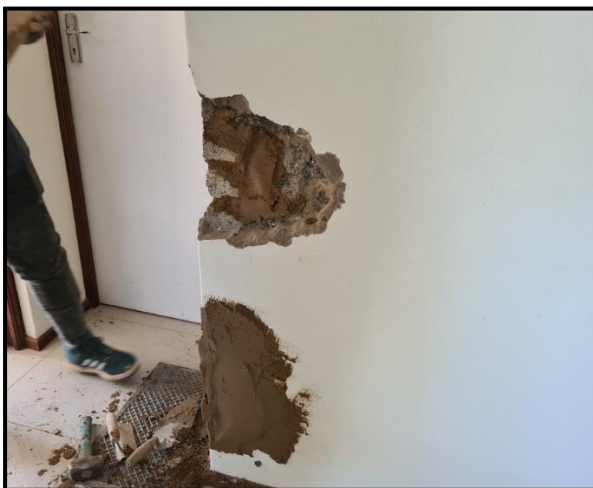
Figure 5-7 Sampling Popped Bricks - Image 02
