Forensic Investigation and Structural Engineering
Remedial Concepts to Erf 23375, George,
House Botha

Forensic Report – Rev 0

16 November 2023

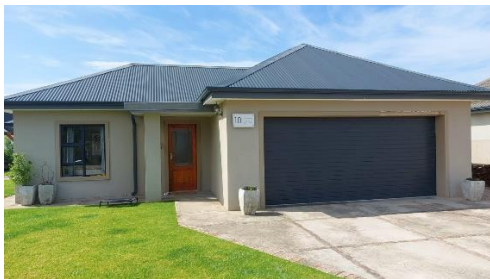
The pictures below show the north elevation of the building with the area of investigation, being a large crack above the lintel over the garage opening. Elaborative comments are given in **Section 2.3.1** below.

Pic 01: North Elevation of building

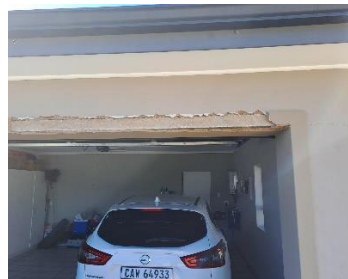
Pic 02: Cracks above lintel

The focus area of the investigation is the large crack above the garage opening. Lintels were installed over the 4,865m opening, however, the differentiation between the concrete lintels and the brickwork above the lintels up to wall-plate level is most probably due to foundation settlement, cracks forming in the walls and no articulated reinforcement in the brickworks above the lintels.

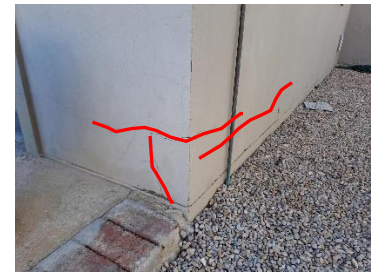
Pic 03: Cracks at corner brick wall

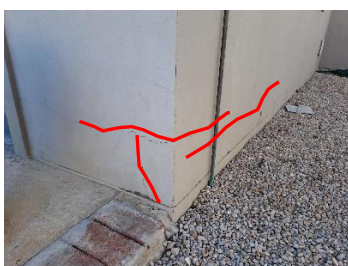
The photos below give evidence of possible settlement in the foundations which leads to horizontal and diagonal cracks in the garage walls, evidently resulted in the crack above the lintel.

Pic 04: Diagonal cracks in walls above surface bed

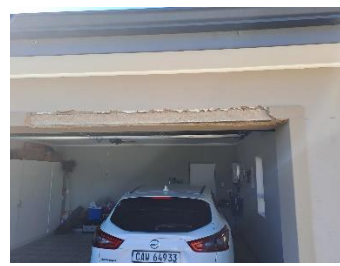
Pic 06: Crack above lintel result in plaster band coming loose

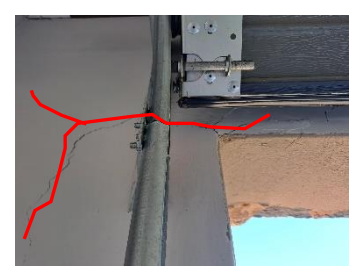
Pic 07: Diagonal crack on inside wall

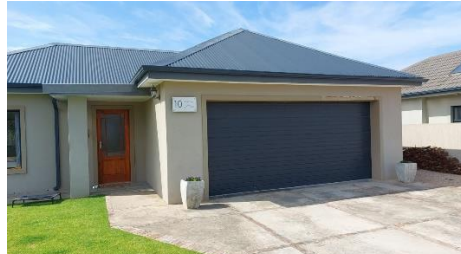
Pic 13: Combination of concrete and brick paving in front of garage and the driveway

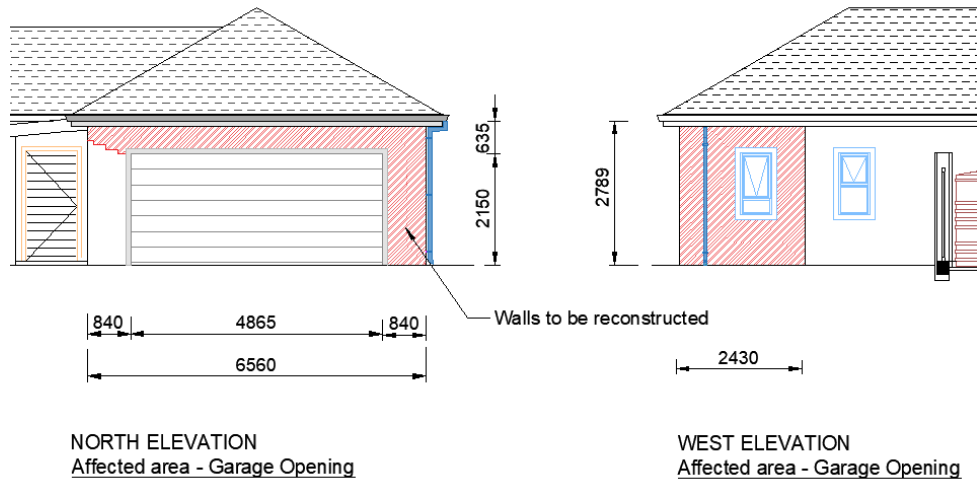
The north-west corner of the garage has settled and the current stormwater application of gravel pebbles is the possible route cause of this defect. It is anticipated that the strip foundation has settled in this area, however, a detailed geotechnical investigation would have confirmed this assumption.

Irregular structural diagonal cracks occur on the northern and western façades of the garage – 1,5m both sides - and is recommended to be reconstructed from surface bed level up to wall-pate level as indicated on **drawing No. HB-01** attached as **Annexure A**. A graphical representation is given below.

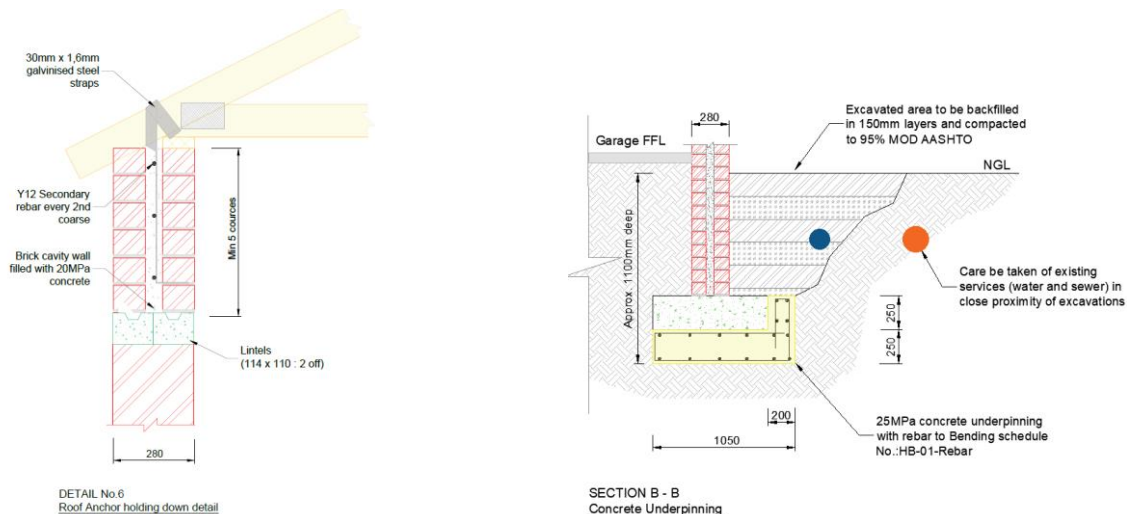
SANS 10400-K, with reference to Table 28 and Figure 32 is clear on the requirements for brickwork over openings less than 5m wide. Remedial detail is given on **drawing No. HB-01** and graphically indicated below.
