**Erf 356, Ships View Road, Glen Stewart Estate,  
Kwelera, East London, Eastern Cape**

CREATED BY:	
Name:	Anton Marais <i>Pr.Eng</i>
Position:	Regional Engineer

Date:	10 June 2025

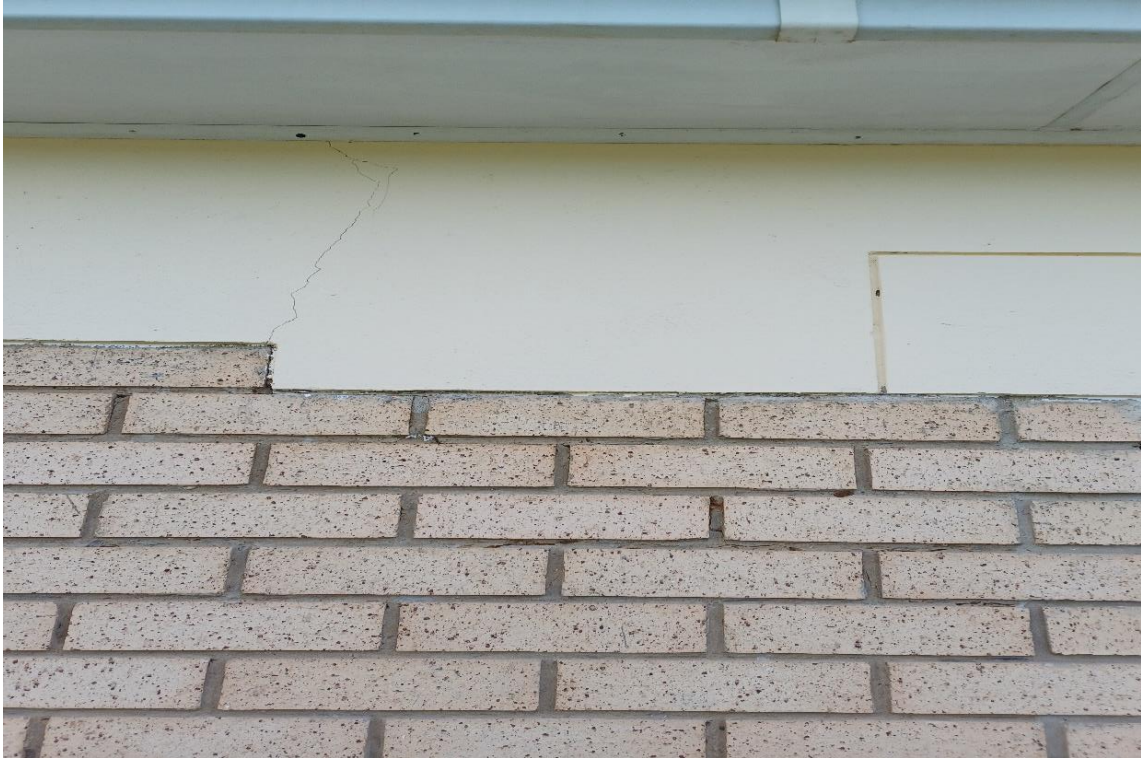
- 5.1.1. A vertical crack is visible on the front wall next to the garage door. The crack is visible on the external face of the wall ( $\pm$  1mm wide) from the top of the wall to lintel height where plaster band ends. This crack is also visible on the internal face in the garage wall ( $\pm$  1mm wide) about 150mm from the internal wall connection to the external wall.
- 5.1.2. Some minor hairline cracks are also indicated on other internal walls in the hallway and rooms.

**Figure 3:** Vertical crack at garage door on external face.

- 7.1. The cracks identified are minor and classified as slight to moderate as per Table 5 (Classification of expected damage in masonry walls) in the NHBRC Home Building Manual. These are therefore not seen as major structural defects and not covered by the NHBRC warranty fund.

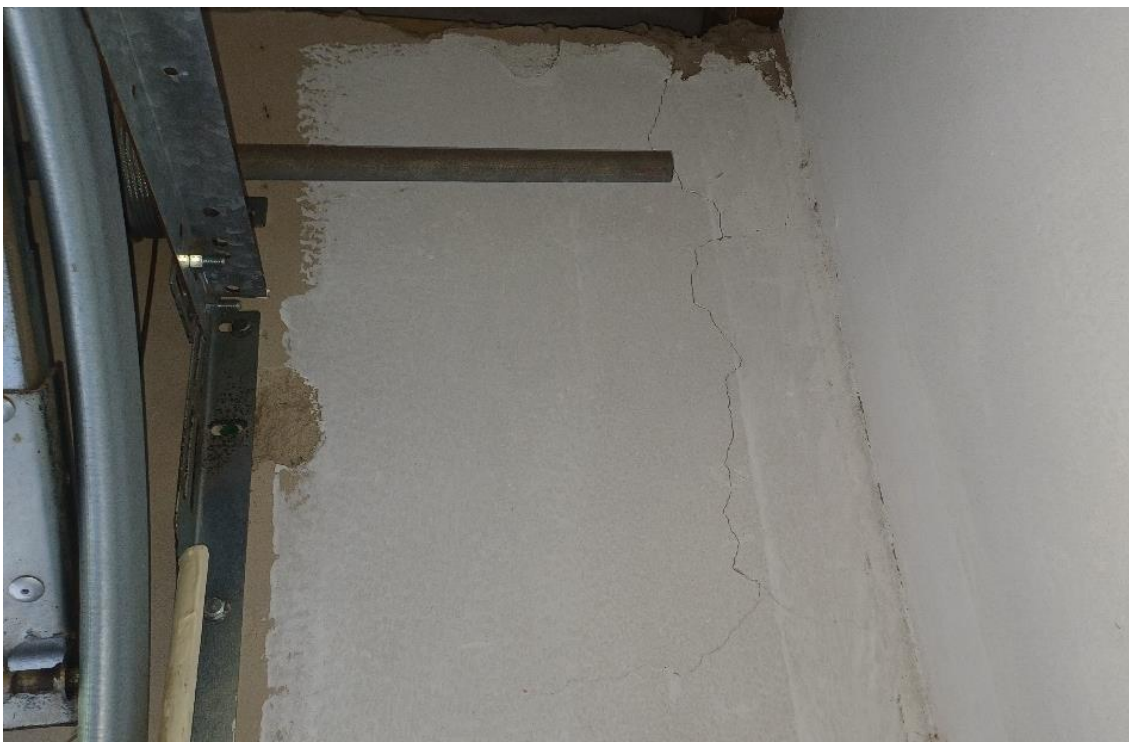
**Figure 4:** Vertical crack at garage door on internal face.

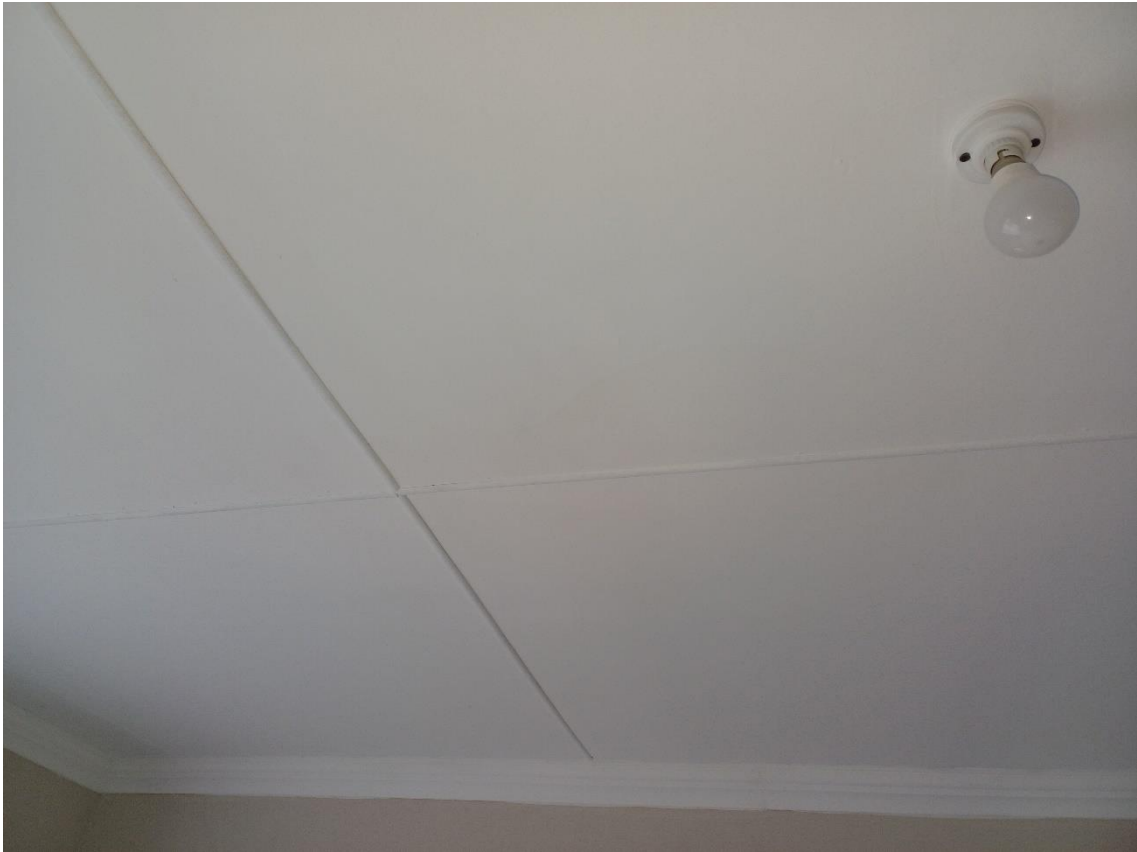
- 5.3.1. Water damage is visible on the walls and ceiling and cornices in the front bedroom.

**Figure 5:** The front bedroom ceiling shows water stains.

- 7.3. The roof items indicated are the cause of the identified leaks on the ceilings and cornices. The identified leaks are mainly in the garage and the front bedrooms. This roof leak is covered by the NHBRC warranty. The specific cause of the roof leak, however, is not clear as there are various items identified which could impact on the watertightness of the roof. This includes the omission of the tilting batten, incorrect installation of the valley gutter, cracked and missing ridge mortar pointing, cracked and loose tiles, under tile membrane not continuous etc.

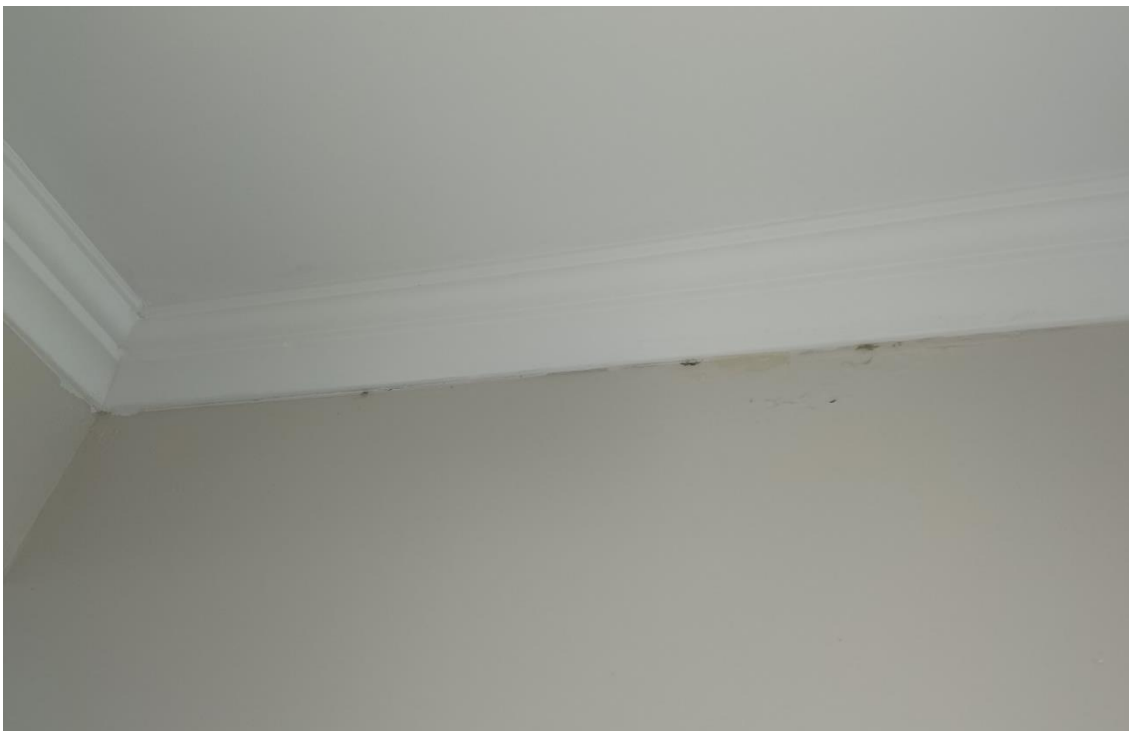
**Figure 6:** Signs of water damage at ceiling cornice.

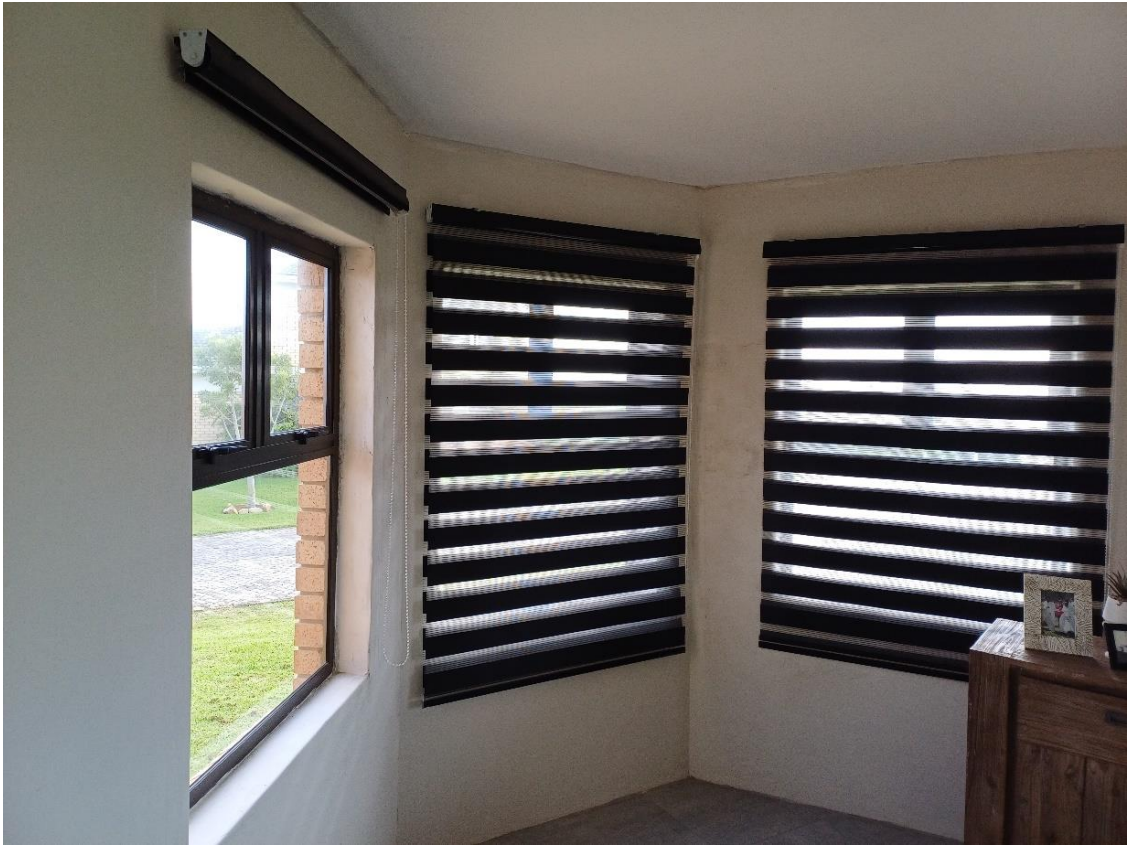
- 5.2.1. Water damage is visible on the internal painted walls in the living room.
- 5.2.2. Water damage is visible on the wall next to and in the reveals of the bay windows on the north-east side of the house.
- 5.2.3. Water damage is visible on the wall below the window and on the internal sill of the south-east side of the house below the balcony at the external braai.

**Figure 7:** Water damages on walls at the bay window in the living room.

- 7.2. The water damage on the internal walls appears to be due to leaks at the window frames of the identified windows. They are mostly due to the above balconies' stormwater not focused but flooding over the side above the indicated window.

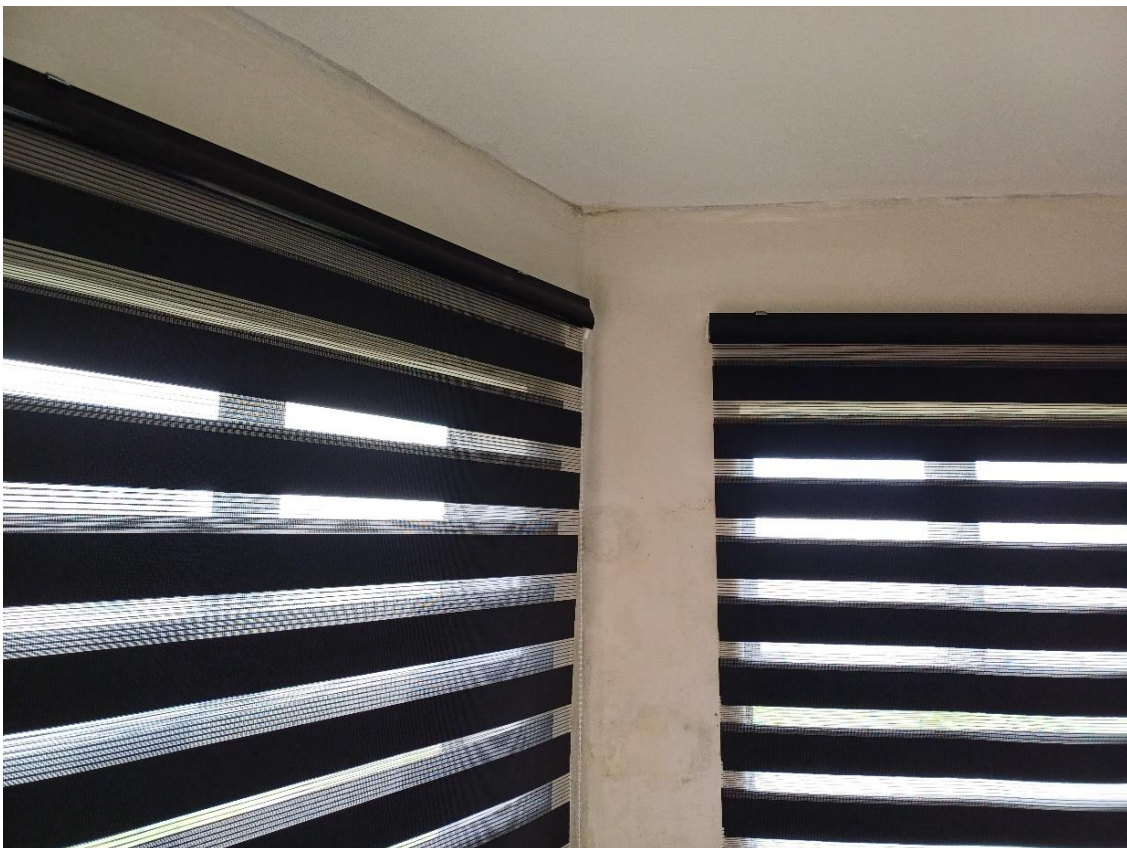
**Figure 8:** Close-up showing water damage.

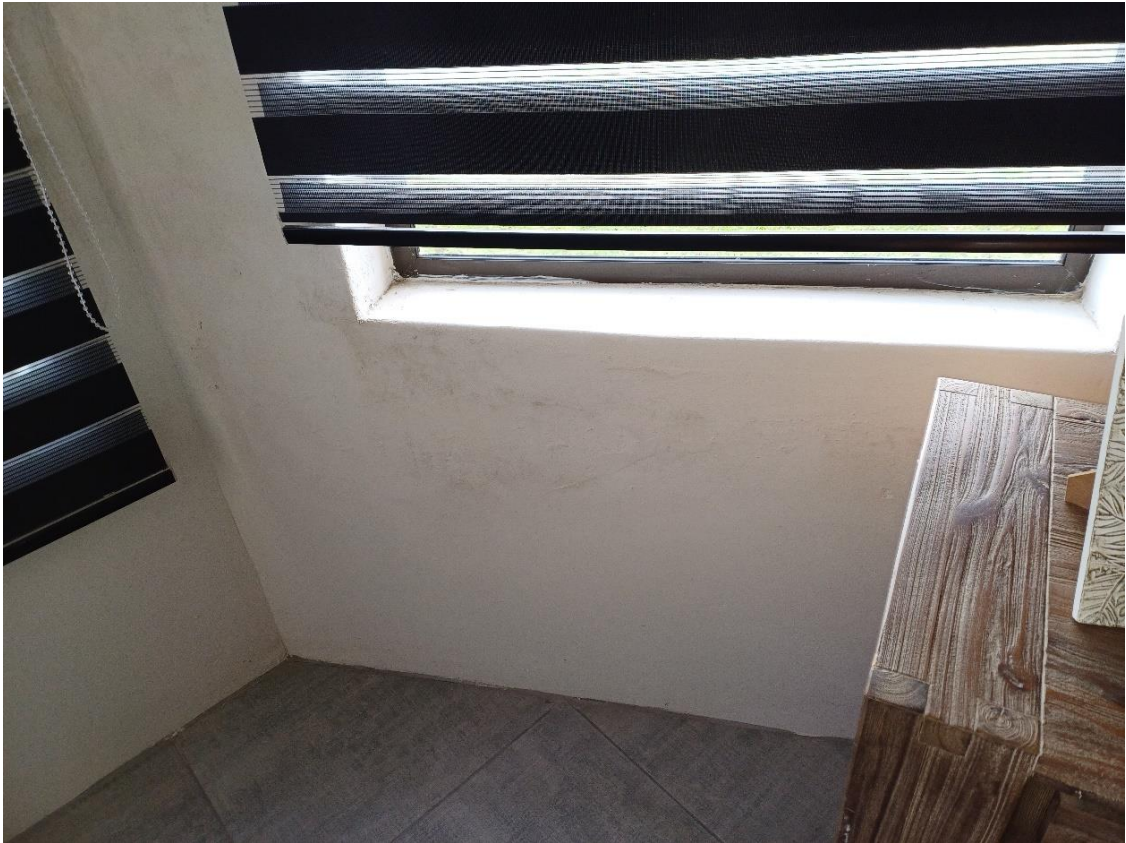
**Figure 9:** Water damage at living room windowsill.

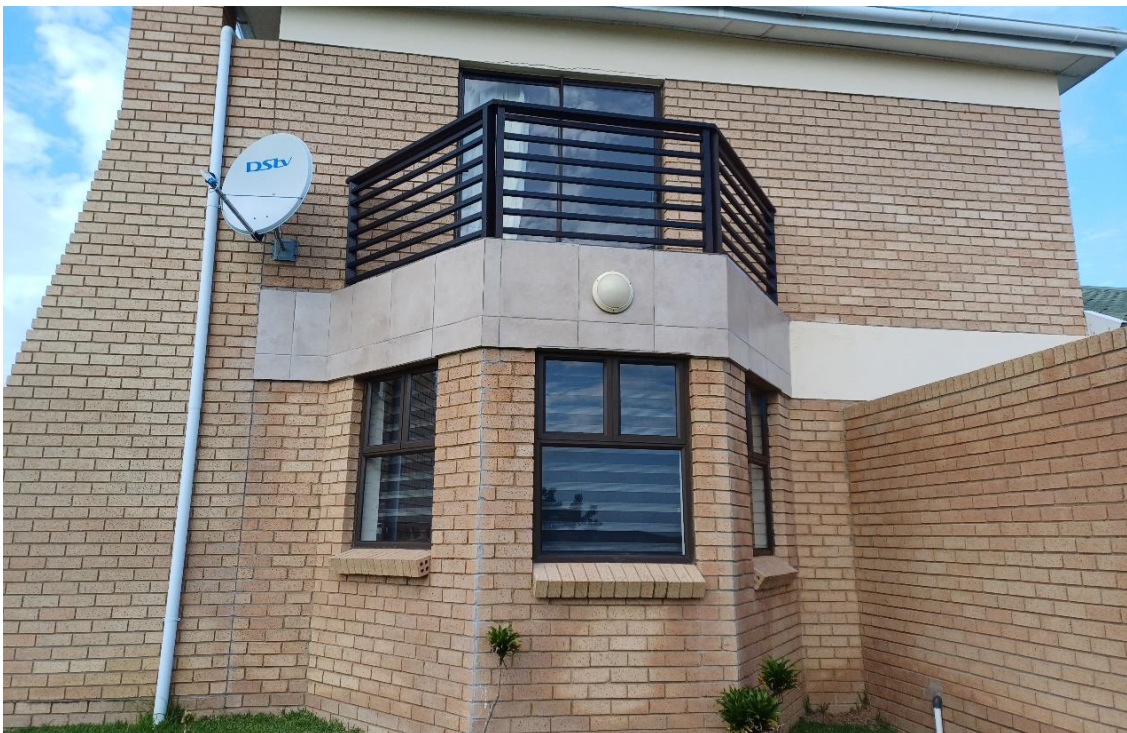
**Figure 10:** External view of bay window and balcony.

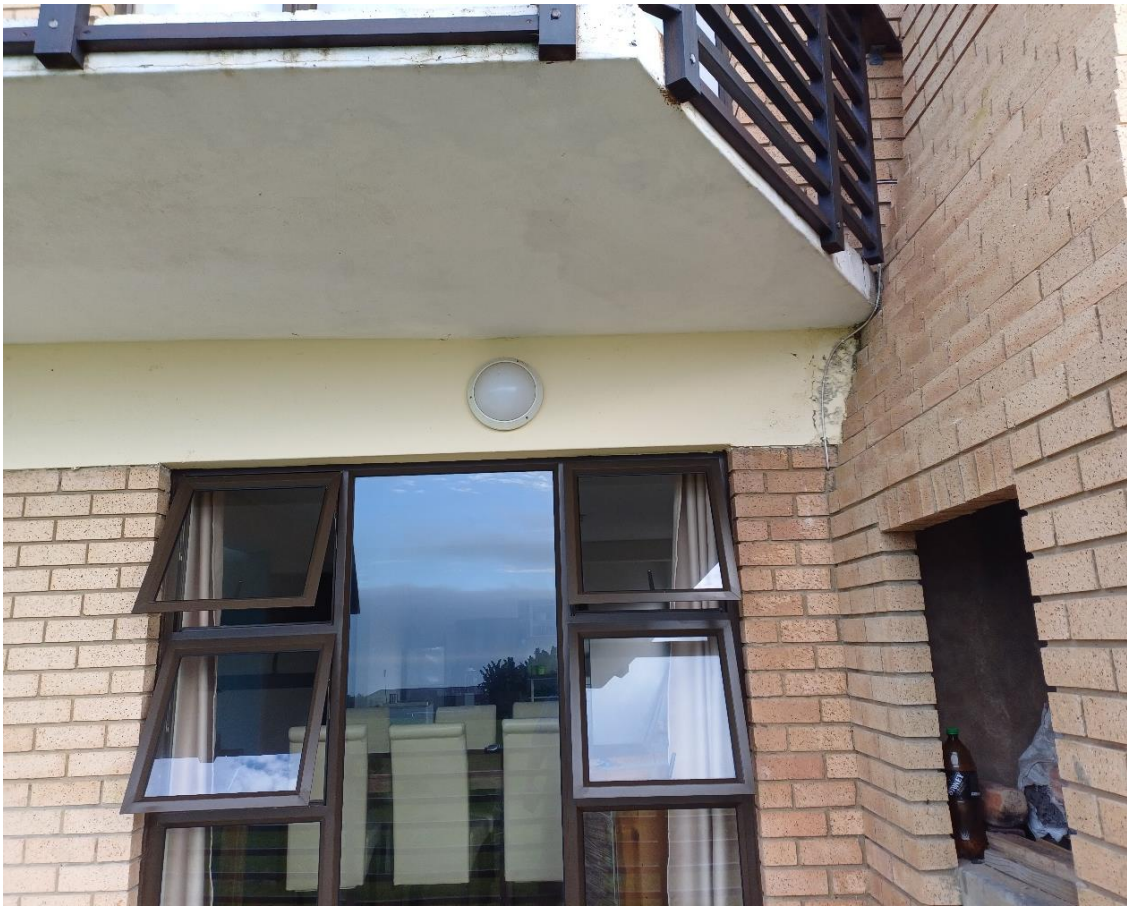
**Figure 11:** First floor balcony detail above window where moisture is visible on sill.

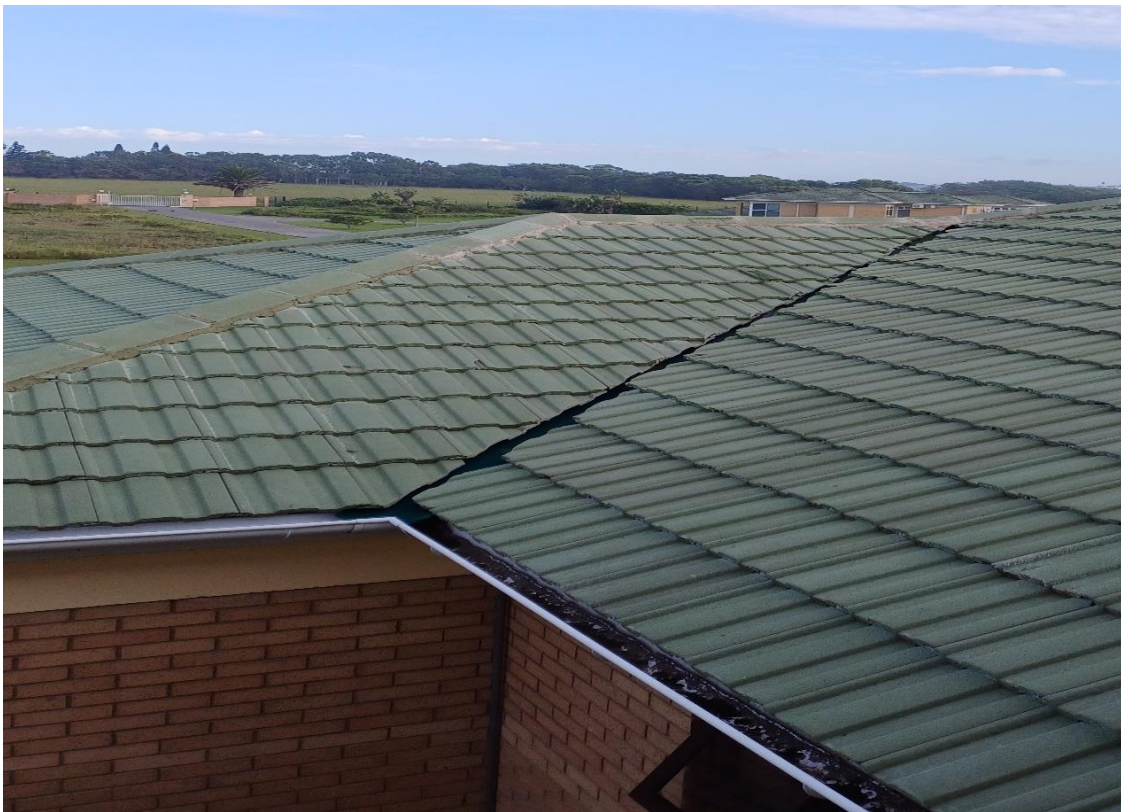
**Figure 12:** Roof valley above garage.

- 8.1.4. Re-lay the first row of tiles and secure them properly.
- 8.2. Address Valley Gully Issues:
  - 8.2.1. Remove all tiles in the valley areas.
  - 8.2.2. Install appropriately sized timber valley boards along the length of each valley, securely fixed to the roof structure. These provide a solid base for the valley lining.

- 8.2.3. Install high-quality, SABS-approved, reinforced breathable under-tile membrane directly over the valley boards and extended well under the adjacent roof tiles.

- 8.2.4. Install metal valley gutter over the valley boards. Ensure adequate width and upturned edges to contain water flow.
  - 8.2.5. Re-lay the valley tiles ensuring they are correctly cut and aligned to follow the line of the valley, allowing sufficient space for water run-off into the valley lining without obstruction. Secure them properly

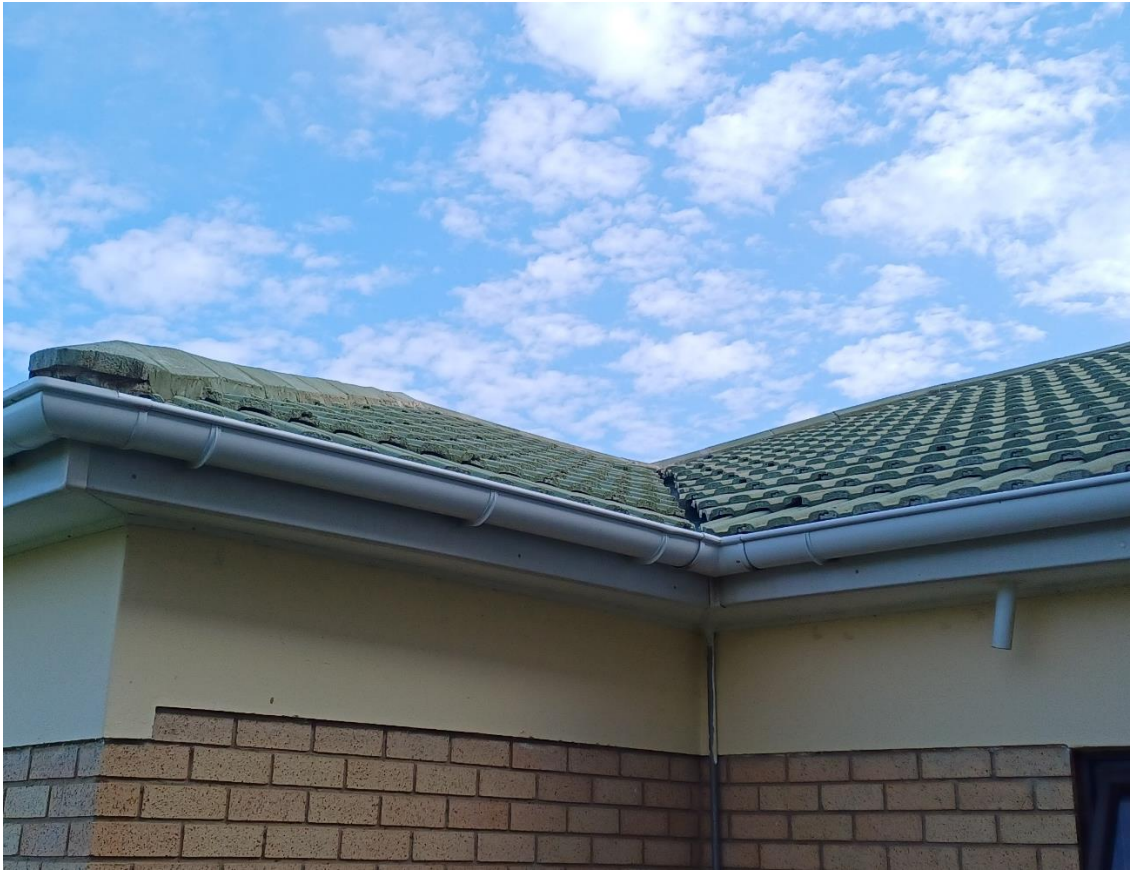
**Figure 13:** Roof valley gutter above garage – bottom view.

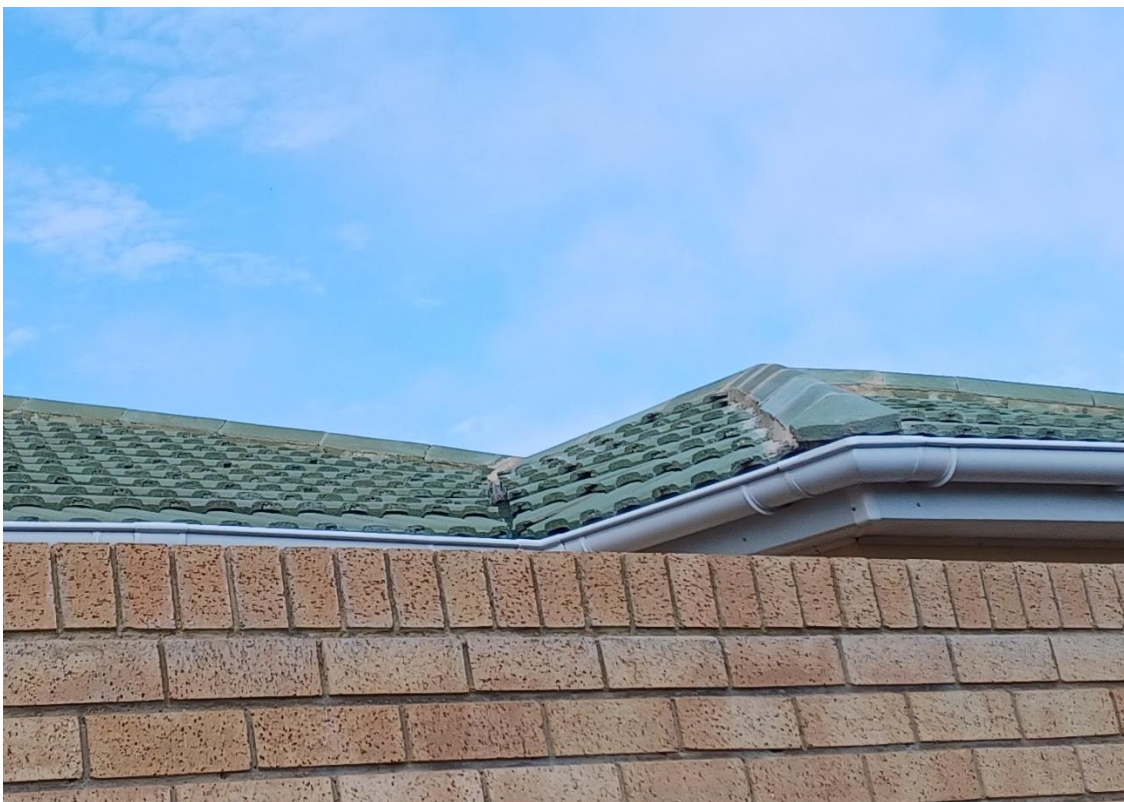
**Figure 14:** Roof valley gutter above the front bedroom.

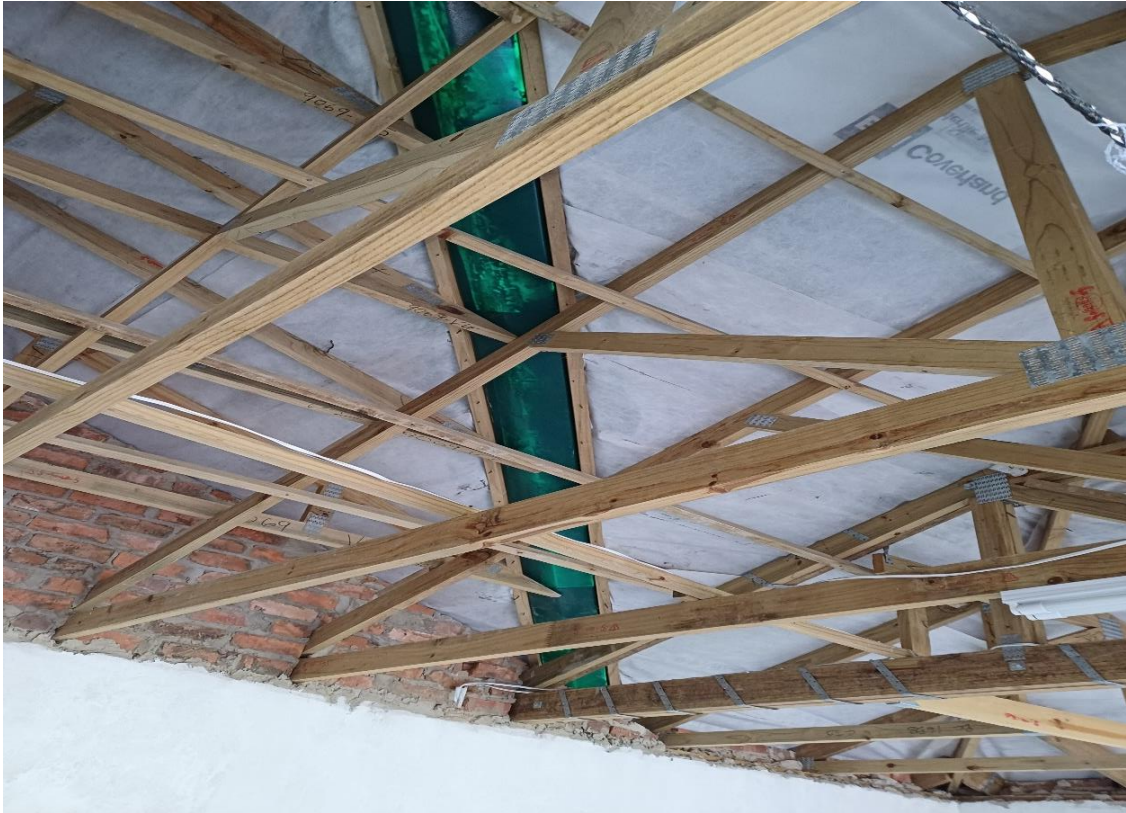
**Figure 15:** Roof valley gutter above garage – internal view from bottom.
