Investigation and Structural Engineering Remedial  
Concepts to Erf 208, Sagewood, Parklands North  
House Gosai

## Report – Rev 0

**13 January 2025**

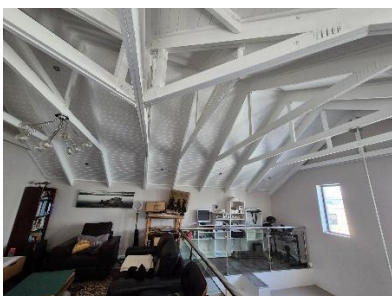
Visual inspection to the roof assembly, which is a heavy wooden architectural design, indicated cracks at wall plate level at each support point of the roof trusses and at the corners of the walls. The picture album below provides visual evidence of the complex roof design and cracks at the support areas.

**Pic 02:** Complex architectural roof assembly design with no ceiling

Noticeable is the absence of bottom cord and bracing roof elements which prevents torque, rotation and deflection of roof trusses. Remedial concepts are given in **Section 3.3** of this report.

#### ACTIVITY 2 : STIFNERS & BRACING TO ROOF ASSEMBLY

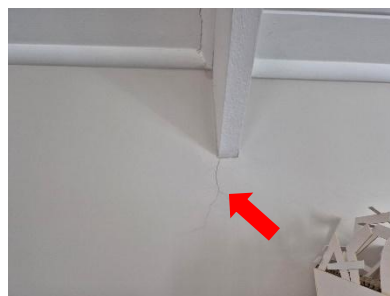
**Pic 03:** Crack at each support location of roof truss at wall plate level

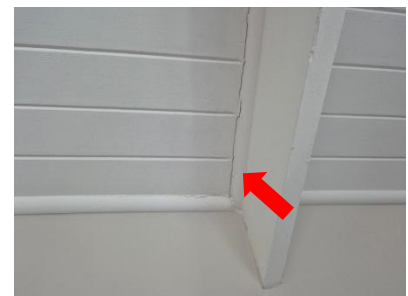
**Pic 04:** Separation of roof assembly finishing elements

The original RFQ related to water ingress at different locations of the building, which were indicated by the Home Owner also to be on wall-plate level, especially on the 1<sup>st</sup> floor roof assembly. Evidence of this is also noted from the separation of the roof trusses, architectural finishing and pine ceiling covering which constitutes the roof assembly.

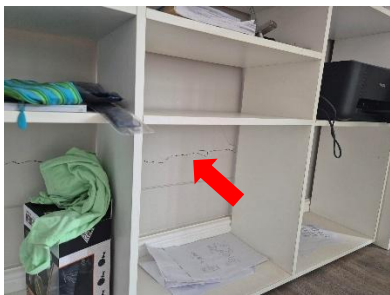
Possible settlement of the eastern elevation's foundation could have result in the medium to large horizontal crack on the inside of the external wall of the 1<sup>st</sup> floor and is most likely the cause of defect to this area of investigation. No noticeable crack on the same level is observed on the external wall at the same position of the 1<sup>st</sup> floor, which is unusual for such large width crack on the inside of the wall.

The crack is continuous on the same level, approximately 200mm above the upstand beam level of the 1<sup>st</sup> floor concrete slab which cause of defect is a possible weak mix of mortar between the bricks or insufficient brick force on the specific level.

**Pic 05:** Horizontal crack above upstand beam level

5. <u>1<sup>st</sup> Floor</u> Crack in eastern elevation wall	<p><b><u>Crack repair</u></b> Expanded metal lath application repairs to low- and high-level cracks as detailed on <b>dwg No. HGosai – Struct 01</b></p>

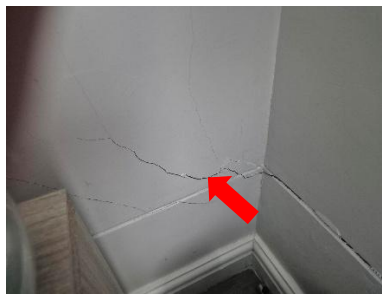
**Pic 06:** Crack in corner of bedroom 3 wall and above upstand beam level

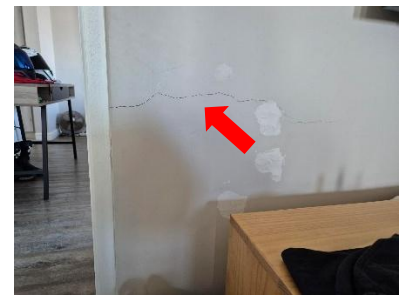
**Pic 07:** Crack in wall at Bedroom 3 door entrance

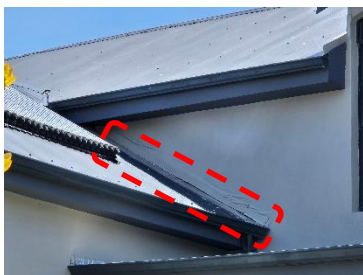
Inspection of the external perimeter of the building indicated some self-attended cracks on both the ground floor and 1<sup>st</sup> floor level of the building. Of interest is the defective and damaged roof flashing and water proofing detected on the northern edge of the roof covering the Study/Guest room on the ground floor.

Interesting is that this defect is a high possibility for the existence and development of the crack as elaborated on in **Section 2.2.2** above as it is on the same location and height. Repairing this to specification will attribute to a more safe and stable structure.

**Pic 08:** Defective roof flashing and water proofing

Damaged roof flashing and waterproofing was detected on the northern edge of the roof covering the Study/Guest rooms of the building on ground floor. Repair of this section is detailed on the drawing attached as **Annexure A** with schematic image below.

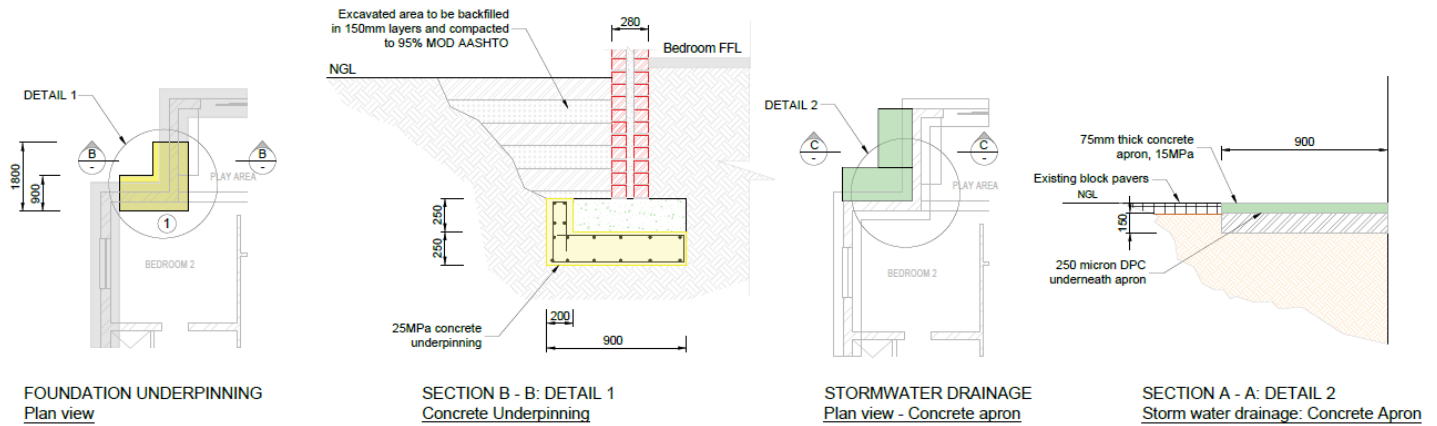
A noticeable vertical crack is recorded at the corner of two external walls in Bedroom 2, which is supporting the “RI Concrete Beam” as indicated on the architect’s drawings. The cornice above the crack is also showing some degree of separation from the wall which indicates continuous development of the crack in question.

Concern is raised that this specific location of the building is supporting a reinforced concrete beam which supports the roof section over the internal play area and bedroom 2. Repair and strengthening of this wall section is elaborated on in **Section 3.2** of this report.

**Concept A - Underpinning:** Preventative measures to strengthen the foundation supporting the walls in question is underpinning and proper stormwater management.

**Concept B – Stormwater management:** To prevent possible settlement, concrete underpinning and concrete aprons are recommended to a small section of the external walls of the building at this location as indicated on the drawings in **Annexure A** with graphical images below.

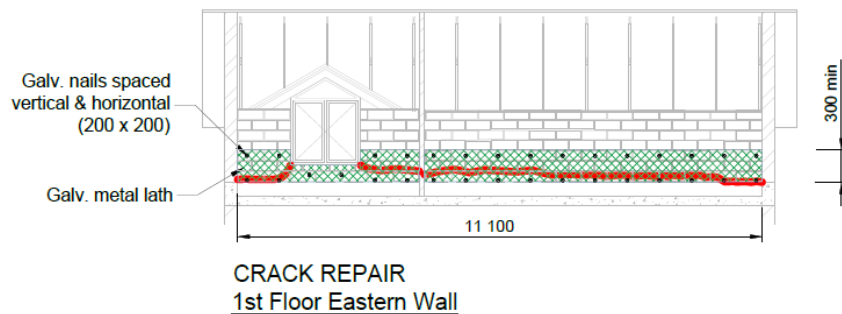
Photos No.2, No.3 and No.4 above illustrates the cracks located above the concrete upstand beam on the first floor, which beam forms part of the 1<sup>st</sup> floor concrete floor slab. Repair concepts to these cracks are provided in the graphics below and as detail on the drawing attached as **Annexure A** to the report.
