11 April 2025

RE: Site report for 'HOUSE NOTH' Leak detection, Property assessment

Top Floor / Parking / Flower box / Full bores

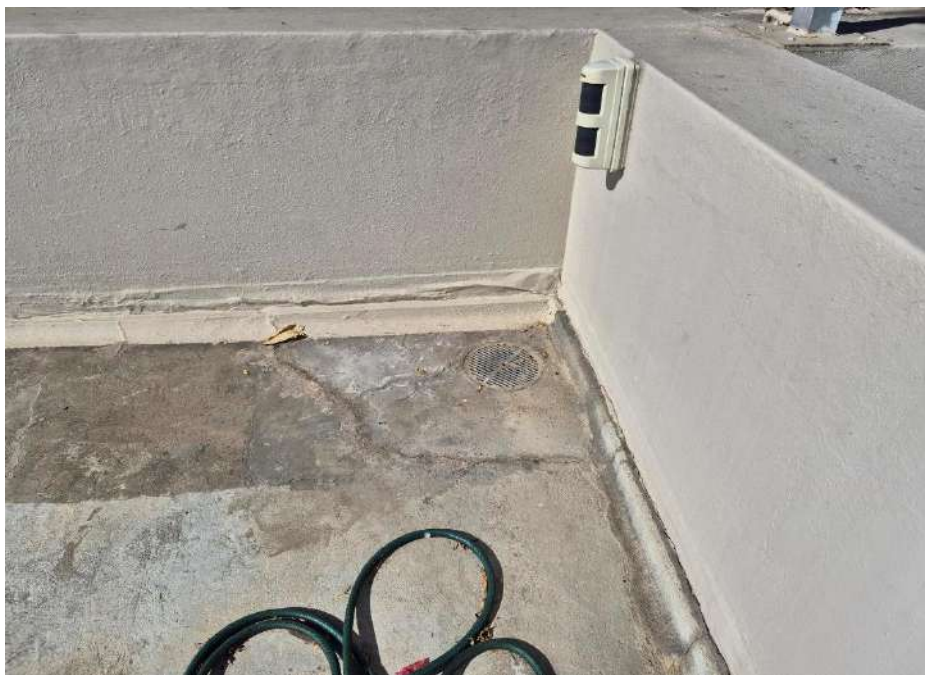
- The sloped concrete slab joins the initial driveway slab with a surface join, which is not sealed in accordance to suitable water proofing practices to prevent water ingress. A surface sealant on the join has disintegrated, and doesn't match the required processes to prevent water from infiltrating the below structure during rain and exposure to water. The full bores drains are level with the surface, and no channel is present to direct and relieve water from the surface. The water in turn runs down the stair case, and rushes into the front door entrance and adjoining structure to cause considerable and ongoing damages when rain is present.

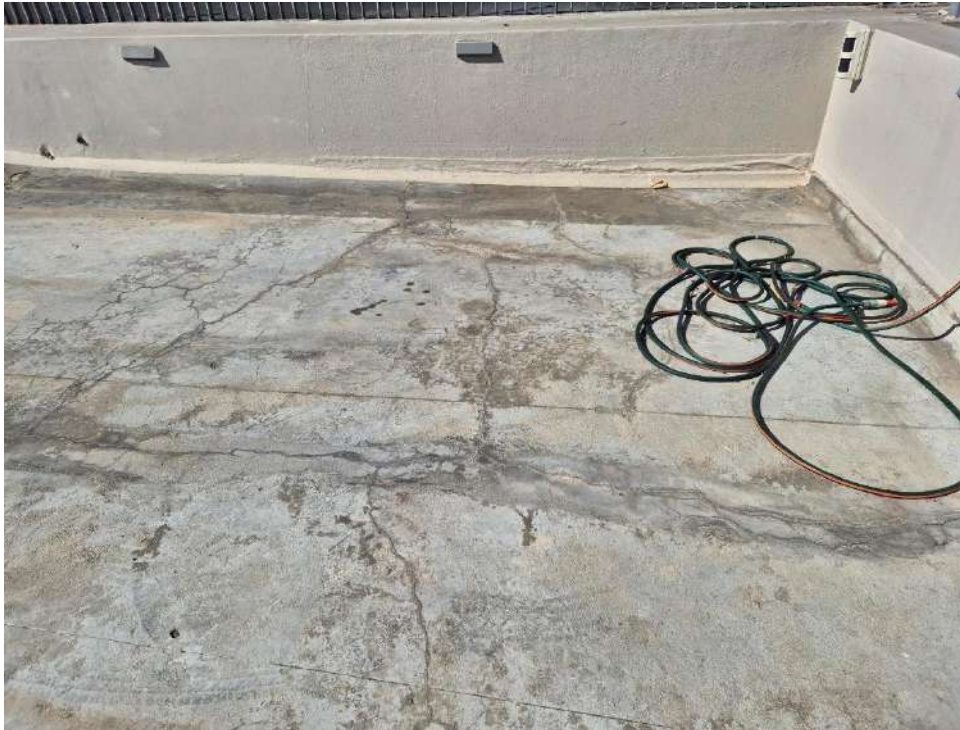
- Visible cracks are observed on the surface, and represents the failing topping that is flaking off the main structure, causing water to infiltrate the structure on the side and surface. The finishing of the structure does not align with the design specification as outlined by the assessing engineer. Surface membrane and water proofing paint is applied to a low level around the ground level, and the method is not suitable to prevent ingress from occurring as evident on the damages present.

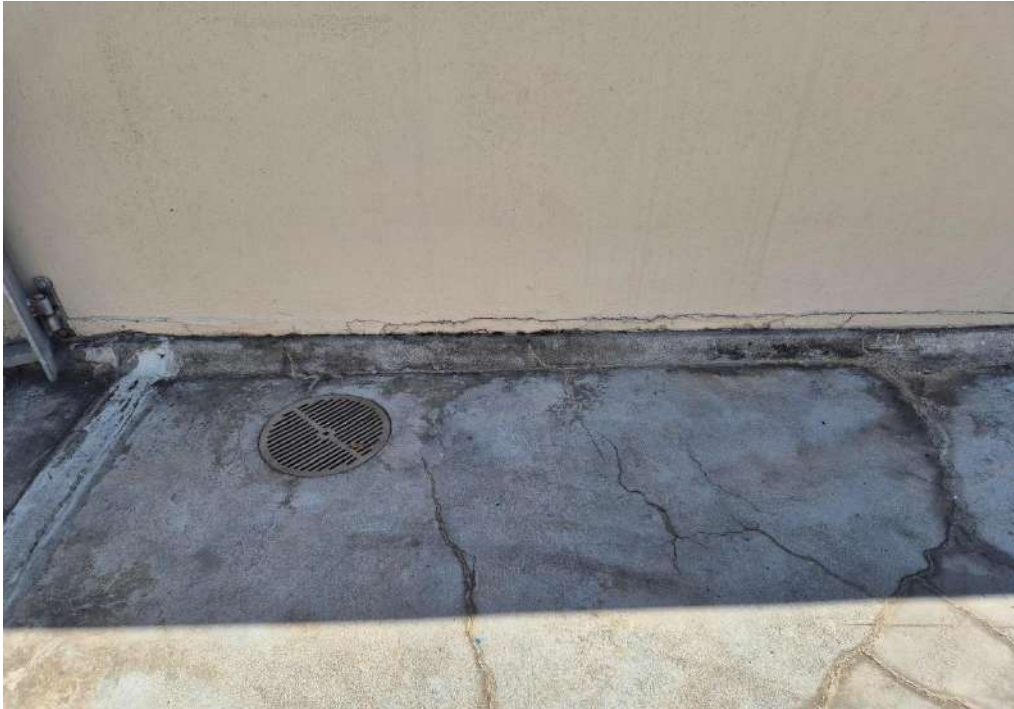
Above image shows that no channels are present for water to be directed successfully to the drainage points. The inside of the drainage also doesn't appear to be large enough to accommodate the influx of water expected to accumulate from the collective surface it is supposed to service. The approximate 100mm cement edging incorporated on the borders will in no way channel the water flow away from the structure, nor will it result in the water being directed to the full bores. Water rushes down the pedestrian walk way to the front door entrance.

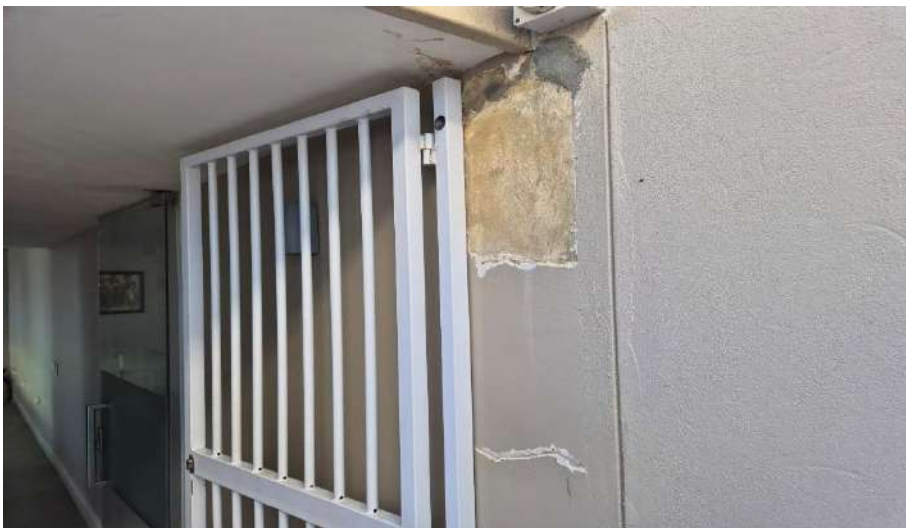
Below image is representing the damages linked to the water ingress from the above parking area, into the front door area.

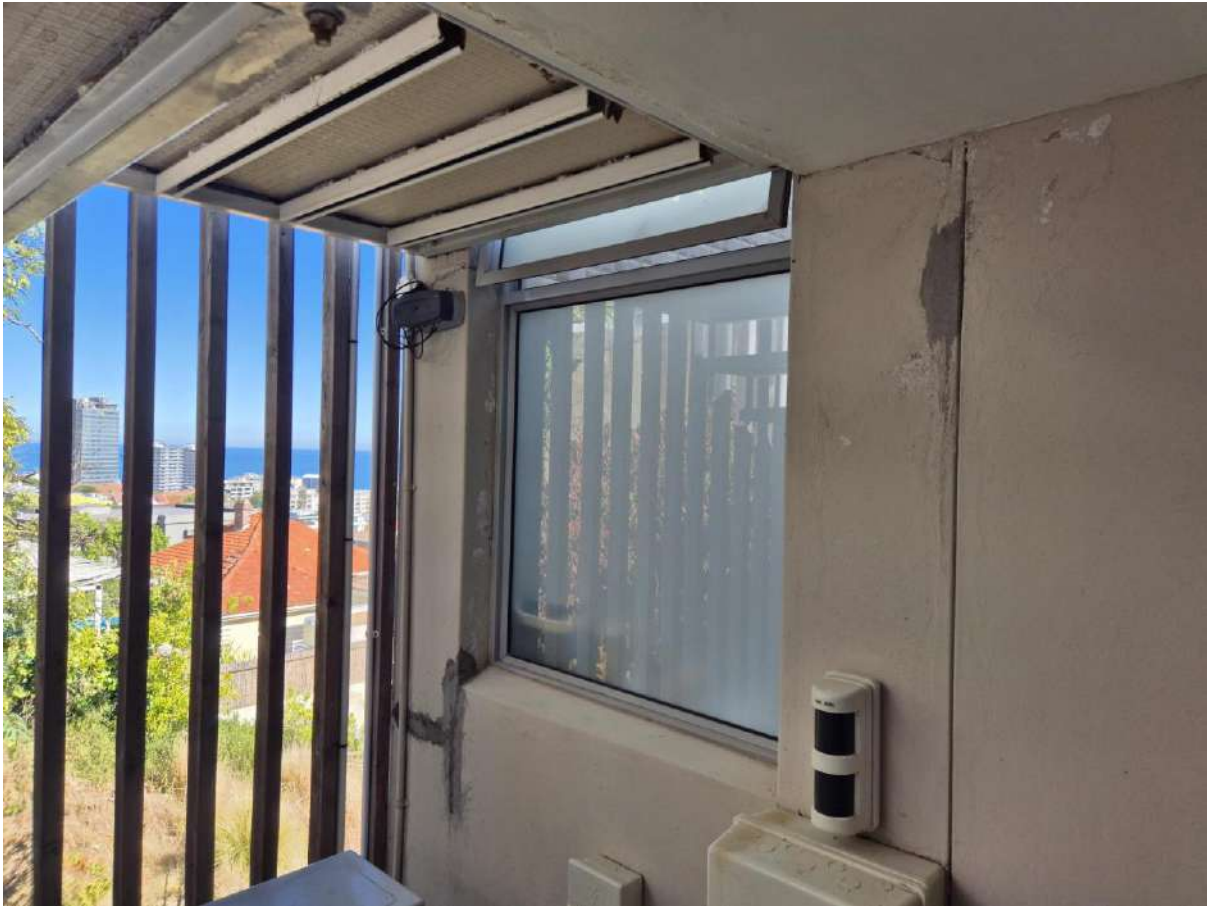
Above image is on the left of the front door, beneath the 2nd inactive full bore bordering the flower box above. Distressed plaster surface being separated from the main structure.

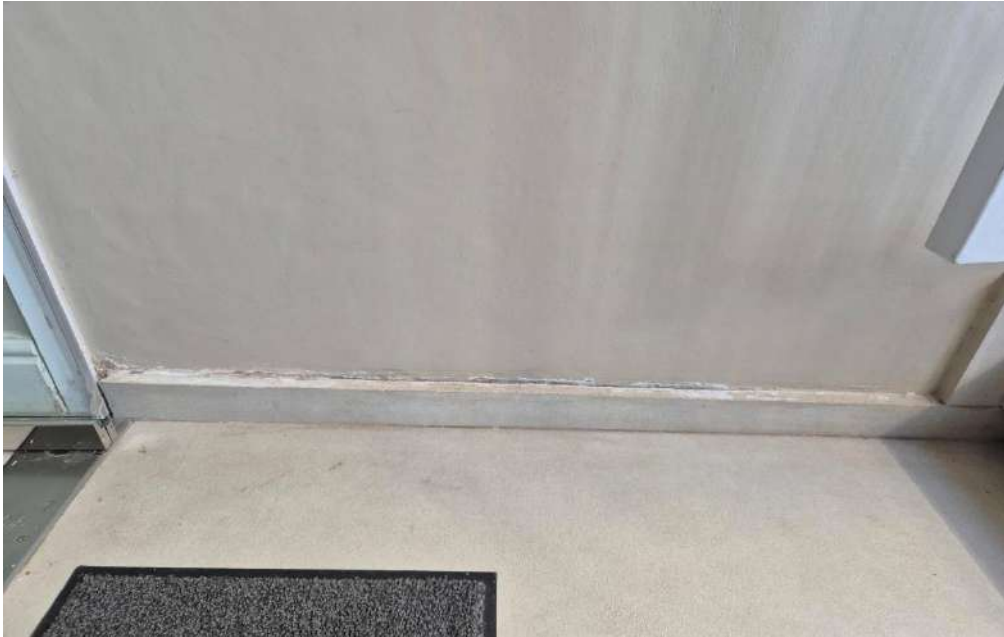
As the water ingress infiltrates the structure, it causes damp to rise off the concrete slabs it lands on as indicated above.

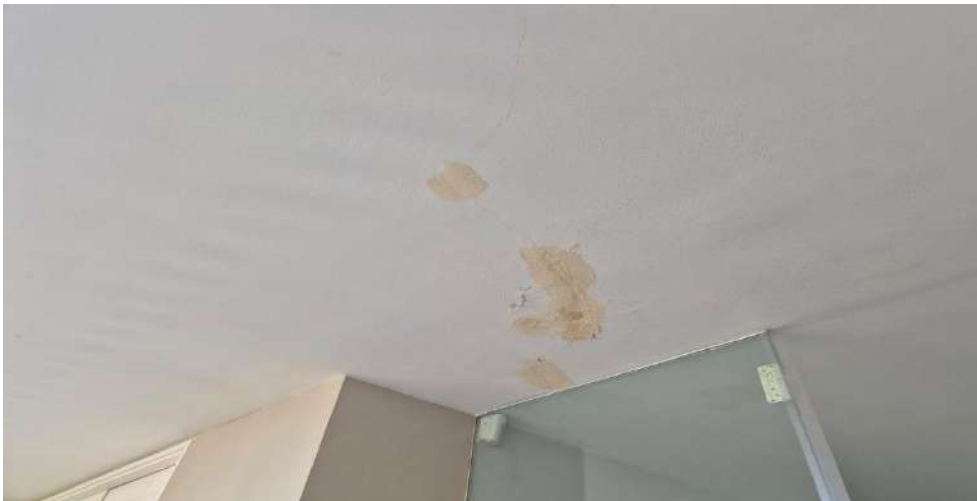
Water damage evident on the below structure from the various references made for the above points of water ingress from the drive / parking, and flowerbox.

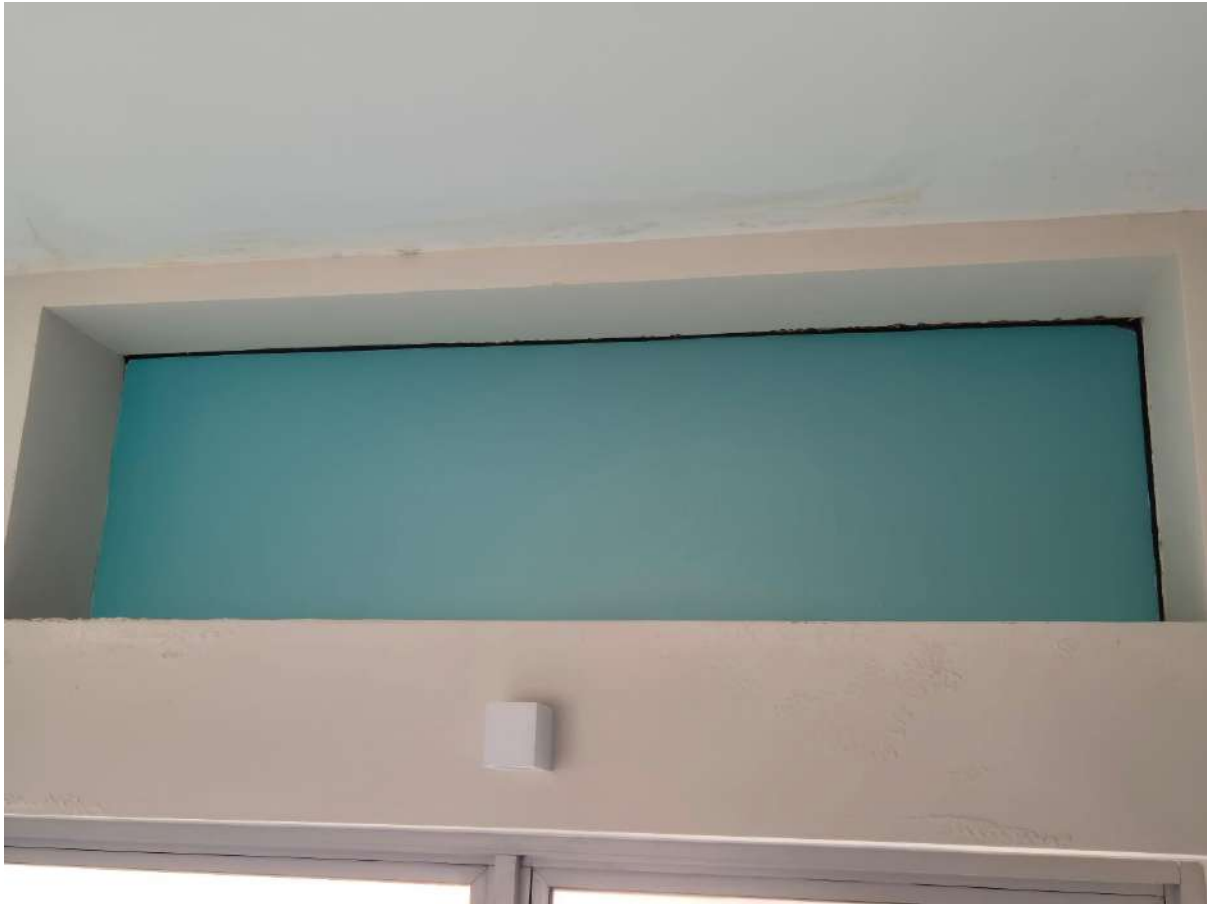
Alongside the pool installation did we observe compromised concrete work around the pool coping tiles. Water from the lawn area where it borders the pool enters behind the tiles causing water to enter alongside the side of the pool and leaks lower down into the building structure and marine glass found in the below room. There is no visible care taken to create for a reinforced water proofing, and the cement that is present already parted from the installation area of the tiles.

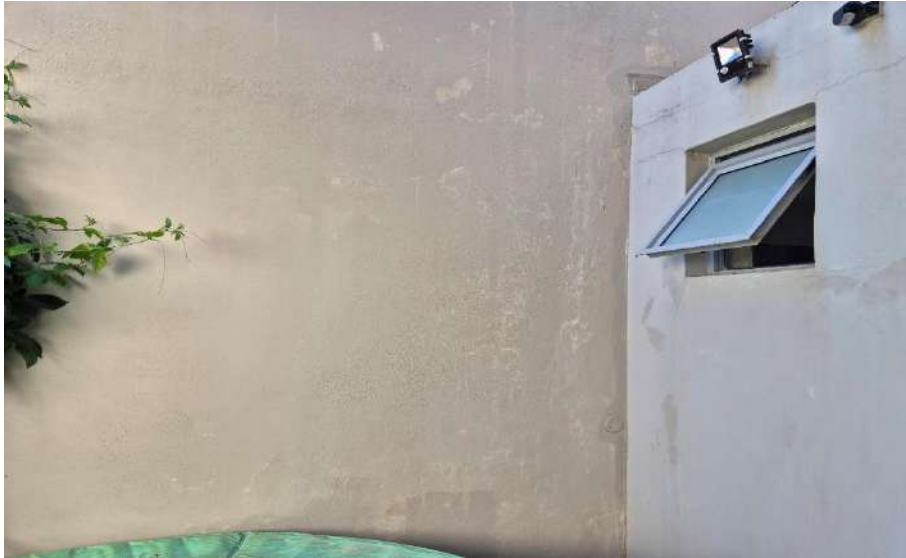
The outside bathroom building is severely damaged due to water ingress from the top of the structure. No acceptable roof provision is present, and the building is filled with rising damp from all levels of the structure. Windows upwards showing severe water damage, from the floor level upwards. The room is constructed in a poor manner and no care observed to prevent water ingress.

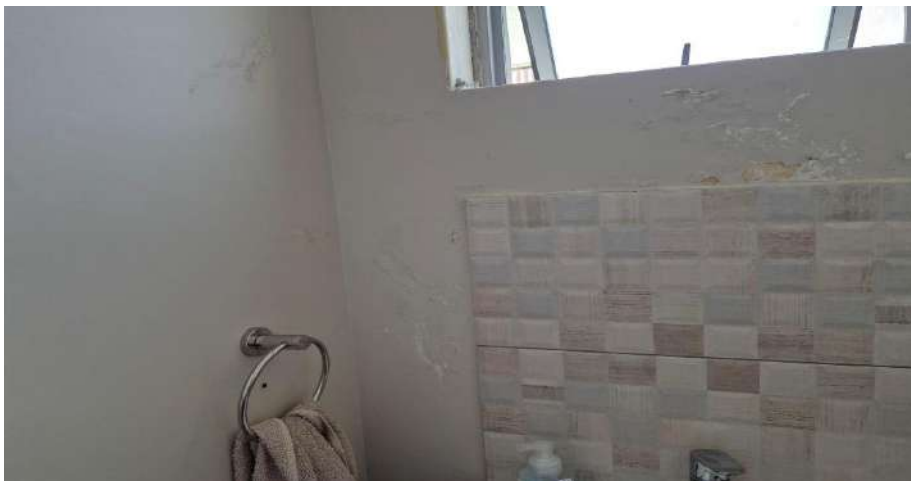
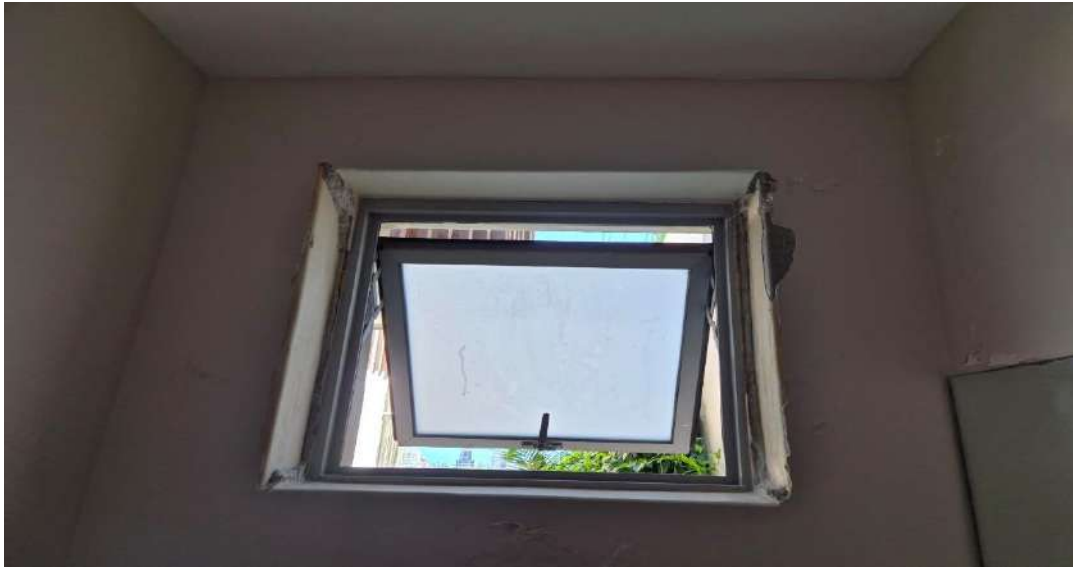
The boundary wall is also subjected to severe water ingress from outside walkway causing ongoing damages as per above and below picture.

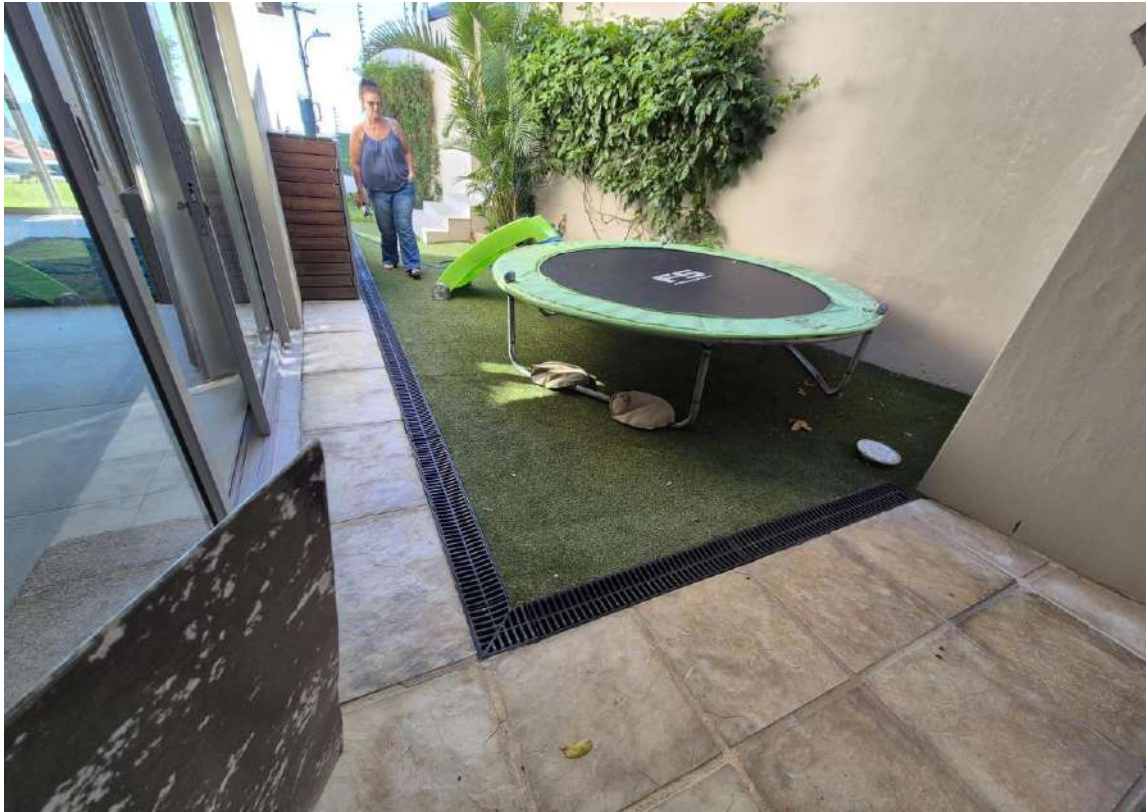
The above indicated that the drainage relieve, is higher than the lawn area. The lawn area is based on a compromised compaction, which resulted in the base dropping excessively, and preventing any water relieve from occurring. The water ingress is further compromising the base and water infiltrating the building structure to all surrounding areas causing not just damage, but could cause for structural movement.

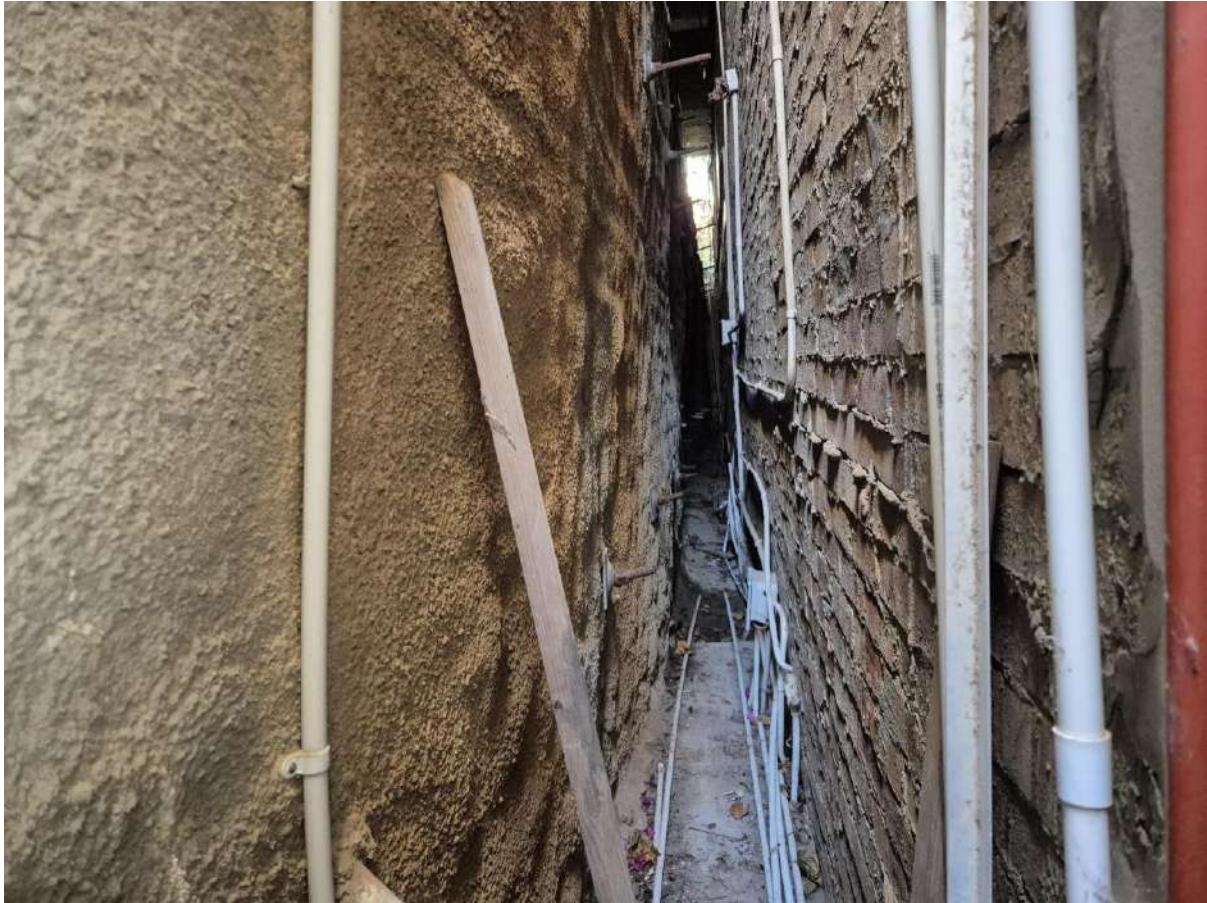
Behind the building is a Gunitite structure with relief pipes, but the water draining from the ground is discharging on an area where no run-off is possible, and the water in turn is absorbed by the structure adding to severe damages as per various images provided.

Gunite structure on the left, and no plaster or water proofing on the super structure to prevent water ingress, no drainage for the water being relieved from the natural soil behind the house structure.

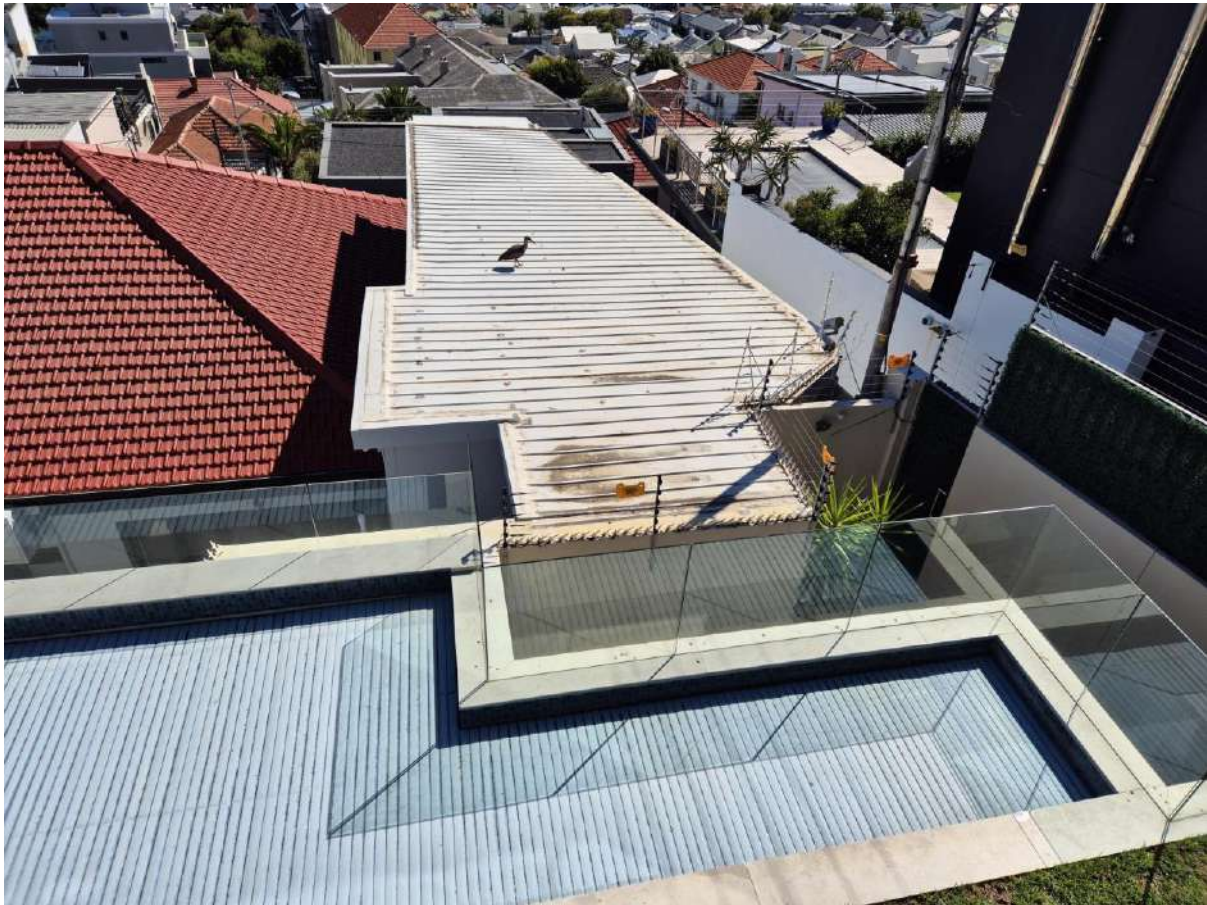
Lower bordering neighbor roof is joining irregularly against the wall of the client property. There is a damaged and bent roof sheet causing for pooling, no run off for water, and unfinished wall plaster left to compromise the area, and water can freely access the client's property causing ongoing plaster, pain and structural damages.

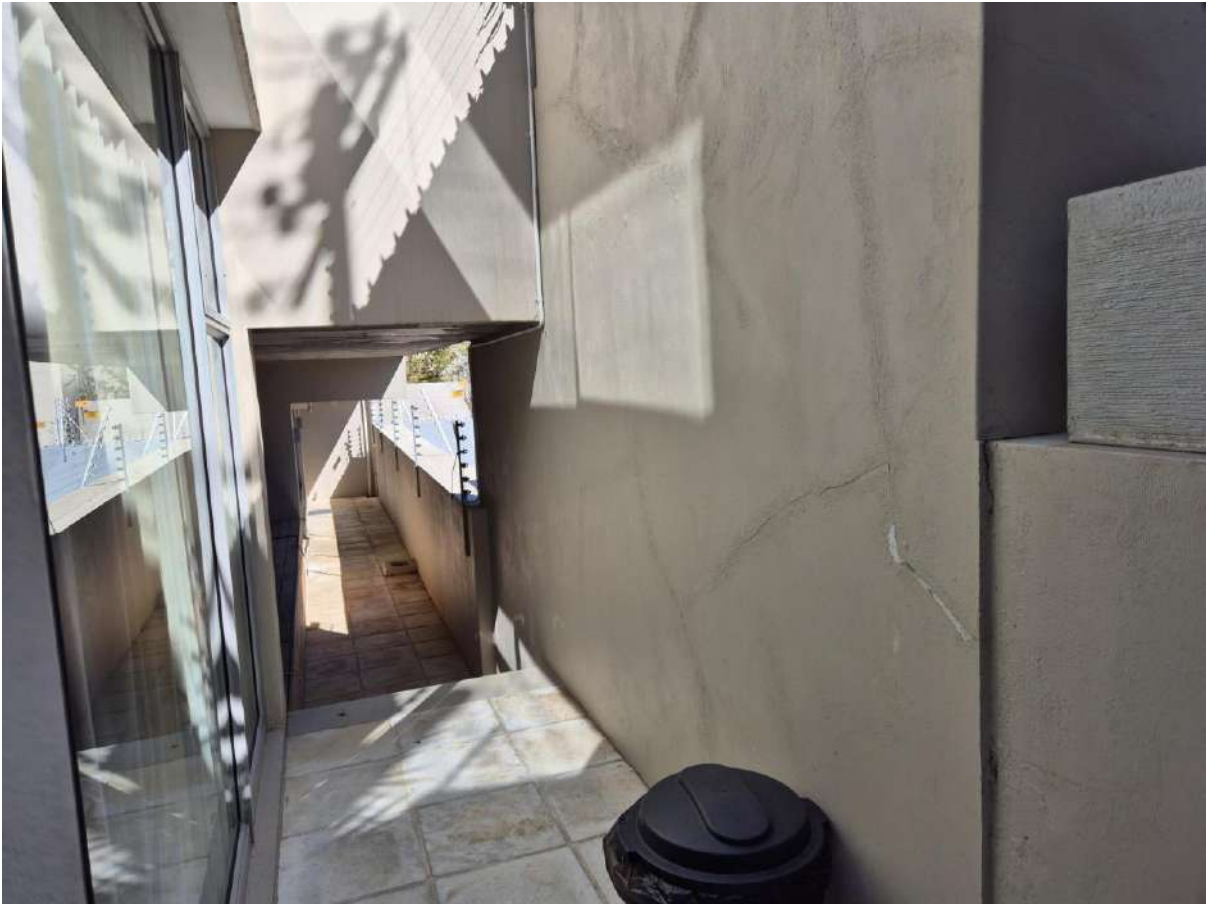
Wall area beneath the neighbor with the compromised and irregular roof structure and poor finished plaster work.

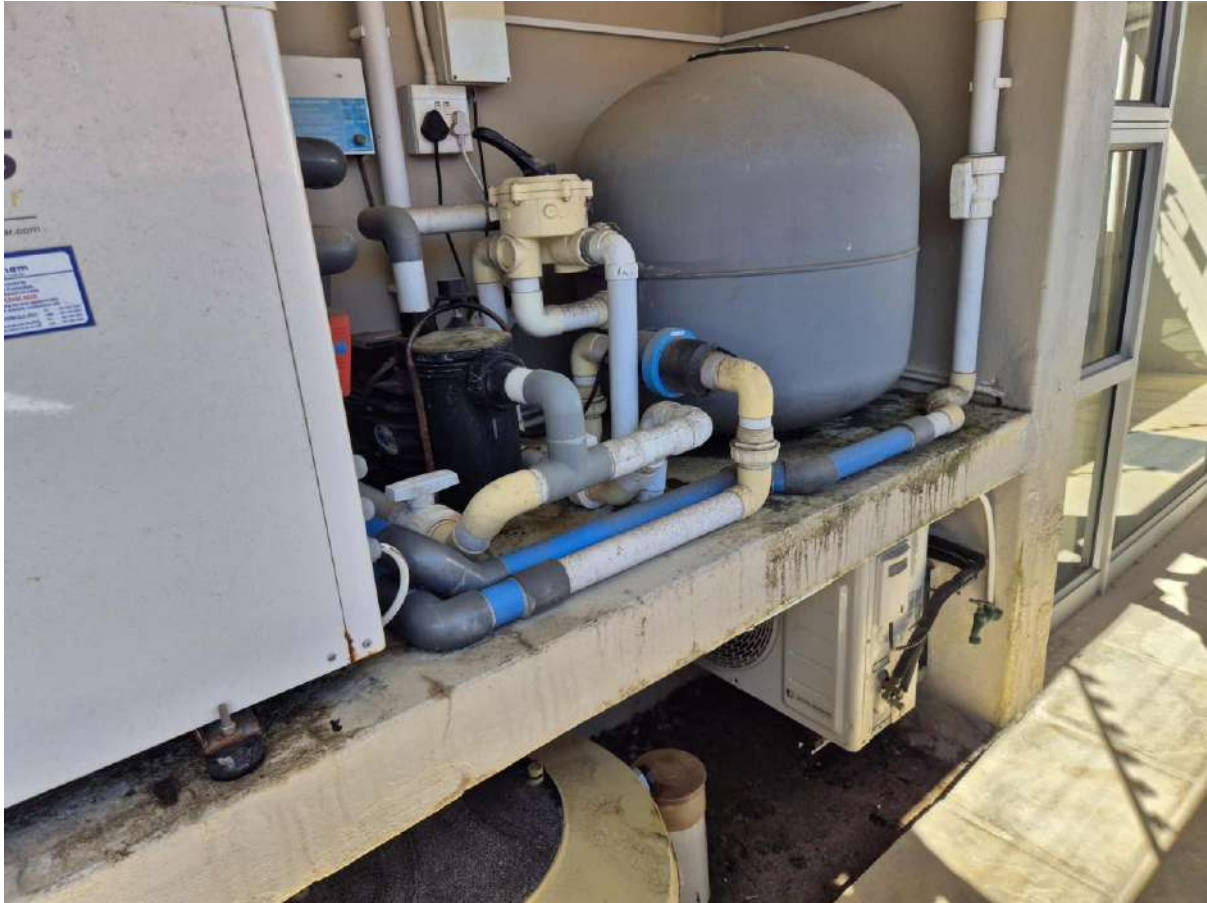
The surface below the pool pump has no concrete infill, causing direct water ingress into the bordering room with severe plaster, paint and structural damages.

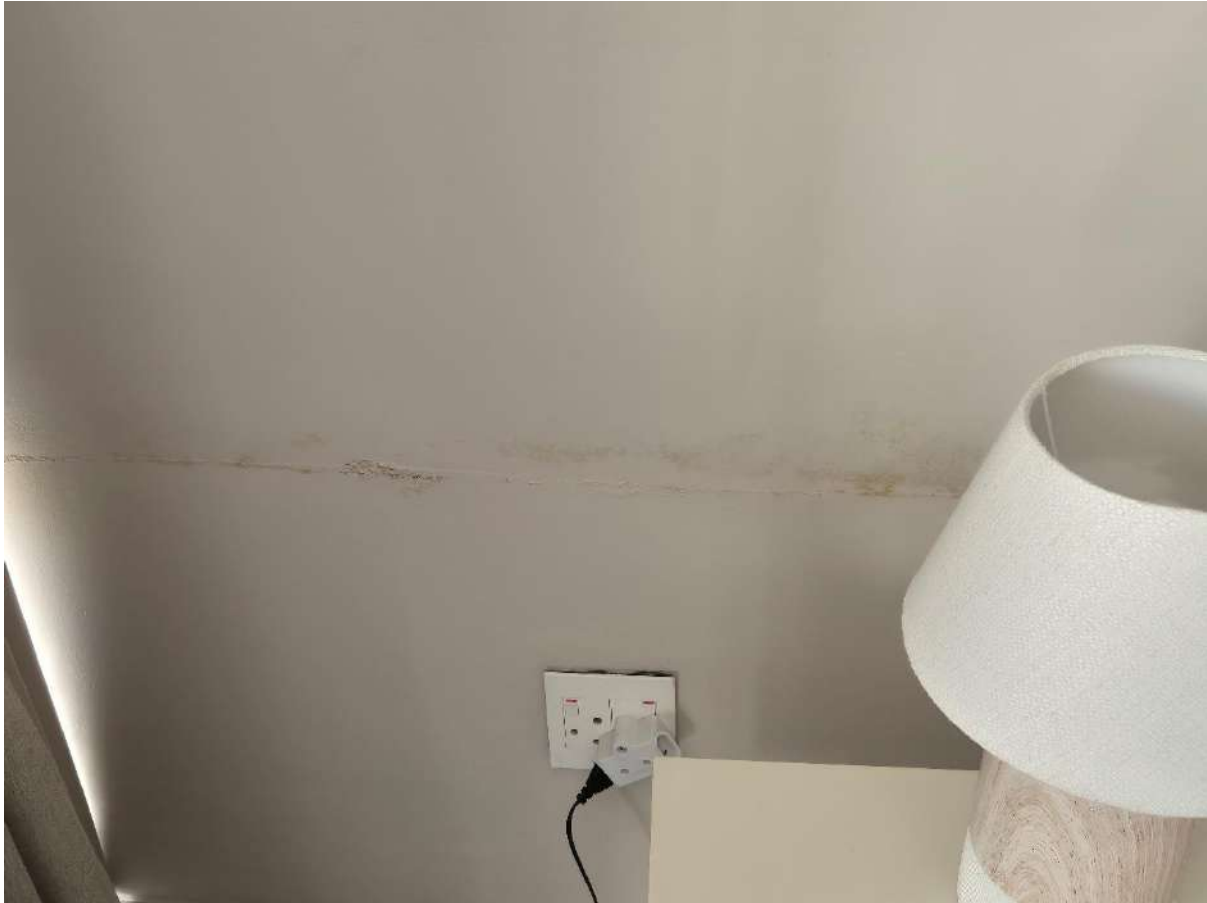
The storm / rain water directed to this area originates from the walk way with side entrance via the fake lawn area, which the base has been compromised. The water runs down this walkway, with no sufficient full bores, and leaves the water to be absorbed by the structure both vertically, and horizontally leaving major and ongoing damages to occur as can be seen on the below image.
