Our ref: P 2402-02-01 Forensic Engineering Assessment Report 00

## FORENSIC ENGINEERING ASSESSMENT REPORT

**HOUSE RUST  
ERF 3228, STERLING AVENUE  
PARYS COUNTRY AND GOLF ESTATE, PARYS**

**SECOND ISSUE**

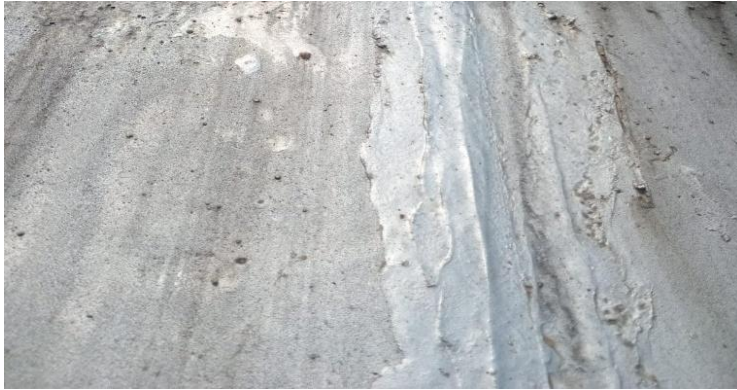
Figure 5: Protruding grooves on screeded surface 1

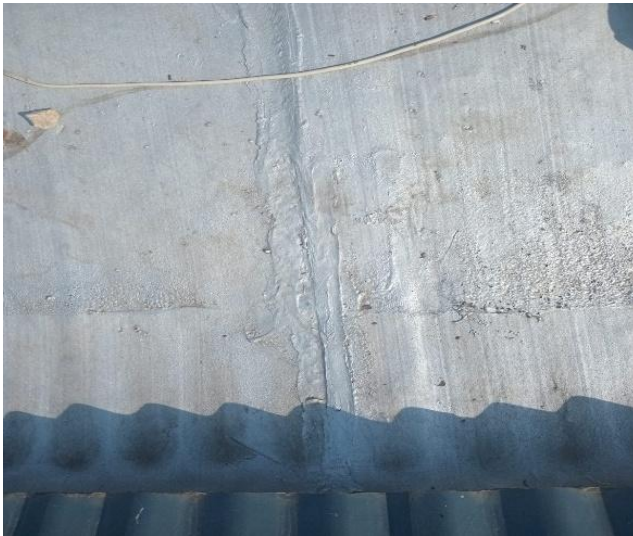
Figure 8: Protruding grooves on screeded surface 2

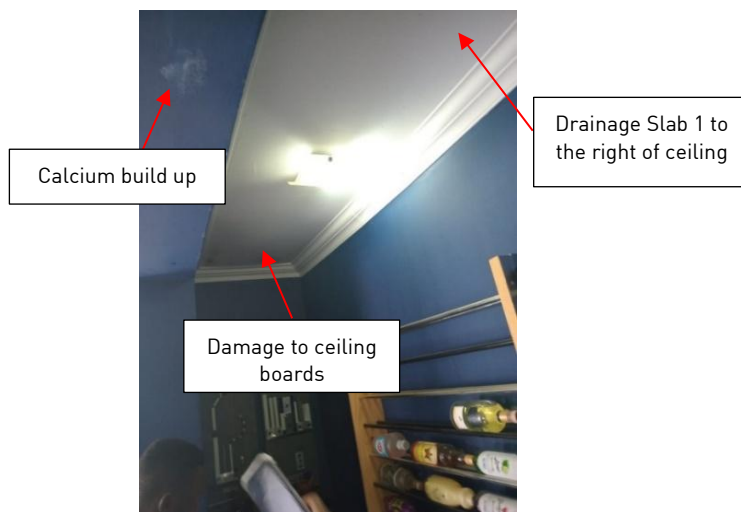
Figure 9: Wine Cellar

The wine cellar, shown in figure 9 below, is located adjacent to the drainage slab 1. It was observed that walls in the cellar had calcium build up on the surface and ceiling boards are stained from prolonged water ingress.

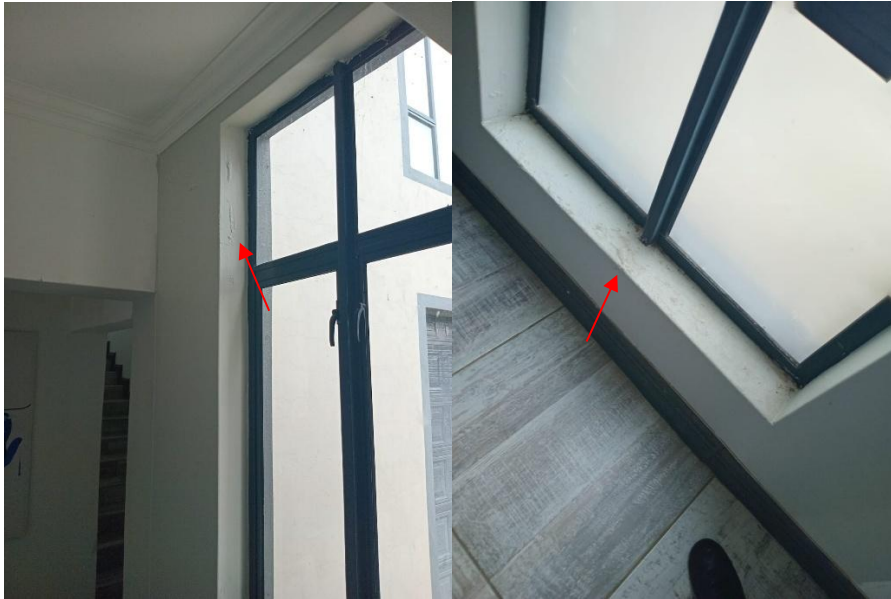
Figure 10: Window at Entrance Foyer

The figure below shows the window in the entrance foyer that is located between drainage slabs 1 and 2. Signs of water ingress were observed as paint bubbles away from the plastered surface.

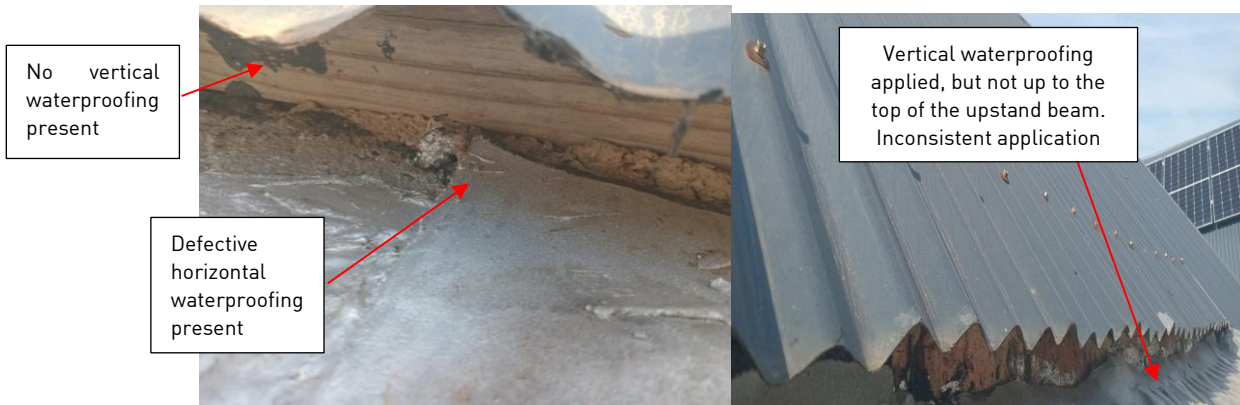
**Figure 11: Vertical and Horizontal Water proofing**

Figure 11 below indicates the horizontal waterproofing done up to the timber beam. The waterproofing installation on the slab is not done adequately or in accordance with standard construction practices. The lack of vertical waterproofing firstly creates easy access for the water to penetrate through porous brickwork and secondly only serves its purpose until the water level reaches the highest point of the horizontal membrane.

Figure 11 also shows partial waterproofing done on the vertical face of the upstand brickwork in certain sections. It should be noted that it does not extend to the top of the parapet.

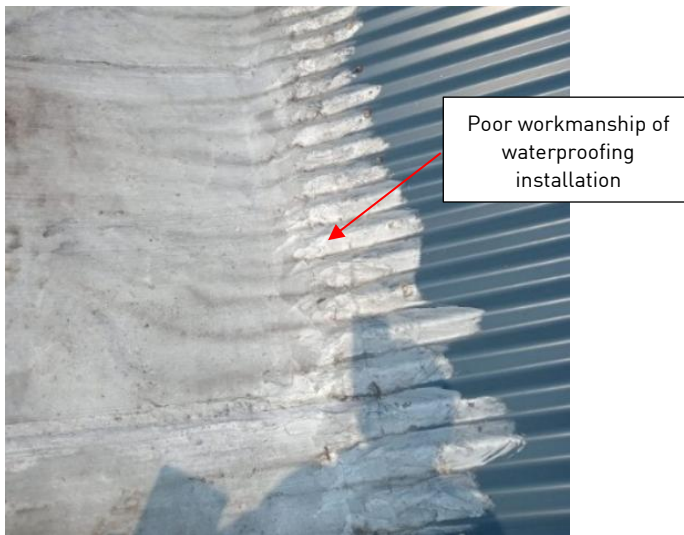
Figure 12 shows the application of water proofing over the sheeting. This is not standard construction practice and poses a problem relating to extensive movement of the sheeting due to thermal variations. The application is unsatisfactory.

**Figure 12: Poor Application of Waterproofing**

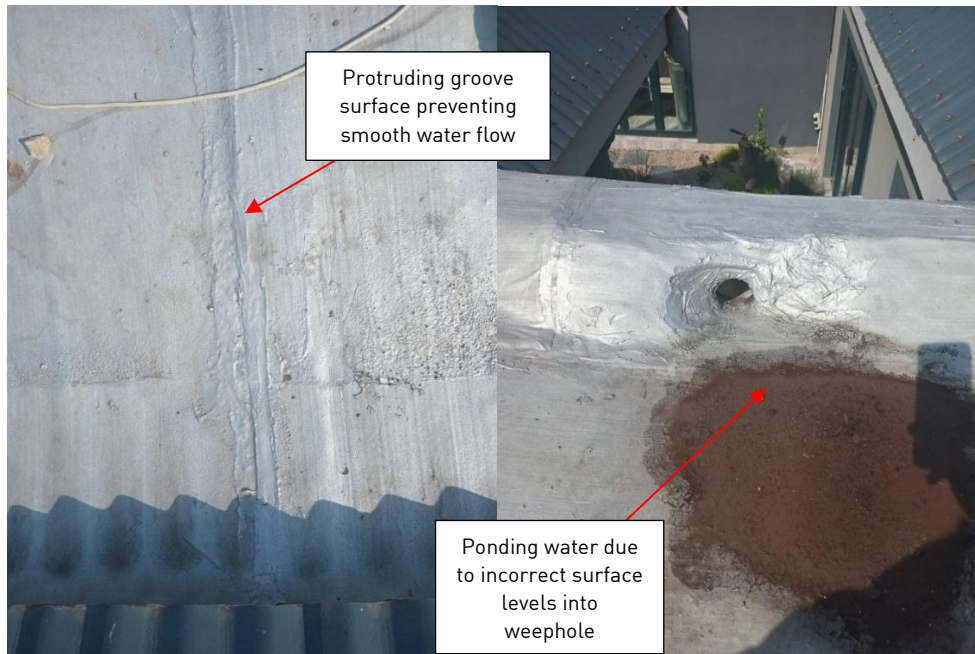
Figure 13: Concrete slab surfaces

The slab has an uneven surface with protruding grooves where water accumulates until it reaches a depth that exceeds the depth of the groove. This is an obvious obstruction for water flow intended to divert towards the weephole. The grooves can be seen in Figure 13 below.

The weephole invert is higher than the lowest point of the sloped slab surface creating a point where water accumulates rather than flows freely into the weephole.

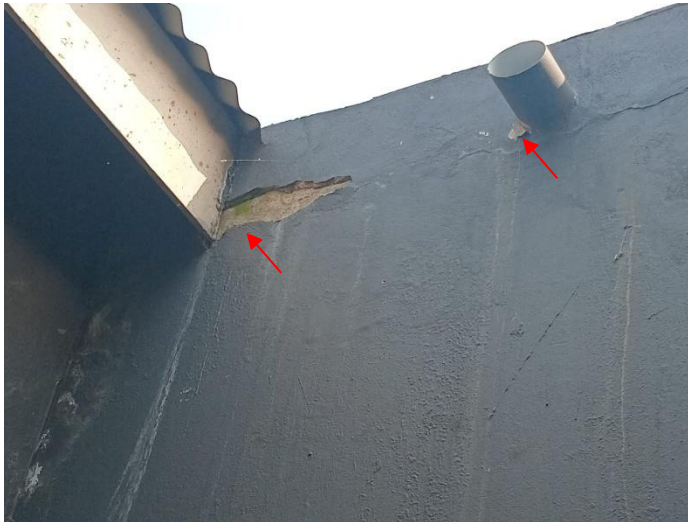
Figure 14: Water damage on external walls

Figure 14 below shows delamination of plaster on the external wall directly below the slab soffit.

The horizontal crack observed is caused by the different expansion characteristics of the concrete slab and the supporting masonry. This is normal structural behaviour and not a cause for concern. Good practice would be to have an expansion joint between the concrete and the brickwork with a sealant to prevent water ingress.

The current situation where a proper joint is not constructed, adds to the water damage seen inside the house. The crack allows penetrating damp to accumulate in the masonry walls.

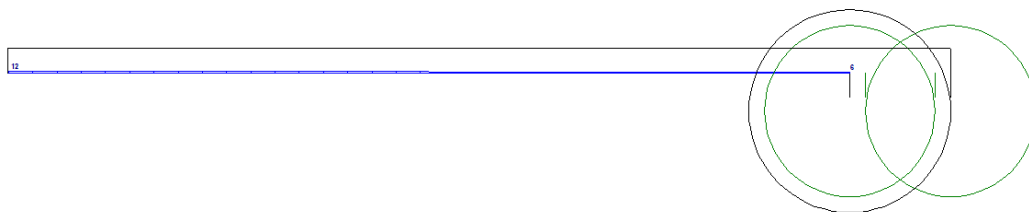
Figure 15:Existing slab simulation model

Figure 15 shows an extract from PROKON's gutter and downpipe analysis software. The simulated slab with similar dimensions is effective in draining the required runoff water through the Ø80mm weephole.

This confirms that the slab is proportionally sufficient to effectively direct the water to the intended location provided that the water proofing is done in an appropriate manner.

In conclusion, the water ingress is caused by incorrect application of waterproofing membranes, insufficient waterproofing in areas and not inadequate structural design.

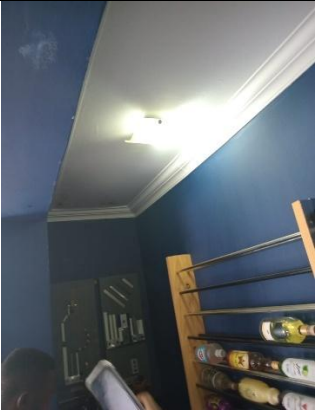
<p>Water ingress into wine cellar</p>	<p>Calcium build- up on the Wall. <b>Structural Defect</b> due to serviceability of the structure</p>	<p>Once the cause of the water ingress is remedied. (As per Method Statement 2 in Annexure B)</p> <p>Ceiling to be inspected, areas affected by water damage to be replaced with matching ceiling board</p> <p>Area of wall that is affected by water ingress to be opened up to dry for 3-5 days</p> <p>Replaster in accordance with Method Statement 1 in Annexure B</p>
2

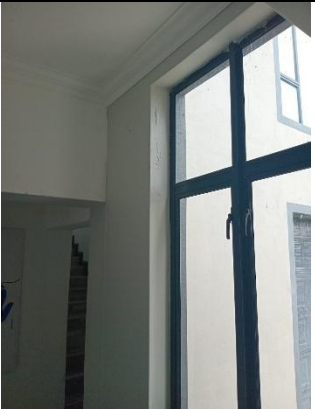
<p>Water ingress at entrance foyer</p>	<p>Paint bubbles away from plaster surface. <b>Structural Defect</b> due to serviceability of the structure</p>	<p>Once the cause of water ingress is remedied. (As per Method Statement 2 in Annexure B)</p> <p>Area of wall that is affected by water penetration to be opened up and left to dry for 3-5 days</p> <p>Replaster in accordance with Method Statement 1 in Annexure B</p>

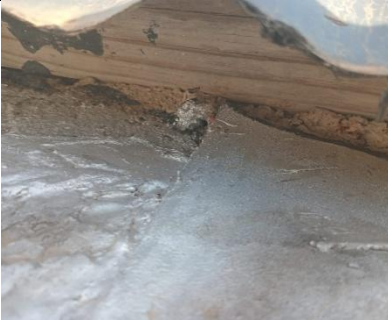
<p>Incorrect application of waterproofing</p>	<p>Does not conform to the serviceability limit state requirements of the building regulations - <b>Structural Defect</b></p> <p><b>The main cause for water ingress into the building</b></p>	<p>Remedial work in accordance with Method Statement 2 in Annexure B</p>
4

1. Remove existing waterproofing and uneven concrete screed.
2. Remove roof fixings for the last portion of sheeting (adjacent to the concrete slabs).
3. Cut the timber rafters and sheeting to lie on the brick upstand beam creating an overhang of at least 300mm if possible.  
If no brick upstand is present, inform Structural Engineer.
4. Re-screed in accordance with Structural Engineers specifications. Slopes and depths to be specified by Engineer.
5. Install flashing as shown in green in the sketch below. The flashing to be fixed to rafters with screws.
6. Waterproof the flashing and new screed layer in accordance with waterproofing specialist's specifications
7. Re-instate IBR sheeting

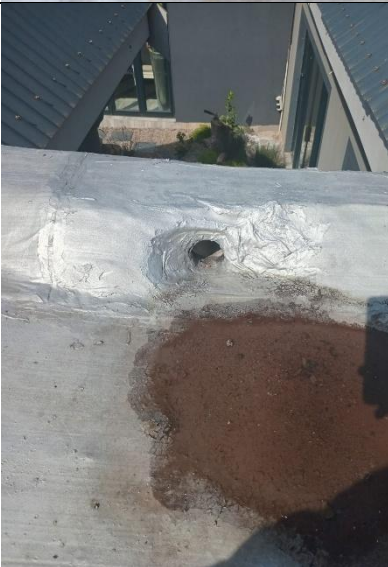
<p>Concrete Slab having incorrect slopes and screeding levels</p>	<p>Does not conform to the serviceability limit state requirements of the building regulations - <b>Structural Defect</b></p> <p><b>The main cause for water ingress into the building</b></p>	<p>Remedial work in accordance with Method Statement 2 in Annexure B</p>

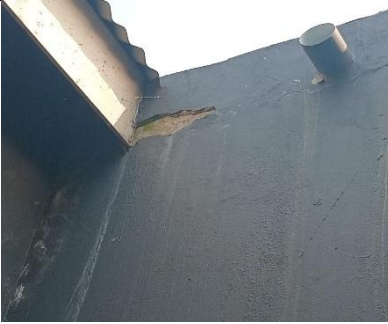
<p>Delamination of plaster on external wall</p>	<p>No expansion joint present between concrete slab and brick wall. <b>Structural Defect</b> due to serviceability of the structure</p>	<p>Once the cause of water ingress is remedied. (As per Method Statement 2 in Annexure B)</p> <ul style="list-style-type: none"> <li>• Remove plaster 300mm above and below line of slab soffit</li> <li>• Scrape out at least 20mm of plaster between the slab and the brickwork</li> <li>• Fill and seal joint with polyurethane sealant approved by engineer</li> <li>• Replaster area with joint over sealant to allow for movement without cracking.</li> </ul> <p>Area of wall that is affected by water penetration to be opened up and left to dry for 3-5 days</p> <p>Replaster in accordance with Method Statement 1 in Annexure B</p>
---	---	---	---	--
