**Construction Defects – Method Statement and Schedule**  
**House Blumenthal - ERF 405 Gamtoos**

This Method Statement outlines the proposed approach, procedures, and responsibilities for the repair of defects identified at House Blumenthal. The defects were formally recorded by the National Home Builders Registration Council (NHBRC) in their Conciliation Report (Reference: 84555204) dated 11 November 2024.

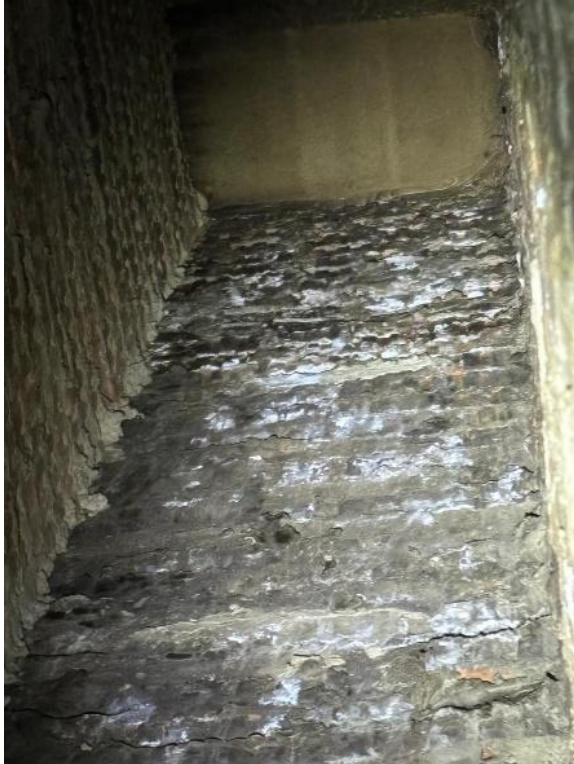
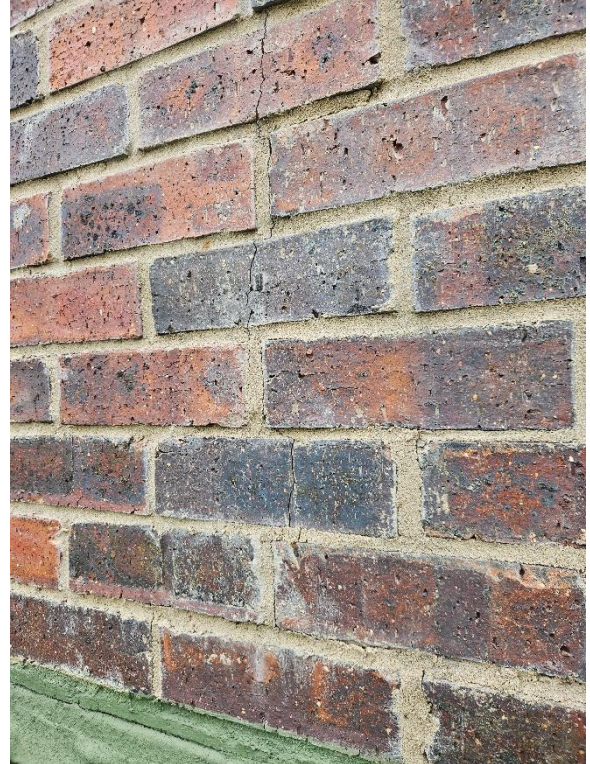
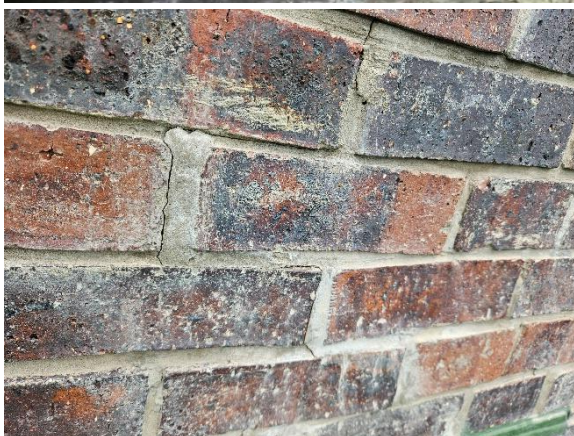
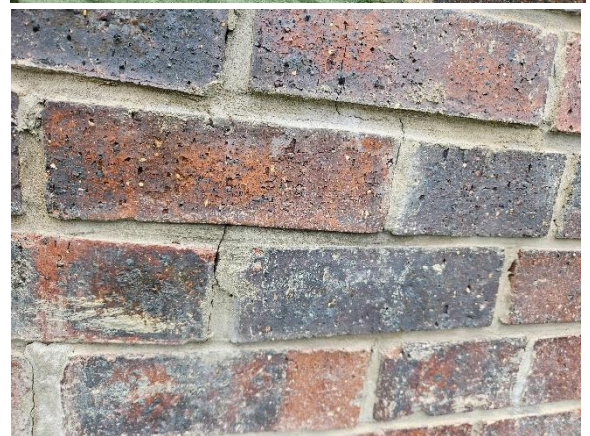
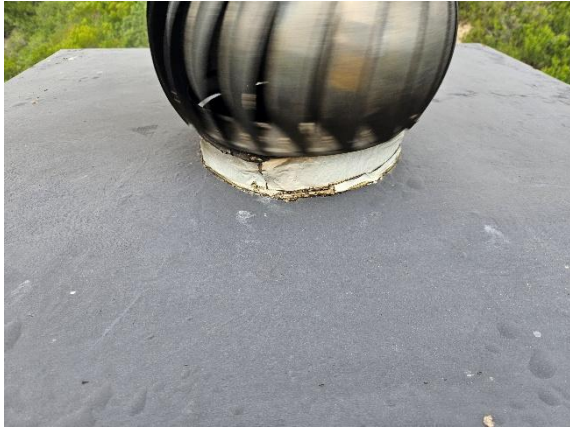
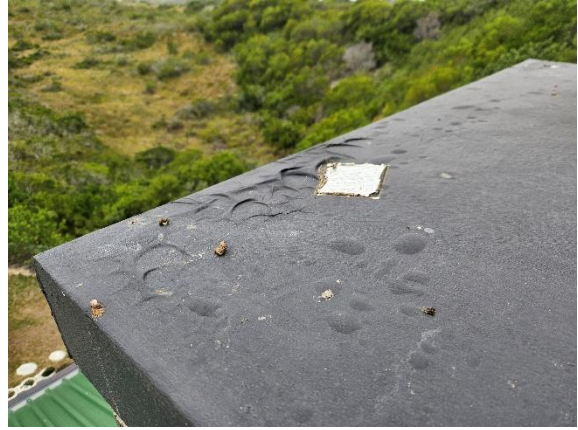
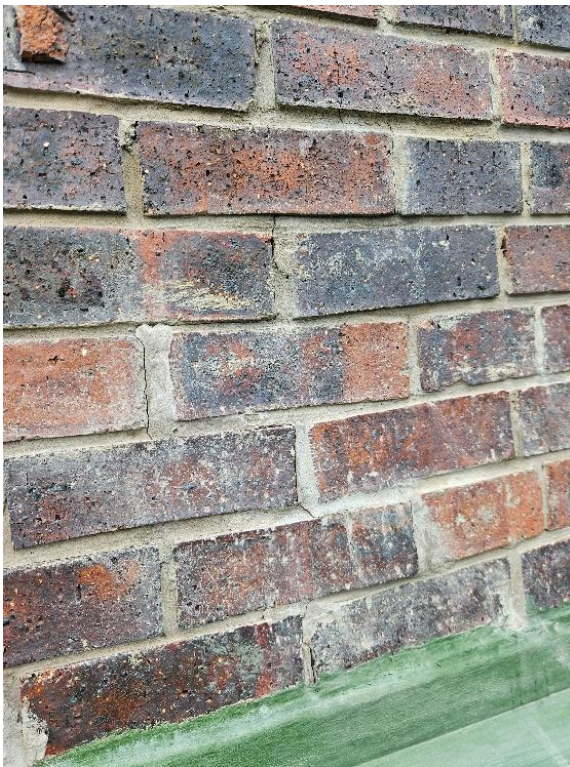
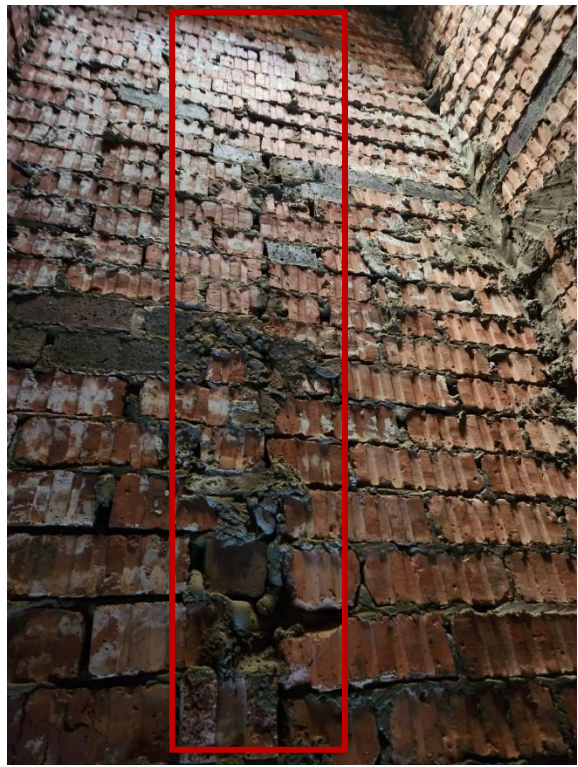
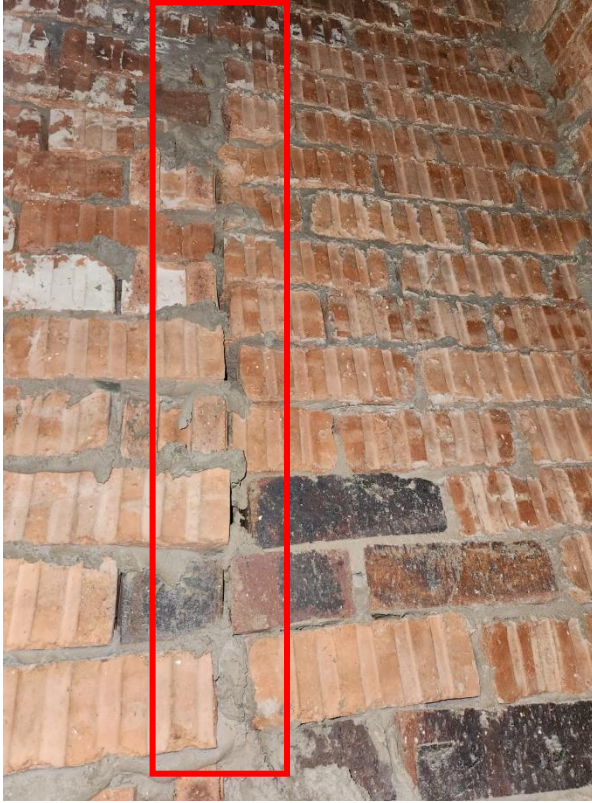
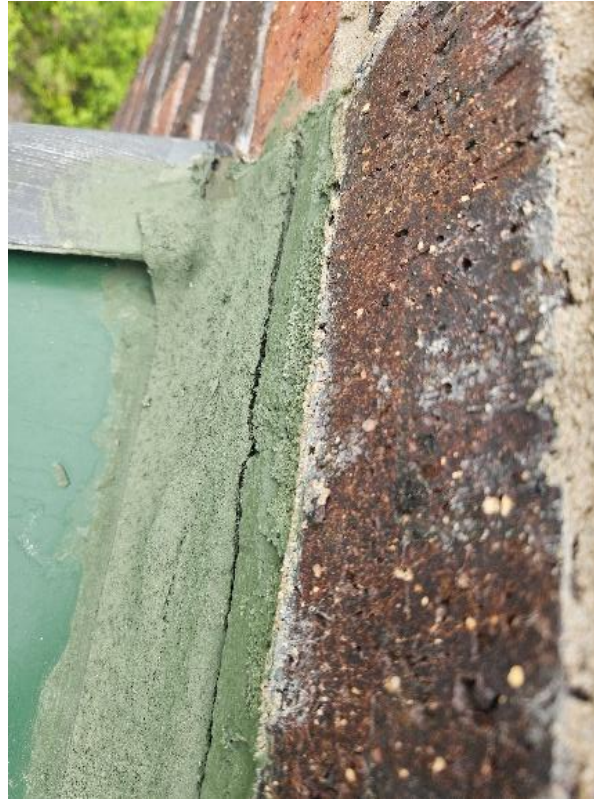
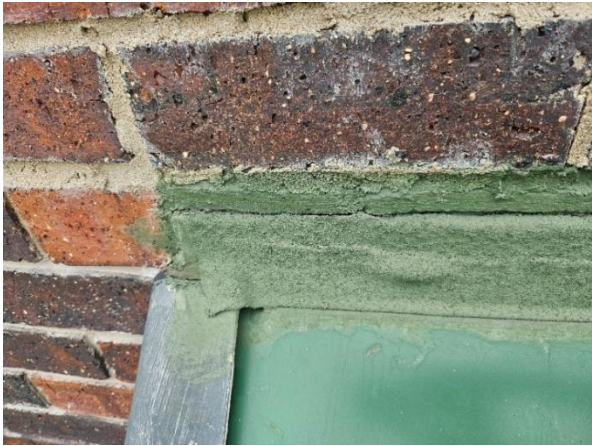
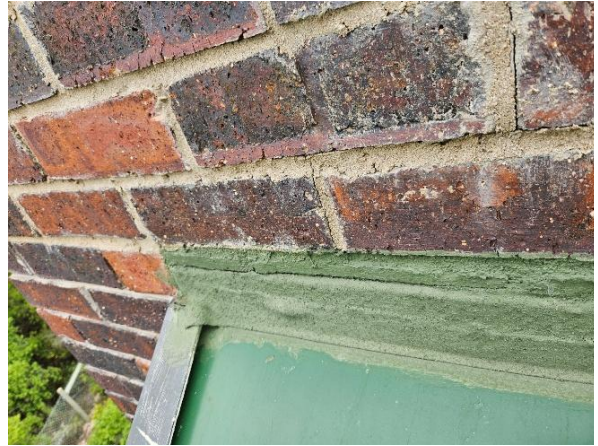
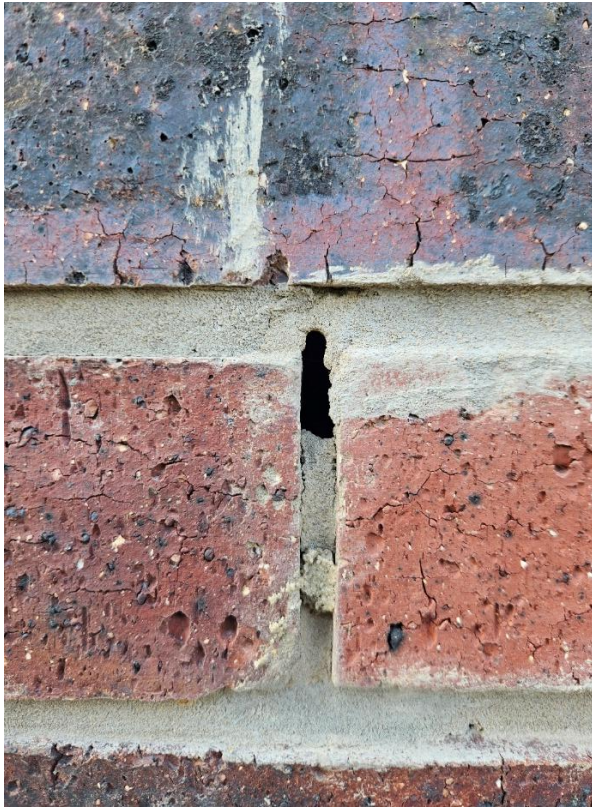
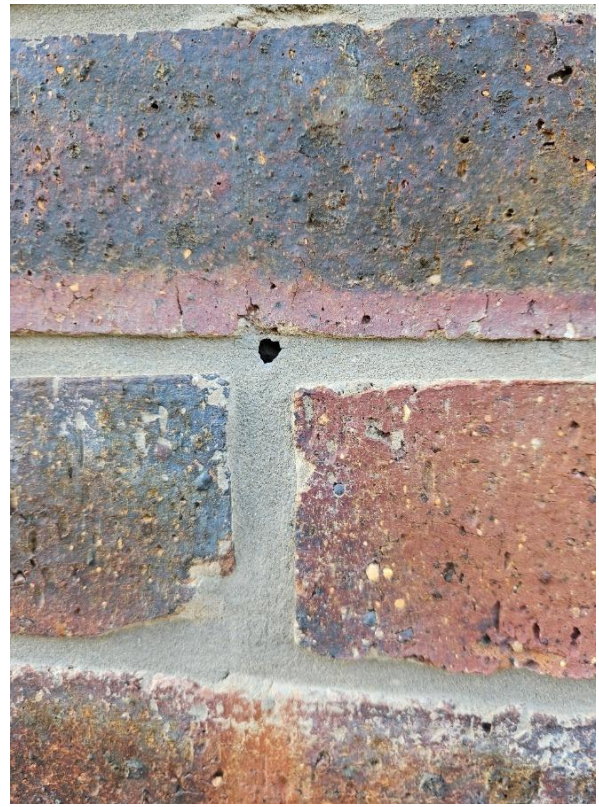
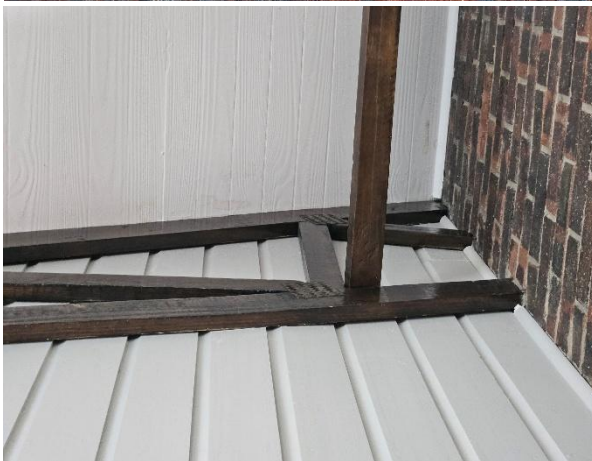
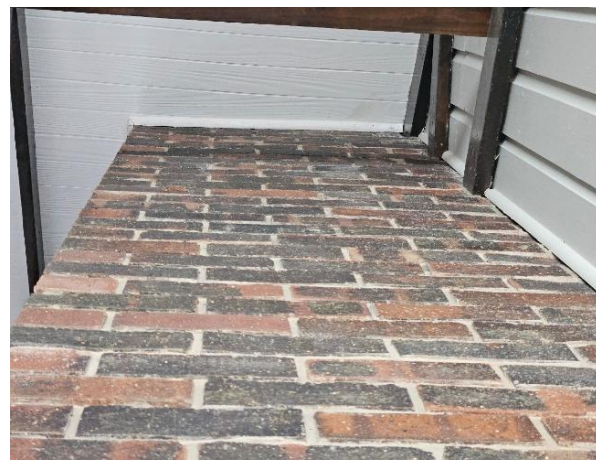
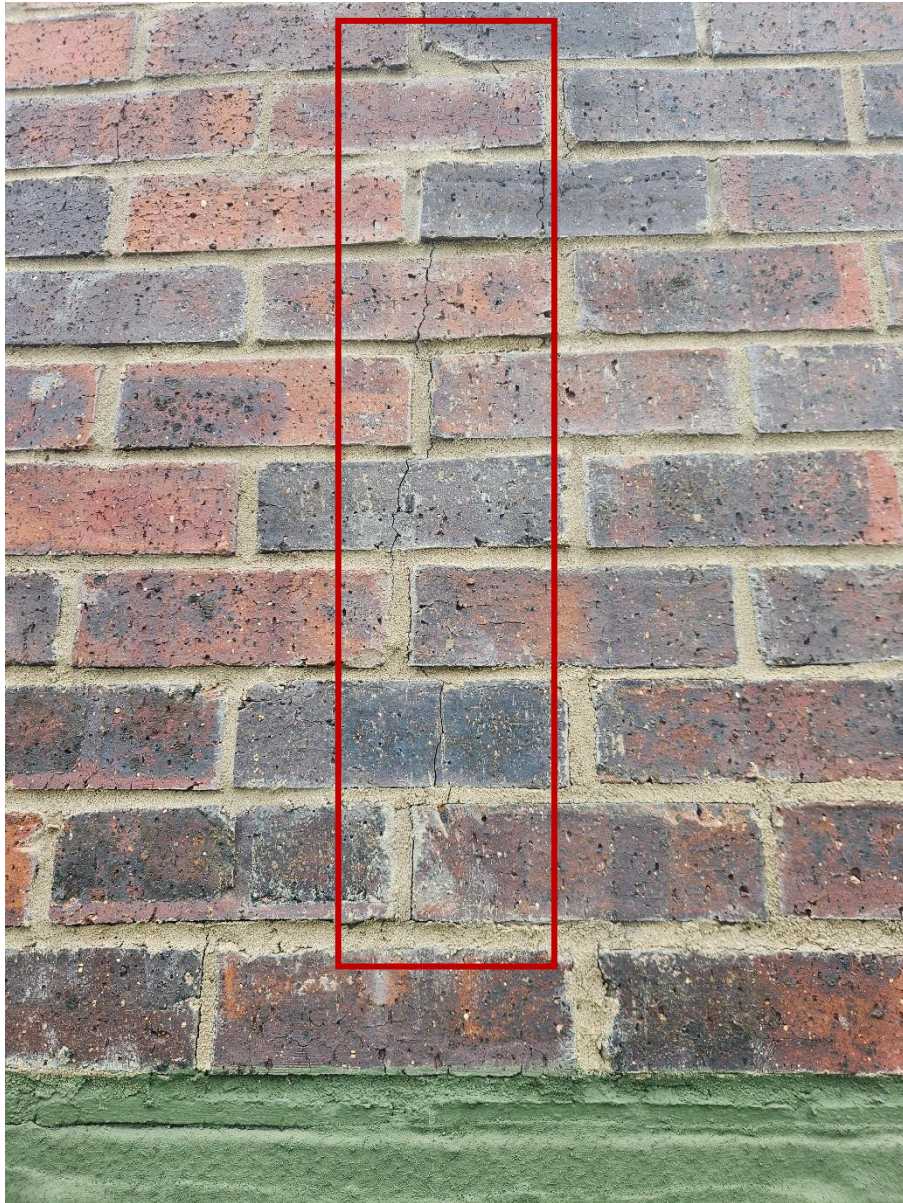
Water ingress was observed at the chimney during rainfall events, with moisture tracking down along the roof truss and resulting in water dripping onto the cupboard and floor below. Defective waterproofing to the chimney structure was noted. In addition, cracking to the masonry brickwork and poorly constructed and deteriorated mortar joints were identified, contributing to the failure to prevent moisture penetration.

The chimney has developed structural cracking on both the eastern and western faces, as evidenced in the accompanying photographic record. In accordance with the NHBRC Home Building Manual requirements for structural integrity and relevant SANS masonry and roofing standards, the following repair method shall be applied:

The existing chimney slab shall be removed in full. The chimney is to be carefully demolished down to the +3 697 UC wallplate level (approximately 20 brick courses). All demolition work must ensure stability of adjacent masonry and roof components, following the principles of SANS 10400-Part B (Structural Safety).

Once the chimney has been removed to a point below the roof covering and truss line, lintels shall be installed on the inner leaf to bridge and reinforce all courses that are not horizontally bonded or interlocked. the chimney is to be rebuilt in accordance with the design. The facebricks to match the existing facebricks. This installation must comply with SANS and the NHBRC guidelines for structural masonry detailing.

A new slab is to be cast with a proper overhang and drip grooves to prevent moisture ingress in accordance with SANS 10400-Part R (Roofs) and good waterproofing practice. The slab must provide adequate support for the chimney superstructure and ensure appropriate rainwater shedding.

All masonry joints, penetrations, and openings within the chimney structure are to be fully inspected. Any voids or unfilled joints must be opened, cleaned, and packed with appropriate building mortar, ensuring a uniform and weather-tight outer leaf finish. This must be done in accordance with SANS for brickwork.

All roof flashing and waterproofing to the chimney to be installed in accordance with the SANS.
