HOUSE MNGADI

ERF 5259 BLUE VALLEY GOLF AND COUNTRY ESTATE

STRUCTURAL ASSESSMENT

ASSESSMENT REPORT

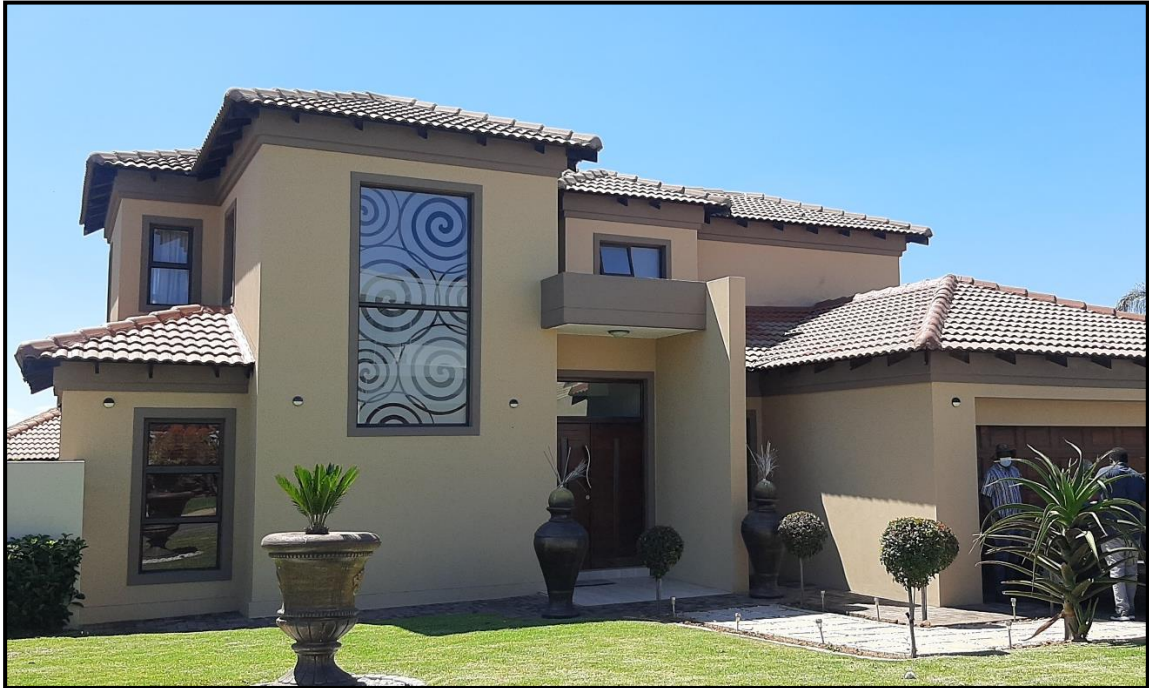
Figure 1-2 Building Elevation – House Mngadi (view from Street Entrance)

The housing unit is a double-storey structure–built form cement bricks, plastered and painted internally and externally. The housing unit consist of an open plan kitchen, living area, garage, and guest toilet, downstairs whilst the upstairs portion of the houses contains the main, two additional bedrooms and pyjama lounge/office.
