11 April 2025

RE: Site report for 'HOUSE NOTH' Leak detection, Property assessment

Top Floor / Parking / Flower box / Full bores

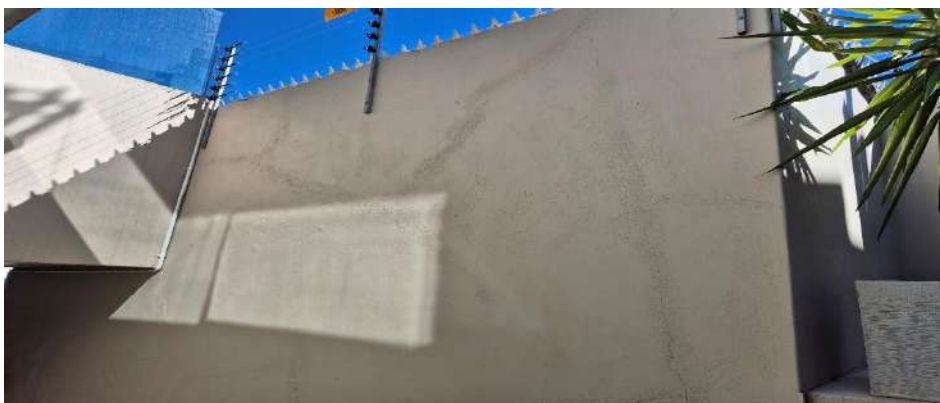
Lower bordering neighbor roof is joining irregularly against the wall of the client property. There is a damaged and bent roof sheet causing for pooling, no run off for water, and unfinished wall plaster left to compromise the area, and water can freely access the client's property causing ongoing plaster, pain and structural damages.
