Our ref: P 2402-02-01 Forensic Engineering Assessment Report 00

## FORENSIC ENGINEERING ASSESSMENT REPORT

**HOUSE RUST  
ERF 3228, STERLING AVENUE  
PARYS COUNTRY AND GOLF ESTATE, PARYS**

**SECOND ISSUE**

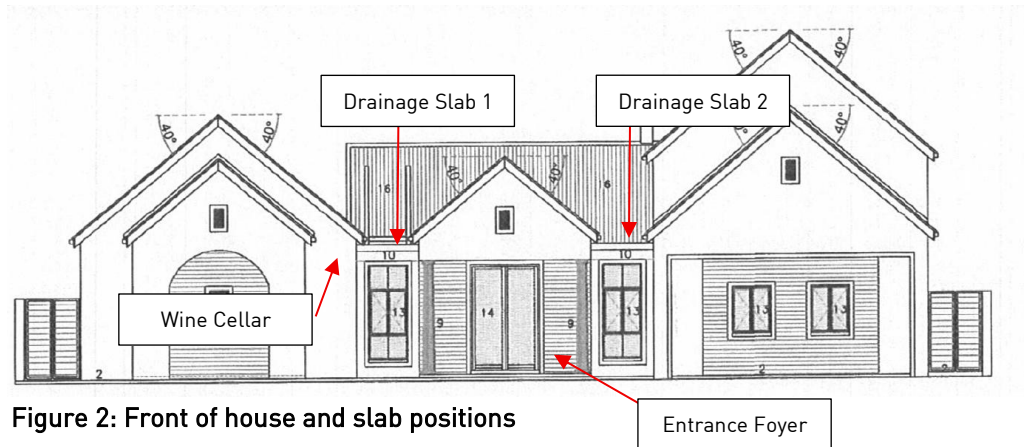
**Figure 2: Front of house and slab positions**

The house has two drainage slabs on opposite ends of the entrance foyer. A visual inspection was conducted on both slabs. Where access was not possible without dismantlement or demolition, assumptions were made to assist with the structural evaluation.
